**U.S. ARMY CORPS OF ENGINEERS  
WALLA WALLA DISTRICT  
FISH FACILITIES WEEKLY REPORT  
#19-2022**

**Project: McNary**

Dates: July 8 – July 14, 2022

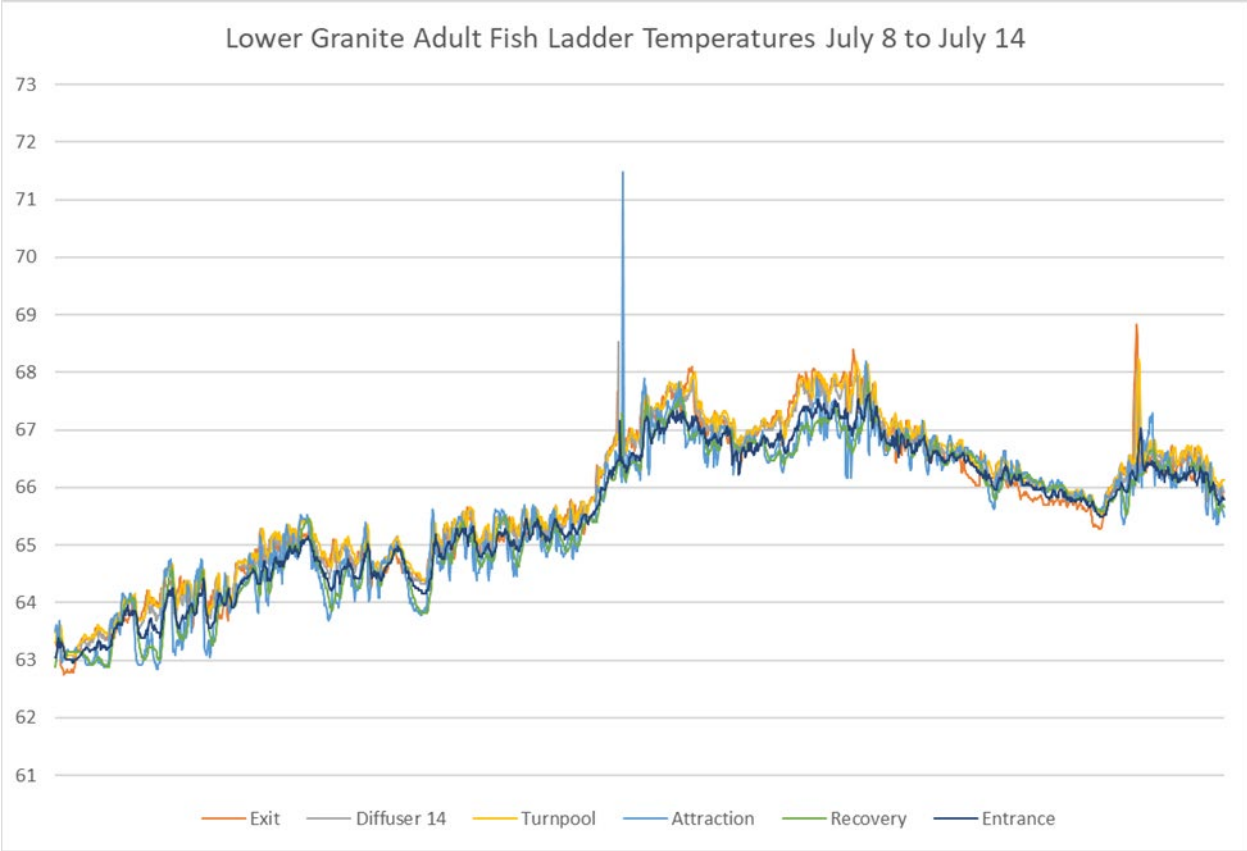
Figure 1. Lower Granite Dam adult fish ladder temperatures July 8 to July 14, 2022.

Comments: The fish ladder cooling water pumps are in operation. The fish ladder exit cooling pumps were removed from service from 1056-1131 hours July 14 to repair a failed solenoid valve on pump 1. The fish ladder temperature probes and system were upgraded over the winter outage season. NWW and NWD continues working on the issue with some sensor readings available online. Two clipped adult Chinook salmon were observed at the fish ladder exit pool July 11. HOBO ladder temperature data are in at the end of this report (Figure 1).
