**U.S. ARMY CORPS OF ENGINEERS  
WALLA WALLA DISTRICT  
FISH FACILITIES WEEKLY REPORT  
#25-2024**

**Project: McNary**

Dates: August 16-22, 2024

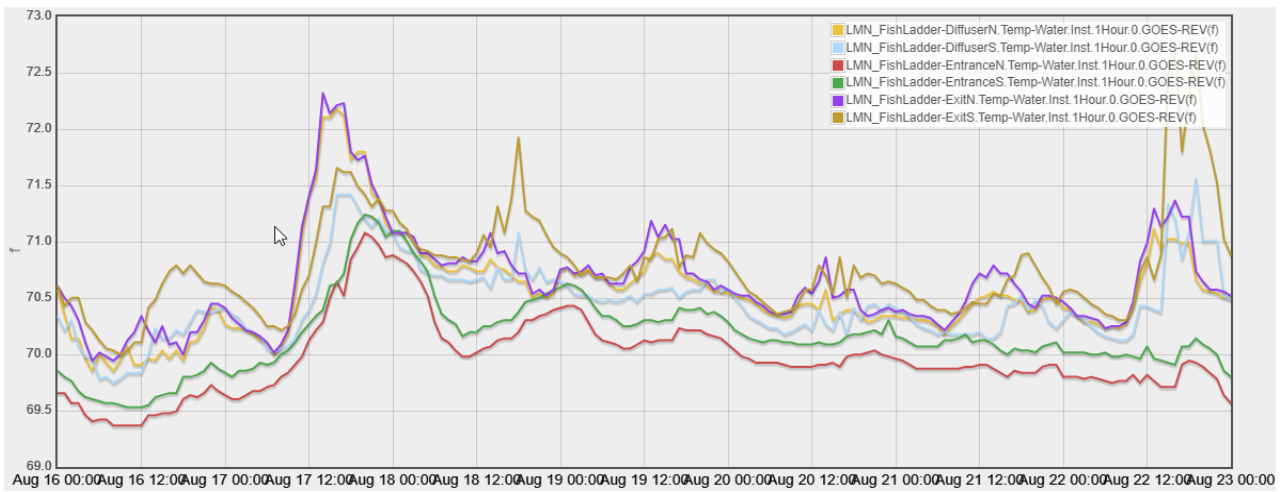
Temperature Probes: The adult passage temperature probes operated correctly during this reporting period. The graph below shows the temperatures per recording point for the reporting period.
