**U.S. ARMY CORPS OF ENGINEERS
WALLA WALLA DISTRICT
FISH FACILITIES WEEKLY REPORT
#26-2024**

Project: McNary

Dates: August 23-29, 2024

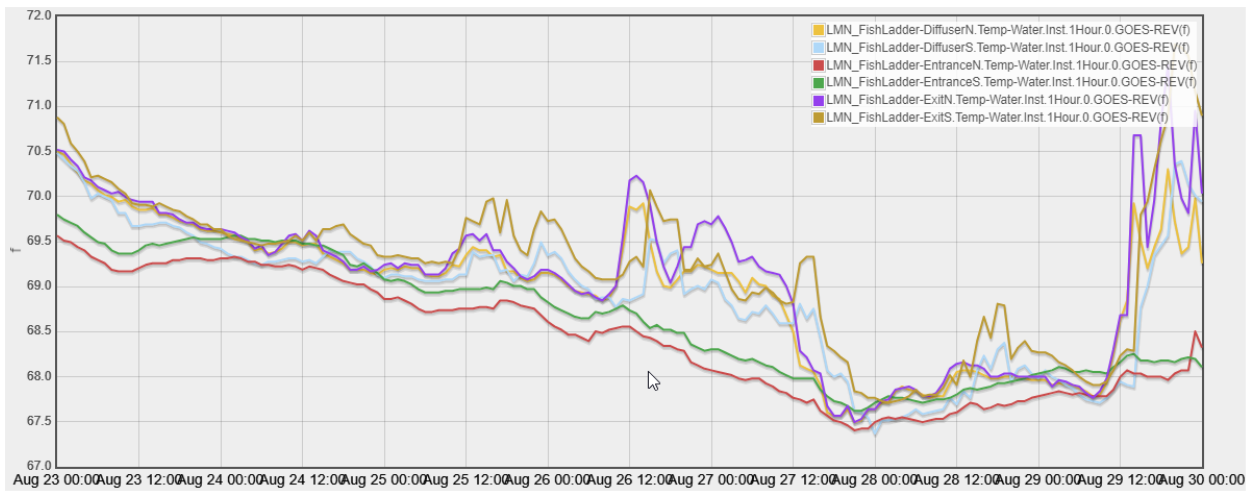
Temperature Probes: The adult passage temperature probes operated correctly during this reporting period. The graph below shows the temperatures per recording point for the reporting period. On August 29, hydrology noticed an issue with the ladder entrance battery. Hydrology will be coming to project on September 3 to replace the battery.
