**U.S. ARMY CORPS OF ENGINEERS  
WALLA WALLA DISTRICT  
FISH FACILITIES WEEKLY REPORT  
#27-2024**

**Project: McNary**

Dates: August 30-September 5, 2024

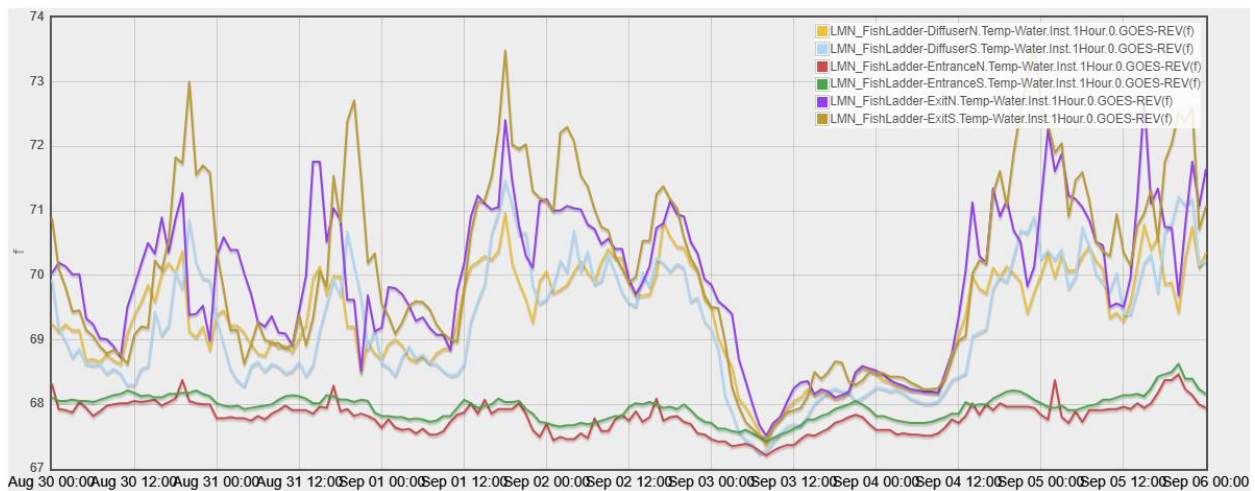
Temperature Probes: The adult passage temperature probes operated correctly during this reporting period. The graph below shows the temperatures per recording point for the reporting period. On August 29, hydrology noticed an issue with the ladder entrance battery; the battery was replaced on September 3.
