**U.S. ARMY CORPS OF ENGINEERS
WALLA WALLA DISTRICT
FISH FACILITIES WEEKLY REPORT
#29-2024**

Dates: September 13-19, 2024

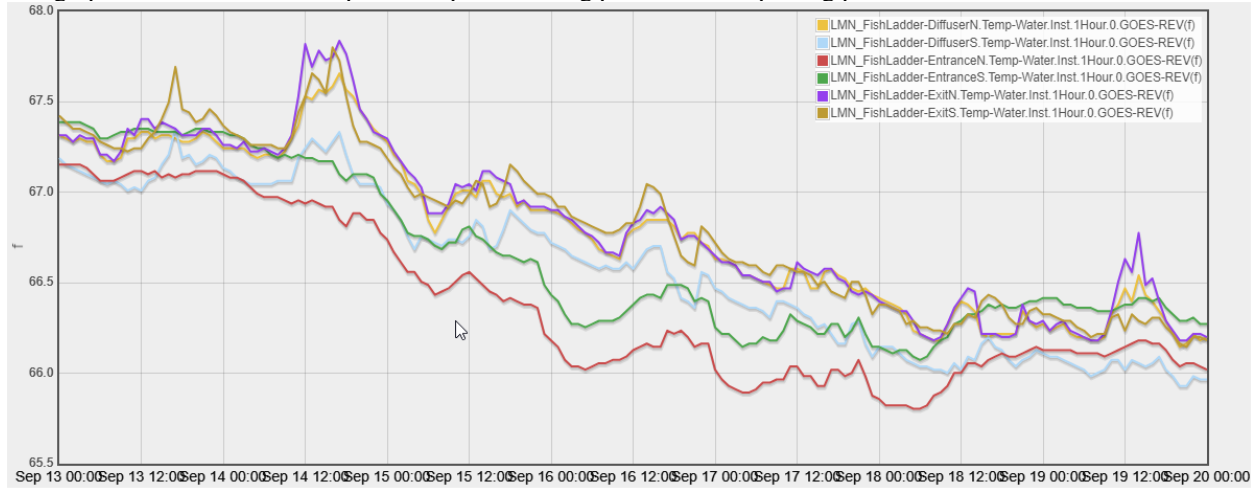
Temperature Probes: The adult passage temperature probes operated correctly during this reporting period.

The graph below shows the temperatures per recording point for the reporting period.
