MEMORANDUM FOR THE RECORD

COORDINATION TITLE - 19CGR01 MFR Ramp Rate Minimum Flow

PROJECT - Cougar Dam

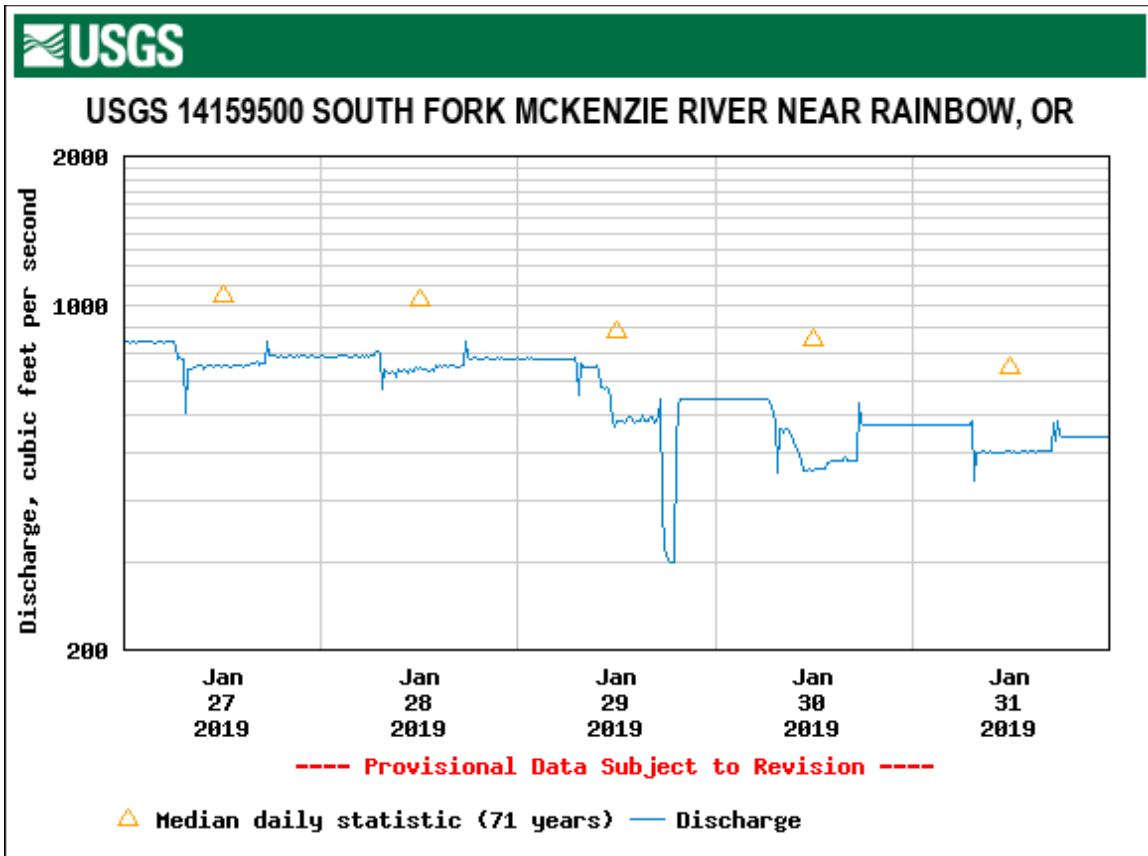
Description of the problem - On 29 January there was an error while transitioning unit flow (both units) at Cougar Dam to regulating outlet (RO) flow for fish passage operations. Instead of a target flow around 580 cfs, it decreased to about 260 cfs resulting in a ramp rate deviation (-0.51 feet/hour) and a flow (277 cfs) deviation below minimums detailed in the Biological Opinion (BiOp).
