August 3, 2017

Memorandum -- delivered via email

Subject: NMFS' comments on MFR "17BCL06 minimum flow ramp rate"

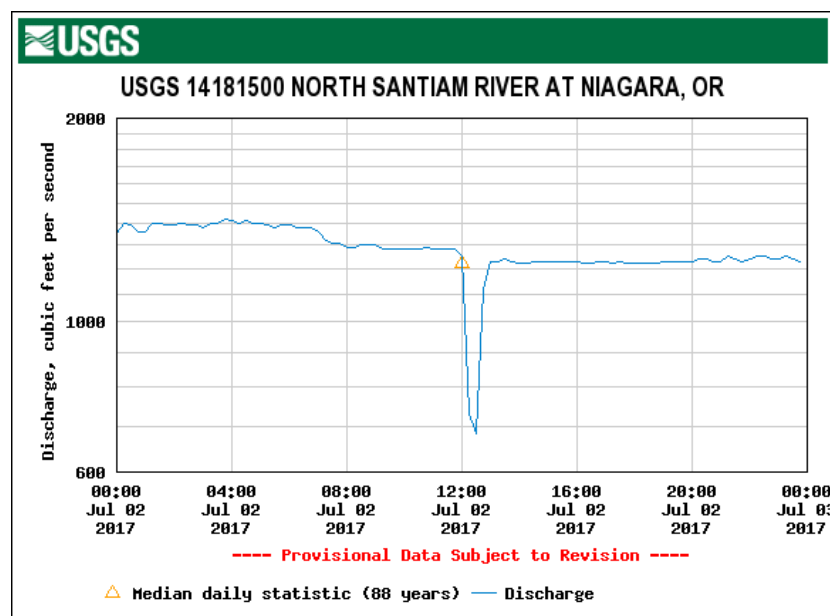
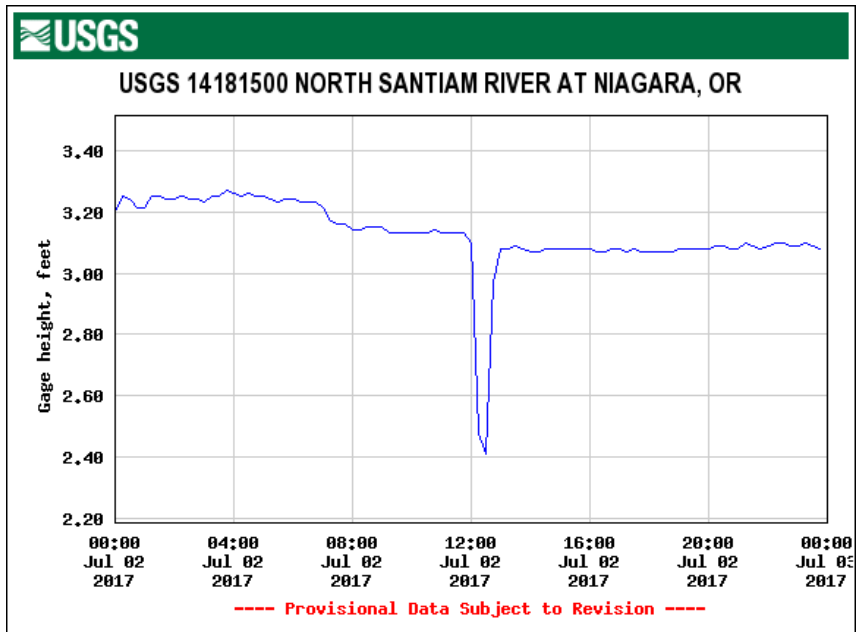
This MFR describes a violation of minimum instream flow targets and a coincident ramp rate deviation observed on July 2nd 2017 at around noon due to equipment malfunction. The minimum flow target specified by the Willamette Biological Opinion (BiOp) for July is 1,200 cfs below Big Cliff dam, however flows dropped to almost half of that (682 cfs) for less than an hour during this event. Gage height in the N. Santiam dropped and then increased by almost 0.7 feet in each direction within that hour (approximately 12pm to 1pm). This led to a maximum ramping rate of -0.6 feet/hour when the limit established by the Willamette Biological Opinion, RPA 2.6, is -0.2 feet/hour during daytime hours. Further, the auto-gate function used to maintain outflow in the event of a malfunction also failed.

This rapid change in river level set off alarms at the Minto Fish Facility several miles downstream according to ODFW staff (G. Grenbemer, pers. communication via email 7/3/17), indicating a risk that their pump system could run dry at those low levels.

NMFS agrees that it is likely some fish were impacted by this flow rate and ramp rate deviation, as incubating steelhead eggs in redds may have been dewatered and steelhead fry and Chinook salmon juveniles expected to be present may have been stranded by this sudden change in river elevation. However, it is impossible to know how many fish may have been stranded because the short duration of the event precluded any opportunity to survey the area, and the number of redds potentially dewatered is unknown. Therefore, it is not possible to estimate the full impacts to listed Chinook salmon and steelhead as a result of this flow and ramp rate deviation. However, we anticipate any impacts of redd dewatering were minimized by the brief duration of this event.

NMFS would like more information about the cause of the equipment failure and why the back-up system failure occurred. We understand that unforeseen failures and outages will occur, which is why back-up systems have been put in place. If these safeguard systems are not adequate to prevent negative impacts due to equipment failures then these shortcomings need to be addressed. NMFS would like the Corps to provide a detailed explanation of the steps that are being taken to update equipment and/or procedures to ensure this kind of equipment failure will not result in minimum flow or ramp rate deviations in the future.
