MEMORANDUM FOR THE RECORD

TITLE – 17DET04 Minto Fish Facility Hoist Failure

PROJECT – Detroit/Big Cliff Dams, Minto Fish Facility

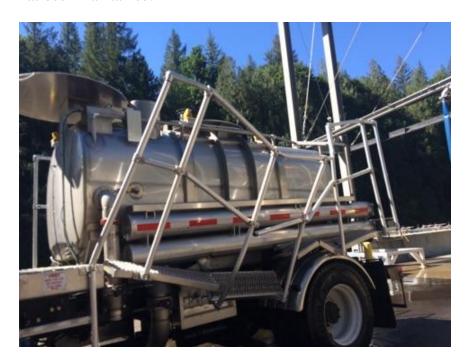
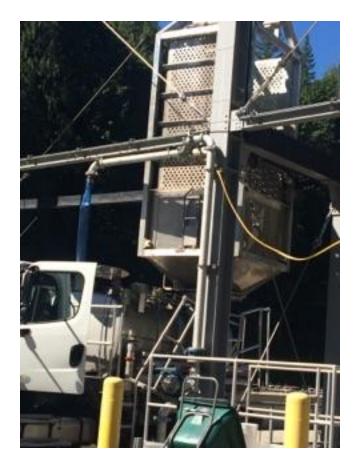
On July 31, 2017, operators (ODFW) at the Minto Fish Facility were using a hoist to lift a hopper for loading fish into a truck for upstream transport. At approximately 1030 hours the hopper dropped damaging the fish transport truck. The hopper was brought to the hopper stand and a hose supplying freshwater was immediately placed to provide a water supply. Thereafter, approximately 51 adult spring Chinook salmon were netted and placed back into a raceway. Willamette Valley Project staff responded to troubleshoot the issue and it appears the hopper dropped under load due to a clutch/brake failure of the hoist, however, investigation and repair are ongoing.

Fish were trapped in the hopper until they were netted and released into a raceway. The fish transport truck was damaged but is operational. The ability to move fish upstream has been maintained.

The ability to move fish upstream was maintained using the second hoist. Parts have been ordered to fix the broken hoist. Corps staff are looking into the installation of back-up brake system to prevent failure and improve safety. The ideal result would entail each hoist having two brakes.
