MEMORANDUM FOR THE RECORD**SUBJECT: 23BCL04 MFR DC Power Loss – Ramp Rate Deviation****Description of the problem:**

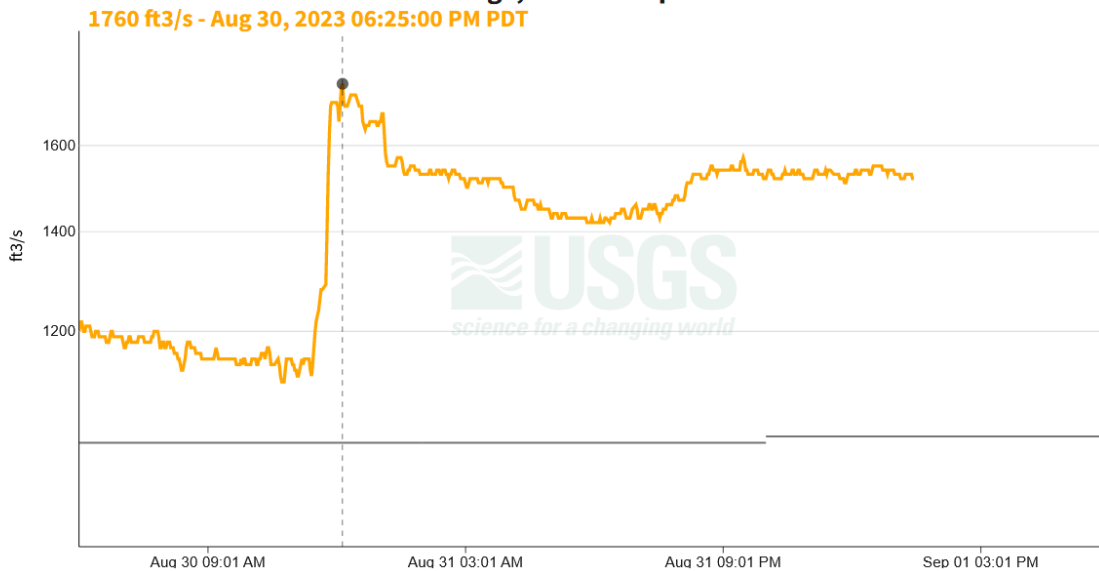
Flows temporally increased from approximately 1150cfs to peak at 1760cfs before returning to approximately 1500cfs. From 1630 to 1730 there was a .45ft ramp rate increase, above the WFOP limit of .3ft/hour.

Fig 1. The increase in flow seen below Big Cliff project seen on 30 August.

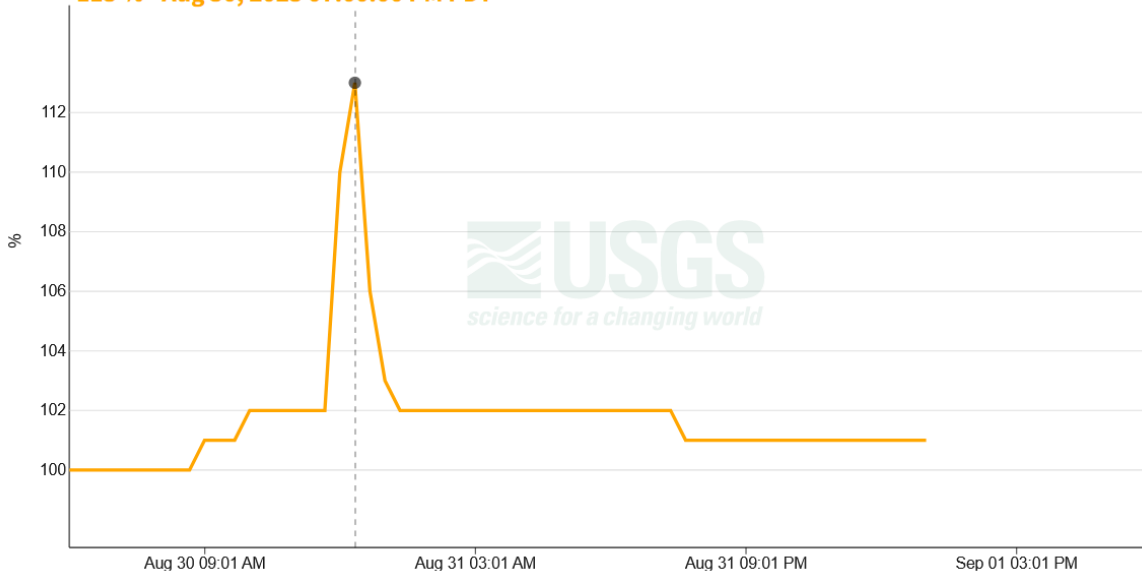
Total dissolved gas (TDG's) also increased from 102% to 113%, above the ODEQ limit of 110%, before returning to approximately 102%.

Fig 2. TDG's were temporally elevated above the 110% limit on Aug 30th.

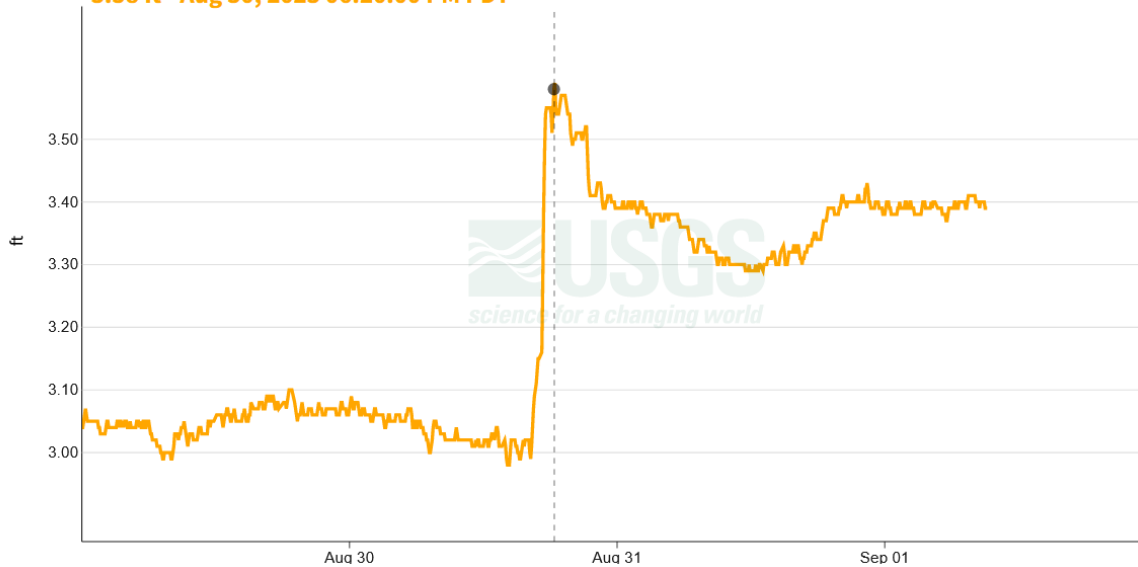
Fig 3. Gage height for the North Santiam River at Niagara, after the temporary increase on August 30th, 2023.
