**USACE Portland District (NWP) FFDRWG Update Form
5 February 2015**

Project Title	Minor Fishway Modifications to Improve Lamprey Passage
SCT Reference Number	
Project Manager (PM)	Gail Saldana (503-808-4781)
Technical Lead (TL)	Scott Wilcox, Small Projects Team (503-808-4435)
Biologist/Coordination	Sean Tackley (503-808-4751)

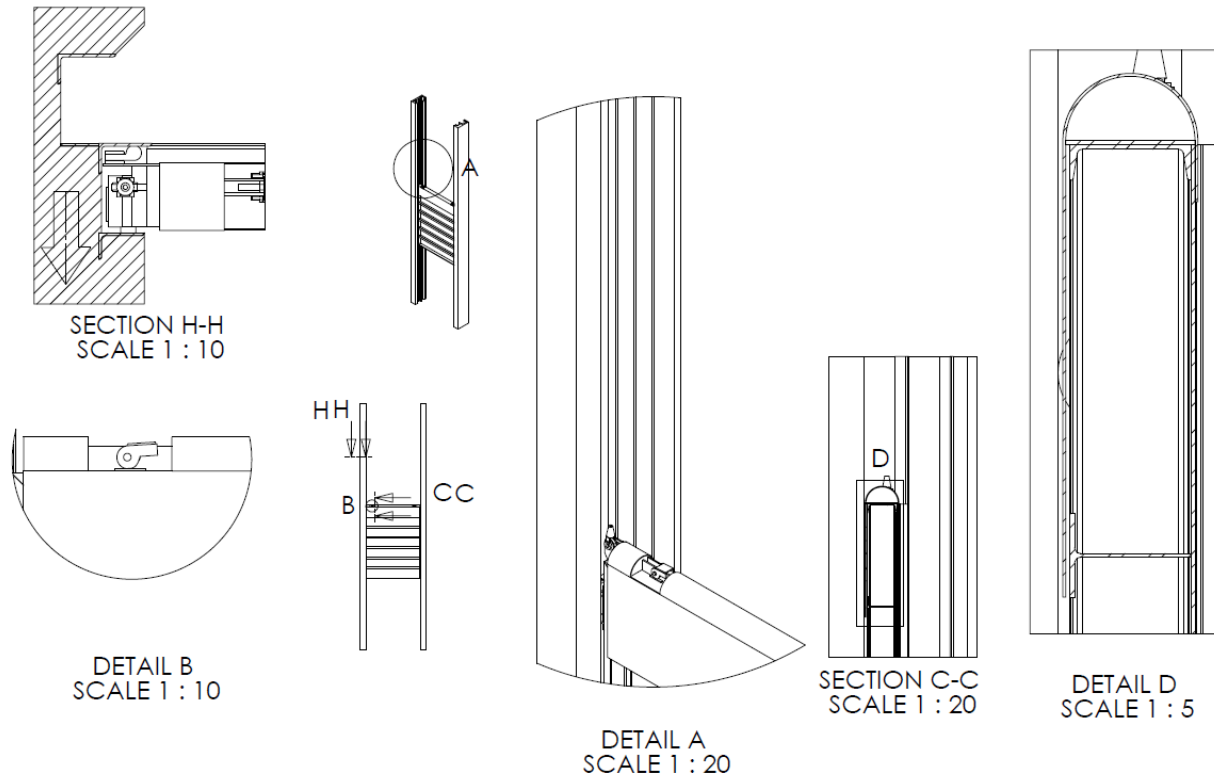
2. BON Project is fabricating and installing new rounded entrance weir caps at all four main BON WA Shore entrance weirs (Figure 1). Caps have been installed on the South Upstream Entrance (SUE) and South Downstream Entrance (SDE) weirs. The north end of the lower fishway was not dewatered this winter, so entrance weirs at that location are under water. BON riggers could not determine a way to safely/feasibly to remove the gates watered up, and dewatering the fishway for removal would have taken a lot of time and effort away from response to a sinkhole that has developed at Cascades Island. Remaining two caps will have to be installed during the 2016-17 IWW period, or as the opportunity arises.

Figure 1. Design drawings for entrance weir crest modifications to improve lamprey passage. Modifications include radiused weir caps, plating on the downstream face of the weir, and plating (not shown) to provide attachment surface over a small portion of guide slot(s). This design will not affect operation of the weir and at the WA Shore Ladder, the modifications will not affect the cross-sectional area of the entrance when the weir is in its lowest position.

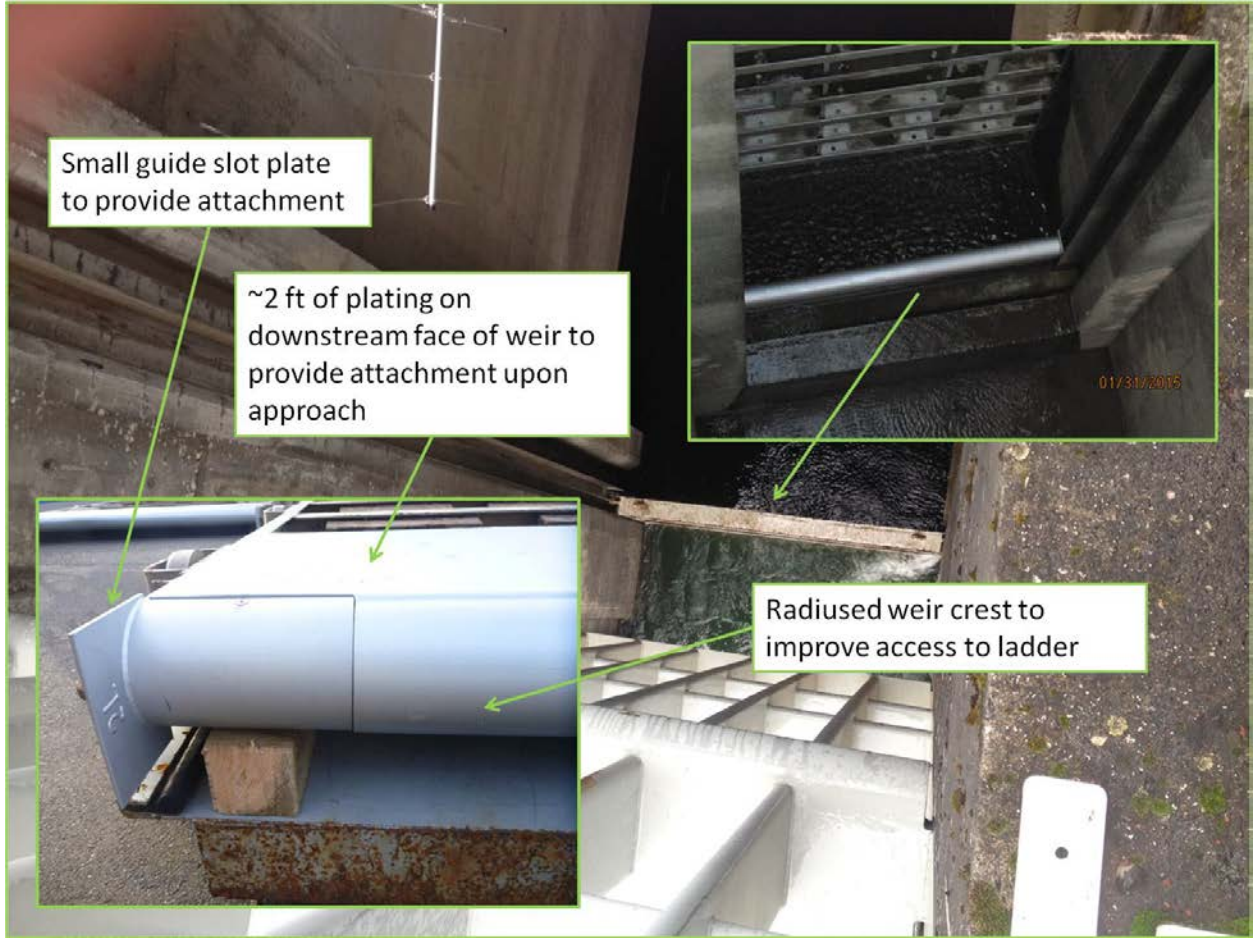
Figure 2. BON WA Shore Ladder entrance weir crest improvements, including photo of installed cap at one of the south entrances for reference.
