CENWP-OD-B

14 July 2022

SUBJECT: 22BON042 MFR U17 Tail Log PL Ammocoetes Morts

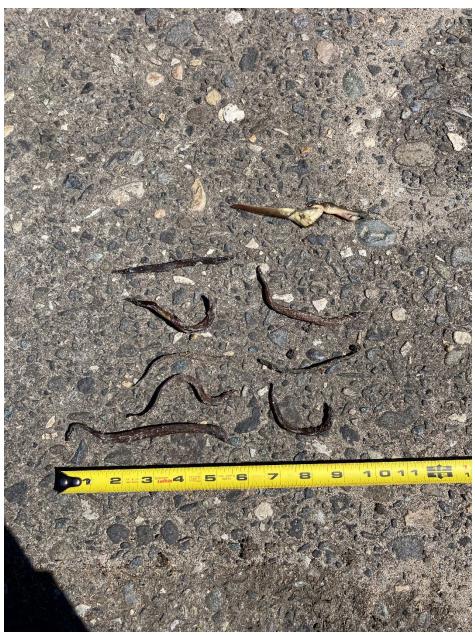
- A. Species Pacific Lamprey (Entosphenus tridentatus)
- B. Origin NA
- C. Length ammocoete stage with lengths between 50 150 mm
- D. Marks and tags NA
- E. Marks and Injuries found on carcass Signs of desiccation and being crushed
- F. Cause and Time of Death Most morts were caused by desiccation between 13-14 July. Several morts were crushed due to being on roadway.
- G. Future and Preventative Measures schedule frequent visits to the tail log equipment after salvage to ensure there are no fish stranded.

Photo 1 of ammocoete mortalities discovered from under deck plate. Please note this photo is only a portion of the 15 mortalities discovered.

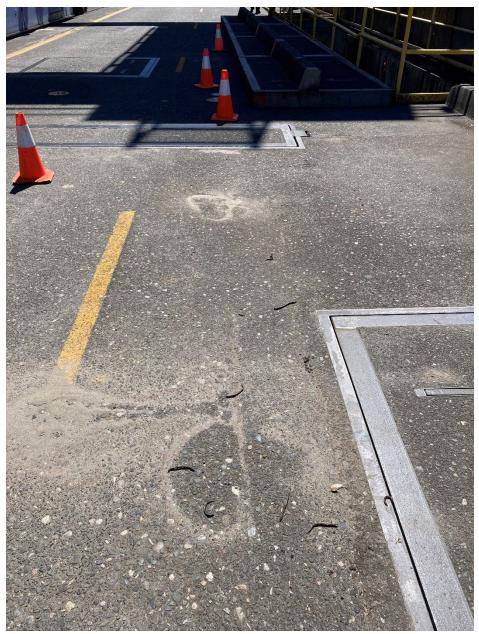
Photo 2 of ammocoete mortalities discovered from under deck plate. Please note this photo is only a portion of the 15 mortalities discovered

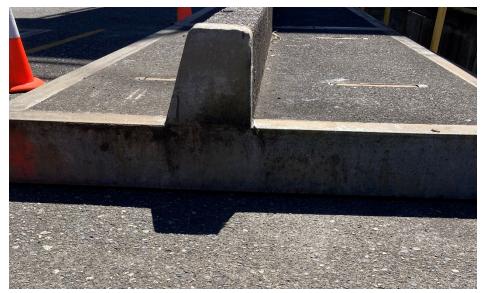
Photo of deck plate on roadway.
