OFFICIAL COORDINATION REQUEST FOR NON-ROUTINE OPERATIONS AND MAINTENANCE

COORDINATION TITLE- 16JDA01

COORDINATION DATE- 22 February 2016

PROJECT- JDA

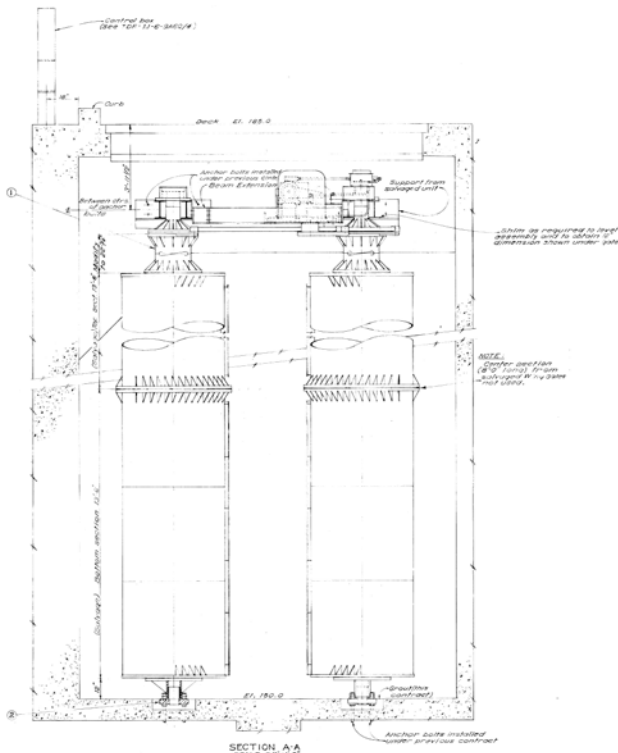
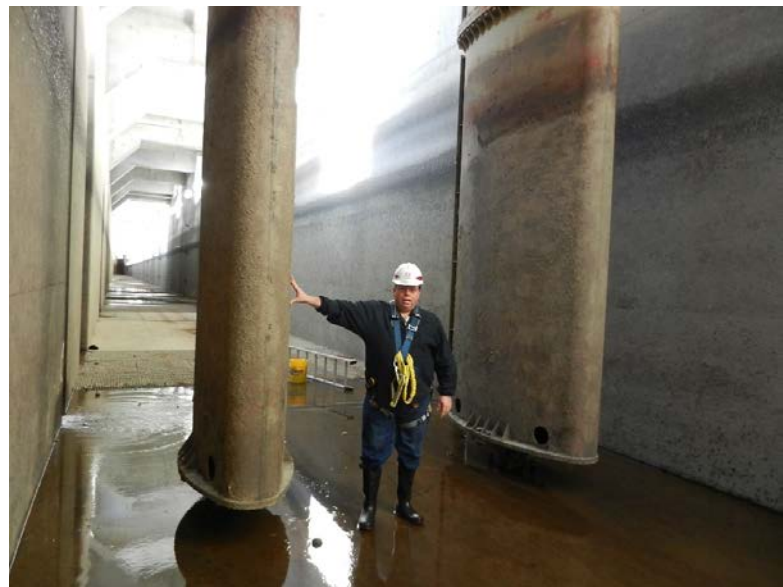
1. Remove Wing Gates: Two wing gates currently sit in the John Day Dam South (JD-S) fishway collection channel (figures 1 and 2) at turbine bay 9. They were constructed with the dam in 1964 in order to facilitate a partial closure or restriction of the collection channel (CC) in an emergency situation. However, they have never been used and due to the reduction in the number of floating orifice gates (FOGs) in 2005 (from ten to four), they are currently obsolete. According to the 2004 Hydraulic Evaluation of Lower Columbia River Adult Bypass Systems (HELCRABS) report, the wing gates actually impede hydraulic conditions (flows) within the CC during regular operations, and the report recommended their removal in order to improve hydraulic conditions and fish passage (Recommended Structural Improvements, page viii).

Figure 1: Diagram (left, closed position) and photograph (right, open position) of the wing gates within the JD-S CC.

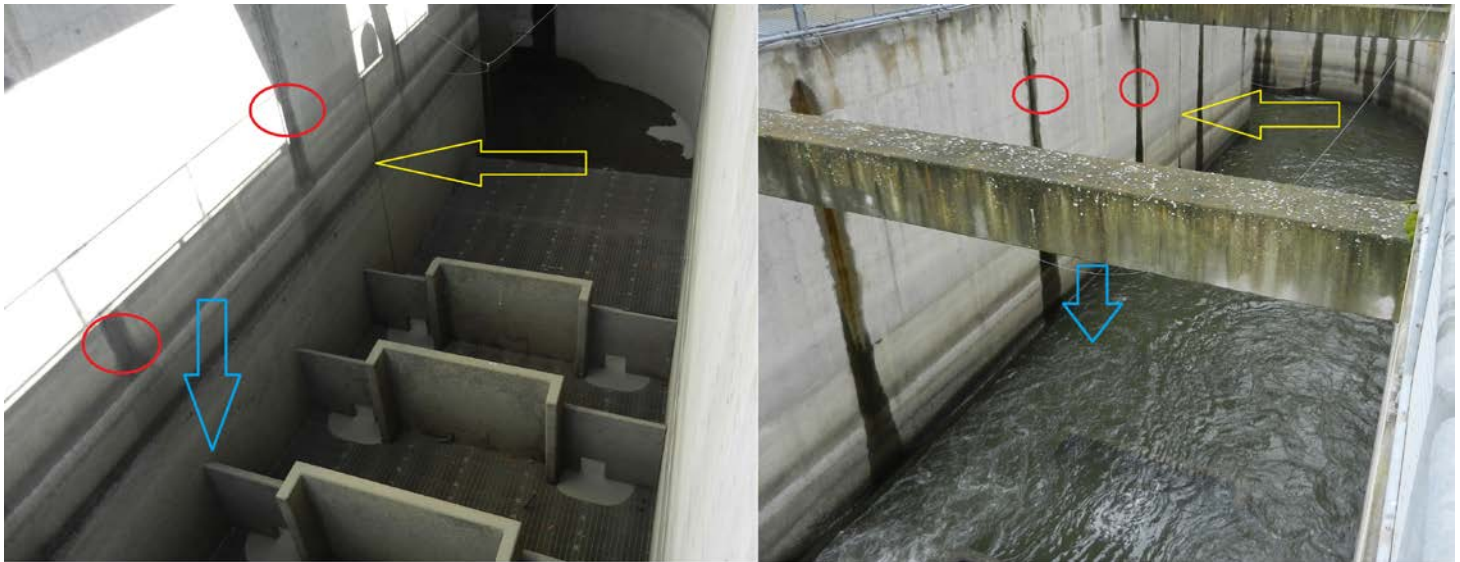
2. Remove Weirs 156-158: This action is symmetrical to the already accomplished and successful removal of the same weirs (156-158) at the JD-North fishway in 2011. These weirs (figure 3) are continuously submerged and therefore provide no hydraulic benefit to adult salmonids, and may be impeding adult lamprey passage. Telemetry studies conducted by the University of Idaho have indicated that some adult salmon slow down in that area, mill, and in some cases leave the fishway altogether (personal communications). Removal of these weirs was also recommended by HELCRABS (page viii). These weirs are only three of five lower fishway weirs that remain submerged year-round; hence weirs 159 and 160 will remain to provide sufficient coverage for any unexpected, future low tailrace conditions.

Figure 3: Lower three weirs at the JD-S fish ladder during winter maintenance (dewatered) on left, and during operation (watered up) on right. Yellow arrows show the same seam in the fishway wall, red circles indicate same water stains. The blue arrows show the location of the third weir proposed for removal. The high water line (not the same as the current water depth), along the wall, can also be used as an indicator.
