MEMORANDUM FOR THE RECORD: 20 LWG 04

SUBJECT: Juvenile lamprey mortality on direct load line dewatering screen.

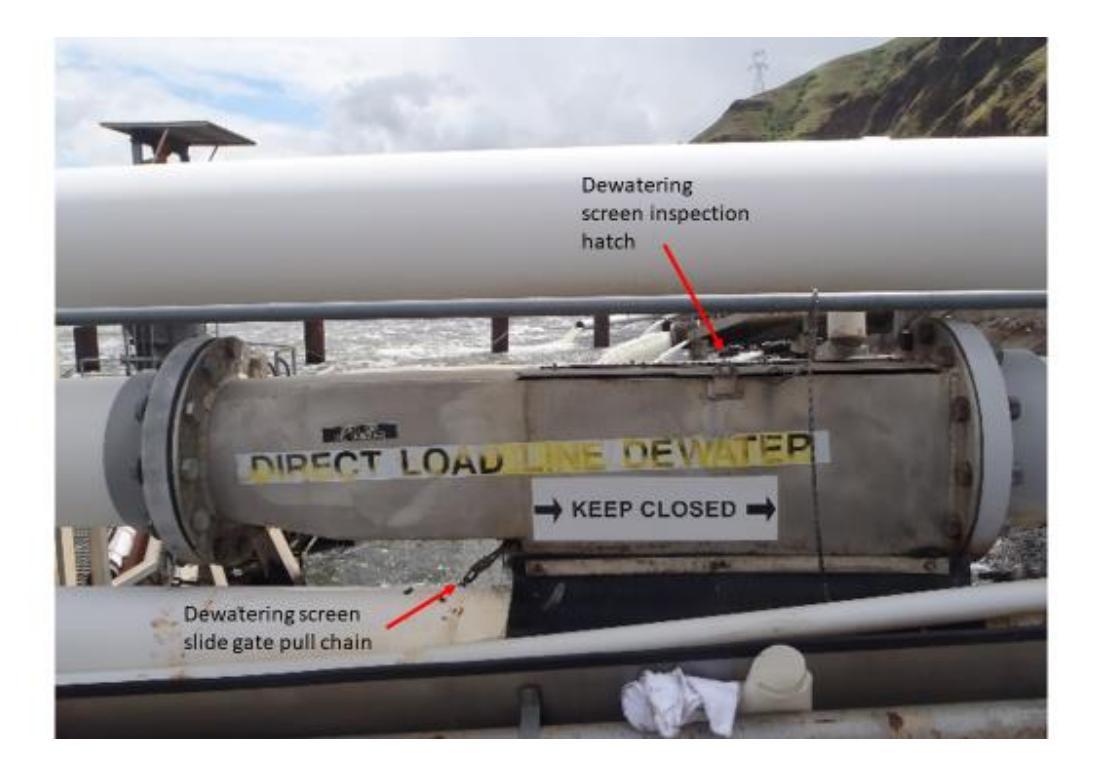
During the May 11 morning facility inspection Lower Granite biological technician observed direct barge loading dewatering screen slide gate was in the full open position. An estimated 100 juvenile lamprey mortalities were believed to be on the direct barge loading line and dewatering screen. The position of this dewatering gate is only changed during direct loading to control the volume of water going into the barge hold and is otherwise left in the closed position. When not in direct loading operation the gate is set closed to provide enough flow for fish that get past the two switchgates to return to the river. Flush water to the direct load system, the direct load dewatering slide gate position, and the direct load line switch gate position were verified during facility water up procedures. It is unknown when or why the unauthorized changes to the direct load system were made. The system was immediately returned to the correct operating positions when the issue was identified. Based on the SMP sample an estimated 27,750 juvenile lamprey were collected over the previous week and a total of 35,180 have been collected for the year as of May 10. No juvenile salmonids were in the flume, pipe, or on the screen. Corrective measures included clearly labeling "keep closed" on the flume (see photo), verbal and email communication to staff of future expectations, and adding the direct load line system as a separate inspection point on the bio tech activity log and biologist/lead tech inspection sheet.
