Memorandum

Re: Bonneville AFF PIT-Tag Antenna Placement

Date: April 8, 2014

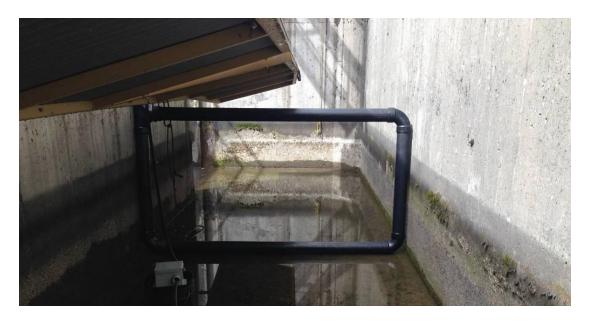
Figure 1. Antenna placed at proposed alternative location. Antenna at this location resulted in elevated noise levels on the existing BO3 system.

Biomark attempted to install a pass-through antenna within the BON AFF fish ladder return channel on 25 March 2014 (Figure 1). Inspection of the noise floor, conducted by PSMFC, on the existing BO3 system indicated interference between the existing system and the antenna at this location, thus preventing installation. Earlier noise listening measurements conducted near the entrance to the channel (Figure 2) did not result in interference with the BO3 system. This location was rejected due to possible disruption of flow and fish striking the antenna (Figure 3). Interference occurred at the alternative location due to the antenna being rotated 90 degrees; this was not taken into account when considering this location for potential antenna placement.

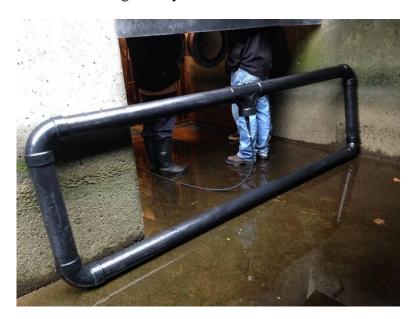
Figure 2. Antenna placed at entrance to BON AFF channel during noise listening survey conducted in fall 2013. This location was rejected due to possible flow disruption and fish strikes.

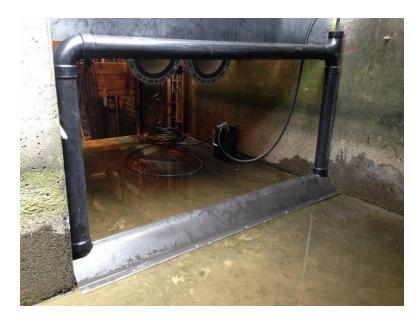
Figure 3. Antenna positioned near the entrance to the exit channel to confirm results from earlier noise listening effort. Fiberglass (FRP) ramps would be used to reduce flow disruption. This location did not result in noise on the BO3 system, but did raise concerns about possible fish strikes and flow disruption.

On 26 March 2014, we tested an antenna at the exit to the return channel. The antenna placed at this location did not generate interference on the existing BO3 system. The antenna required for this location is larger than the antenna intended to be installed, due to the need to extend beyond the opening for placement of anchors. The BON AFF channel was watered up at 1330 hrs on 26 March 2014, preventing any further work within the channel.

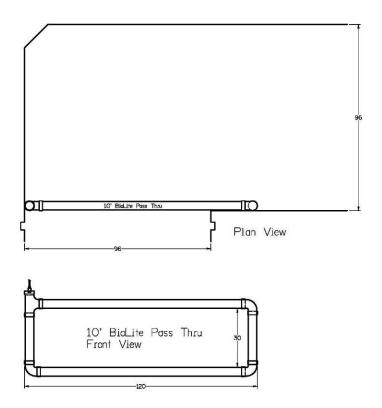
Figure 4. Plan view of potential antenna location at exit to BON AFF channel. FRP ramps would be used to secure the antenna to the channel wall and reduce flow disruption.

Option 1: Install pass-through antenna at exit (Figure 4).

Option 1 would provide the highest detection efficiency as fish are compelled to swim through the antenna. This antenna could be connected to the existing FS1001M reader (FDX-B only) in the facility. Installation would require one day within the channel.

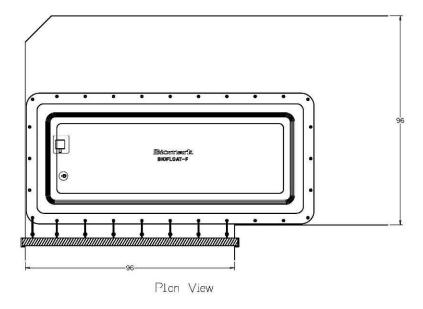
Figure 5. Plan view of 10' BIO Floating antenna at exit to BON AFF channel. First section of shade cover would need to be lifted up, from deck, to allow installation of the antenna.

Option 2: Install floating antenna at exit (Figure 5 and Figure 6).

Option 2 would likely provide acceptable detection efficiency as the nominal detection range of the antenna is 24 inches; water depth is approximately 18 inches. Additional testing will need to be conducted to determine if this antenna in a slightly different orientation results in noise on the BO3 system. The floating antenna could be installed from the deck and operated on a standalone Biomark IS1001 reader placed on the railing above this location (Figure 7). Rigging to secure the antenna would be contained within the existing gate slots.

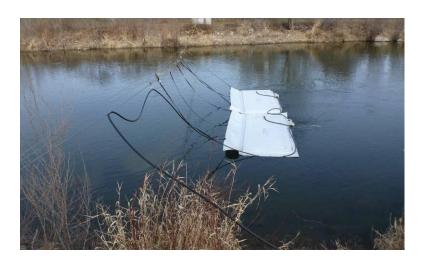
Figure 6. Picture of 2-10' BIO Float antennas installed in the Okanagan River, BC in spring 2014.

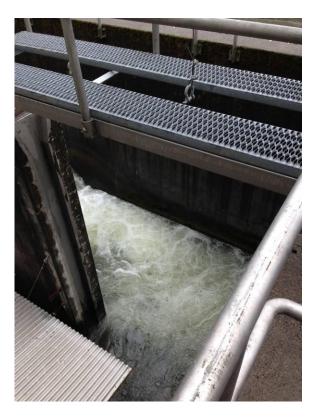
Figure 7. Picture of gate slots at exit to BON AFF channel.
