SOUTH SHORE CONSTRUCTION-NAV. LOCK, NON-OVERFLOW DAMS, FISH LADDER, POWERHOUSE AND SPILLWAY

Figure 6: Areas of significant undermining

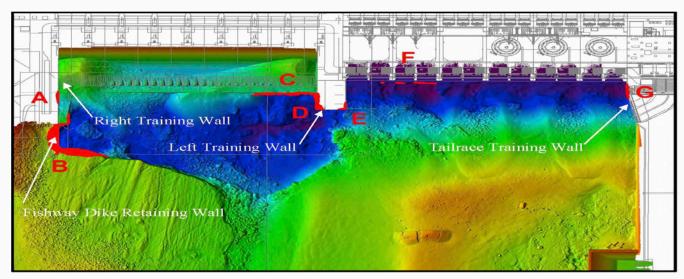
To quantify the amount of undermining, a reference surface is required. At the time of this report, no as-built Computer Aided Design and Drafting (CADD) objects were available for comparison. Reference surfaces were generated from least squares best-fit planar objects aligned to walls. A summary of the approximate extents of the undermining at each area are presented in Table 6. The depth of the undermining is shown as a distance from the reference plane, normal to its surface. Volumes represent the cubic yards required to fill the void under walls or structures created by the undermining process. Volumes were not computed when the undermining created voids under bedrock.

**Table 6: Extents of significant undermining**

Designation	Area	Length (Feet)	Height (Feet)	Depth (Feet)	Volume (Cubic Yards)
Α	Right Training Wall	26	13	3	10
В	Fishway Dike Retaining Wall	76	42	19	1050*
С	Stilling Basing End Sill	30	5	2	5
D	Left Training Wall, North Side	50	14	12	53
E	Left Training Wall, West Side	18	8	2	3
F	Powerhouse	22	4	3	N/A
G	Tailrace Training Wall	46	7	5	14

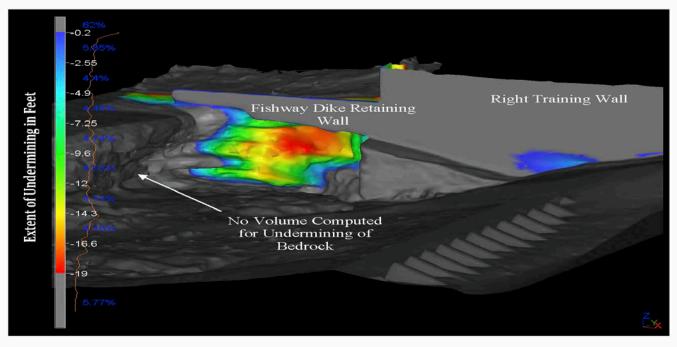
Figure 8: Undermining Area B, Fishway Dike Retaining Wall

A very large area of erosion was discovered downstream of the north fish entrance, shown in Figure 8. This area undermines the Fishway Dike Retaining Wall and bedrock downstream of the north fish entrance. It does not undermine the fish entrance. To measure the volume, the same plane fit to the Right Training Wall computed for Area A, which extends to the end of the Fishway Dike Training Wall, was used as the reference surface.

The void under the Fishway Dike Retaining Wall is approximately 76 feet long by 42 feet high, cutting a maximum of 19 feet into the area behind the wall. The volume of the pocket was estimated at 1,050 cubic yards.

Although a significant amount of undercut exists in the bedrock downstream of the stilling basin, it lies outside of this plane. The volume of this area was not included as there was no information available to reconstruct a reference surface.

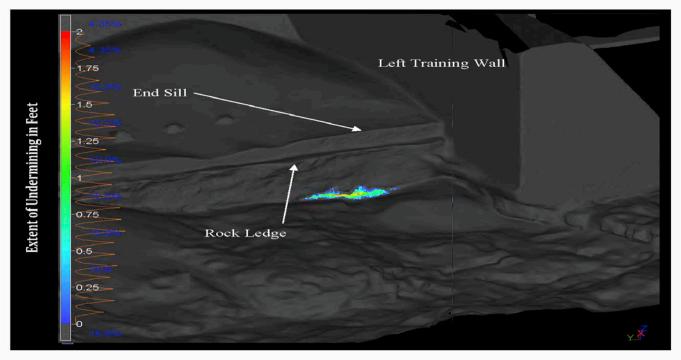
Figure 9: Undermining Area C, Stilling Basin End Sill

Apparent undermining exists beneath the stilling basin end sill, as shown in Figure 9. The extents of the undermining were estimated by fitting a vertical plane through the top of the end sill, then projecting that plane down to the river bottom below. The end sill is resting on bedrock which is being undermined leaving a ledge of material with varying widths at the base of the endsill.

The extent of the area lying beneath the stilling basin slab is approximately 30 feet long by 5 feet high, cutting a maximum of 2 feet into the area below the stilling basin (distance from a plumb line from the end sill and not from the rock ledge projecting downstream). The volume of the undermined area was estimated at 5 cubic yards.
