**MEMORANDUM FOR THE RECORD****SUBJECT: 17BON01 MFR – ROV inspection at Cascades Island Entrance Pool**

On 07 February, Project biologists conducted an ROV inspection of the Cascade Island and B-branch entrance pools. No issues were found at B-branch. Four items of concern were found at Cascades Island.

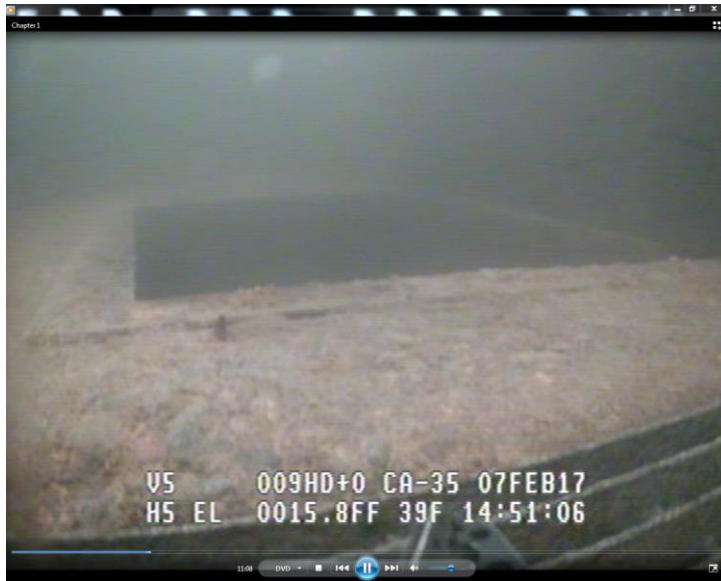
Figure A.

- 1) Diffuser pit access hatch across from FG6-18 is blown off (figure A).
- 2) The south elevator door has a screen opening at its base that is blown open (figure B).
- 3) One piece of grating at FG6-20 is blown off (figure C).
- 4) One of two channel keeper bars on the FG6-16 diffuser plate is blown off (figure D). These bars hold the diffuser plate in place. When the other bar goes, the diffuser plate will displace.
