**MEMORANDUM FOR THE RECORD**

**SUBJECT: 17JDA05 MFR** – Two juvenile chinook mortalities found crushed under SMF switch gate.

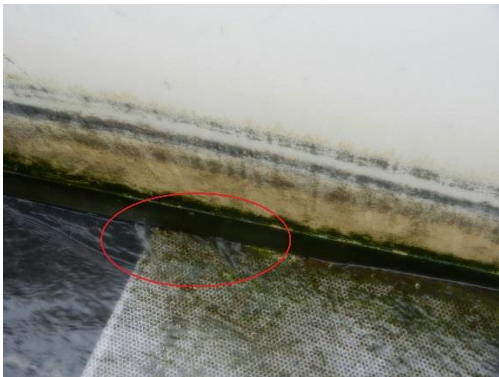
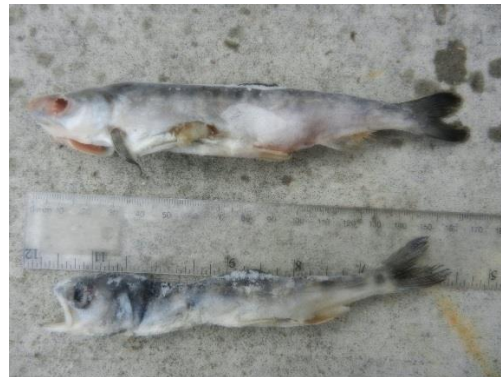
On April 22<sup>nd</sup>, 2017 two juvenile chinook smolts were found crushed under the SMF switch gate during a routine inspection. It appears that a stick got caught under the gate while it was moving between the sampling and bypass modes. Then, other small debris accumulated around the stick, and this caused a short, 1 foot section of its gasket to expand/ bulge out from its proper sitting, mid gate. Total length of gate is ~25 feet. The bulged out gasket was pushed under the switch gate on 4/24 AM, but it is likely to come out when the gate is moved again. JD Maintenance is investigating if the loose gasket can be secured underneath the gate without lifting it up with a mobile crane (a major and lengthy procedure which is best delayed until the winter maintenance season.)

- A. Species – (x2) juvenile chinook
- B. Origin – unknown
- C. Length – N/A
- D. Marks and tags – One adipose fin clipped, another intact. No other marks or tags observed.
- E. Marks and Injuries found on carcass – Both smolts were crushed and severely mutilated.
- F. Cause and Time of Death – Crushed by switch gate, exact time unknown
- G. Future and Preventative Measures – Switch gate will be lifted with a mobile crane for an inspection and necessary repairs the next winter. We hope that the gasket can be secured in place with the gate in place.
