MEMORANDUM FOR THE RECORD – 18 LGS 05 MFR Direct Loading Mortality**SUBJECT: A-side Direct Loading Hose Debris Plug**Background

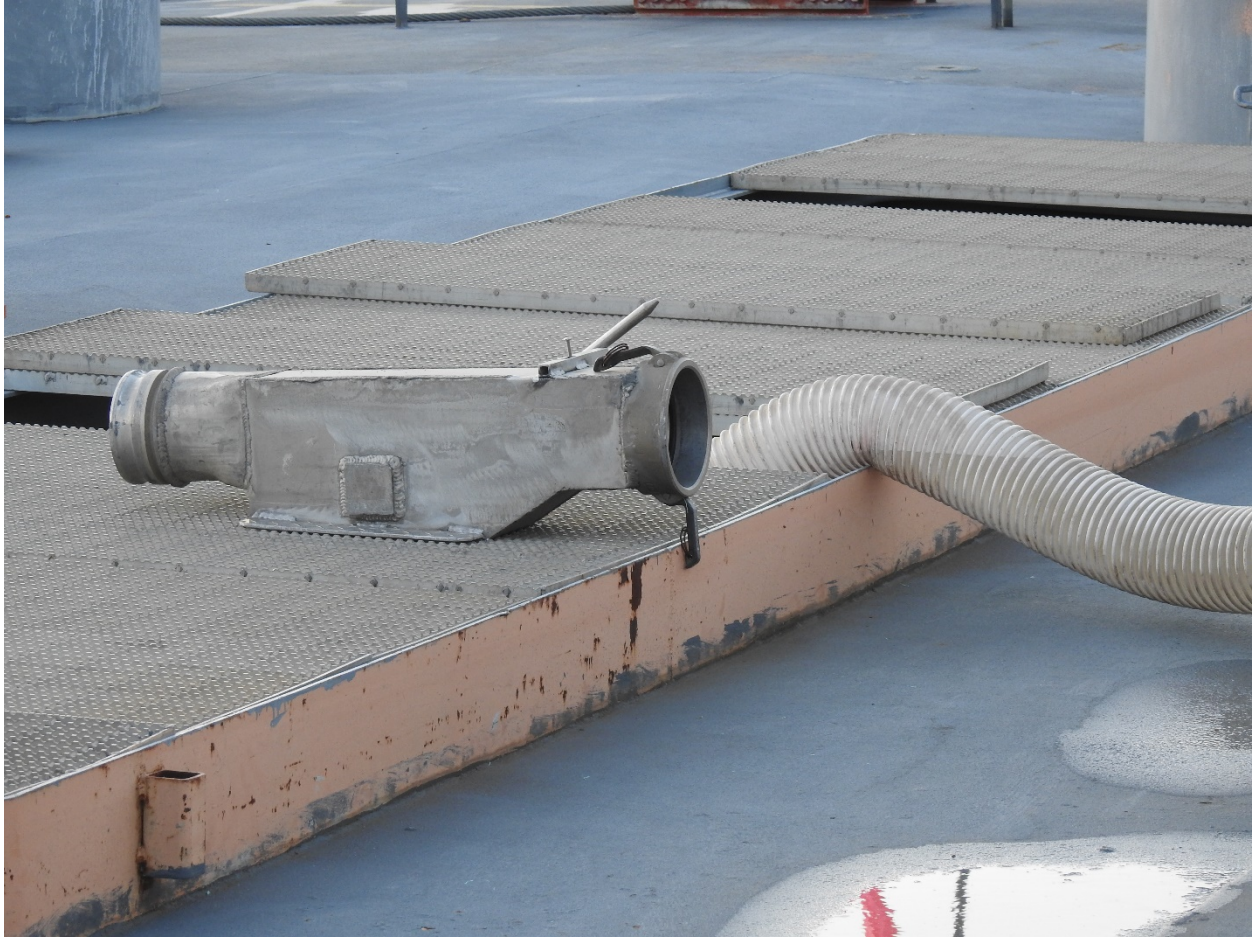
At approximately 01:00 on April 27, the A-side direct loading hose plugged at the cam lock fitting mounted on the transport barge (Image 1). Fish were immediately diverted to raceways in order to unplug the pipe. A total of 389 juvenile salmon and steelhead mortalities were collected.

Image 1: Cam lock fitting mounted on transport barges.

- A. Species – Chinook salmon *Oncorhynchus tshawytscha*, Steelhead *Oncorhynchus mykiss* and Coho salmon *Oncorhynchus kisutch*.
- B. Origin – Hatchery and Wild
- C. Length – N/A
- D. Marks and tags – All fish were examined for PIT tags and coded wire tags (CWT) by ODFW and Anchor QEA employees. Of the 389 fish, 3 were marked with PIT tags (Table 1) and 10 unclipped yearling Chinook were marked with CWT.
- E. Marks and Injuries found on carcasses – N/A
- F. Cause and Time of Death – Debris blockage at 01:00 on April 27.
- G. Future and Preventative Measures – Project staff have quit attaching the A-side direct loading line to the cam lock fitting and will minimize direct loading unless additional capacity is required and debris is manageable.
