**MEMORANDUM FOR THE RECORD: 22 LWG 09 Adult Chinook Salmon Mortalities**

**SUBJECT: Two adult Chinook salmon mortalities**

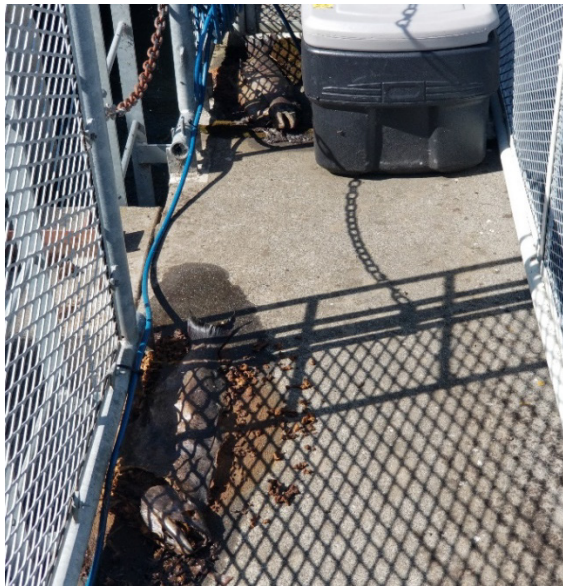
Two clipped adult Chinook salmon mortalities were observed on upper fish ladder control section walkway July 11. Both fish apparently jumped from the ladder landing on the walkway where they were found (Photo 1). Fish jumping from the fish ladder at this location has not been observed in the past.

Photo 1: Adult Chinook salmon mortalities observed at Lower Granite Dam July 10, 2022.

- A. Species – Adult Chinook salmon.
- B. Origin – Hatchery.
- C. Length – N/A
- D. Marks and tags – Adipose clipped
- E. Marks and Injuries found on carcass – Carcasses were in different stages of decomposition.
- F. Cause and Time of Death – It is believed that both fish jumped through the safety chains onto the walkway where they expired.
- G. Future and Preventative Measures – Removable jump screens will be fabricated and installed to prevent fish from jumping through the chains in the future.
