MEMORANDUM FOR THE RECORD: 23 LGS 10 Adult Chinook Mortality**SUBJECT: Adult Chinook Mortality**Background

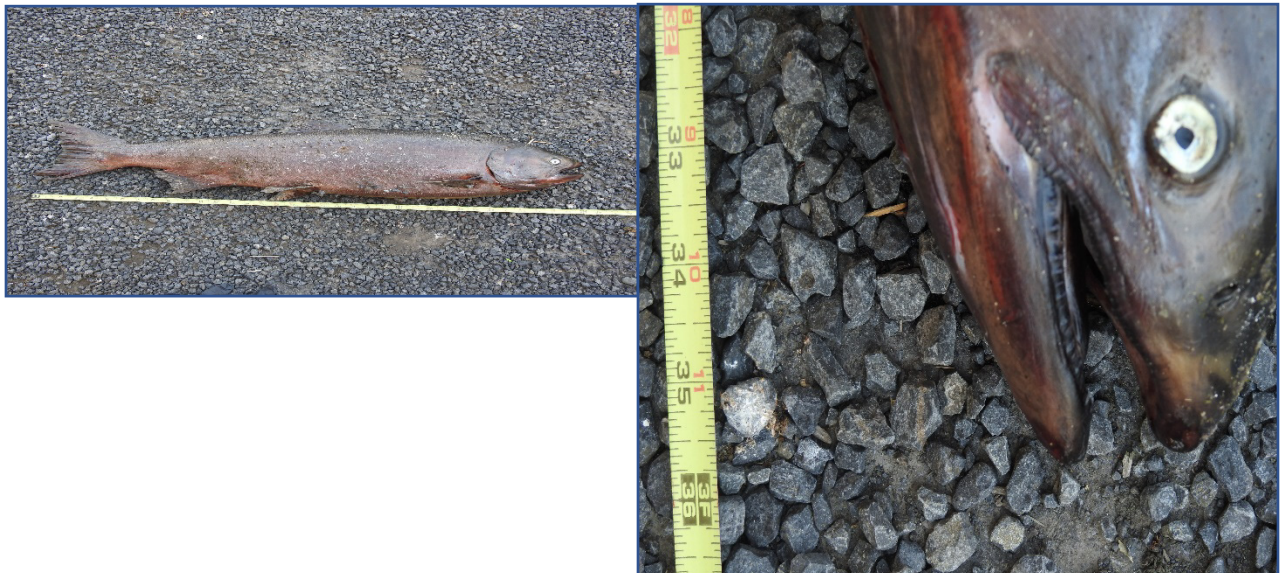
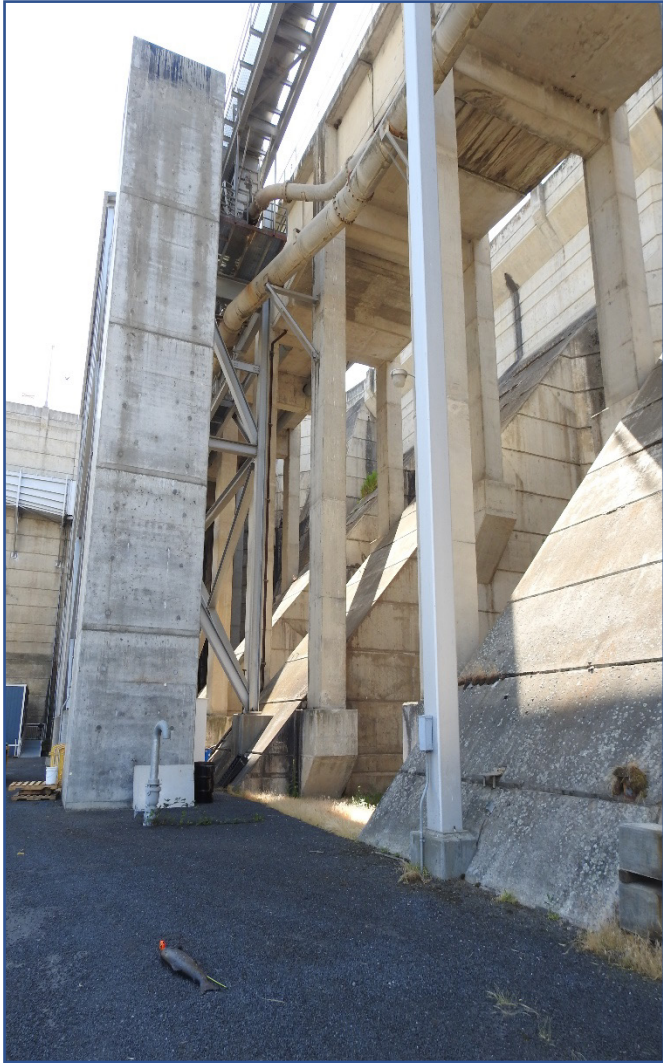
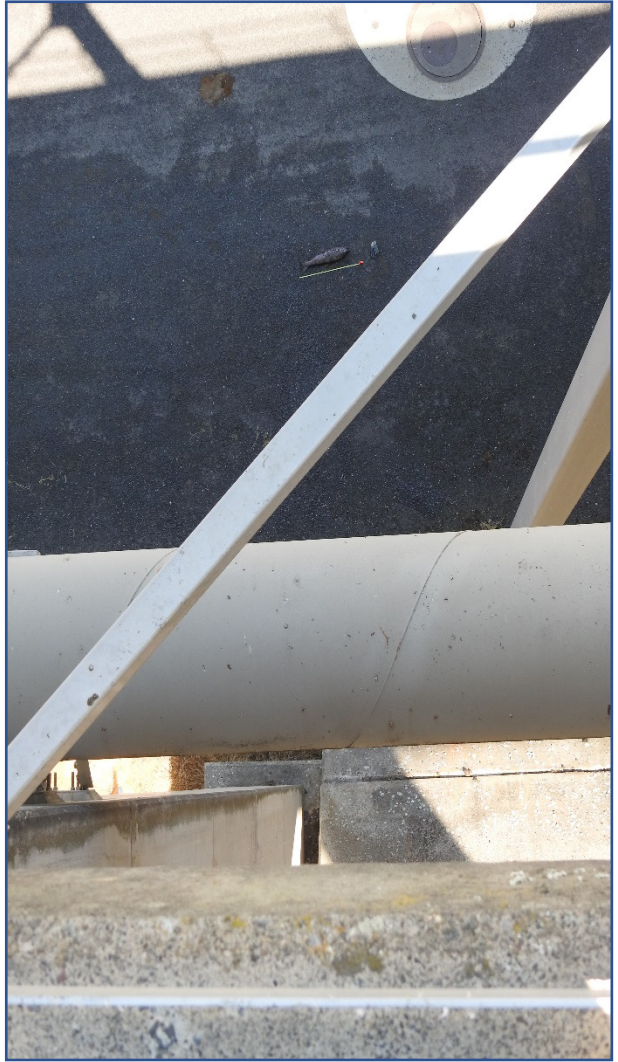
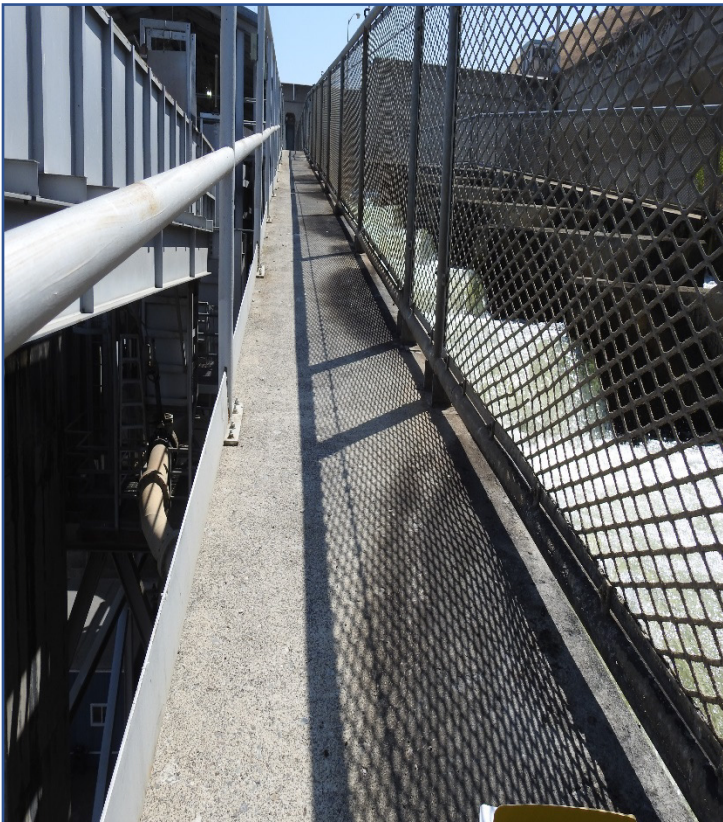
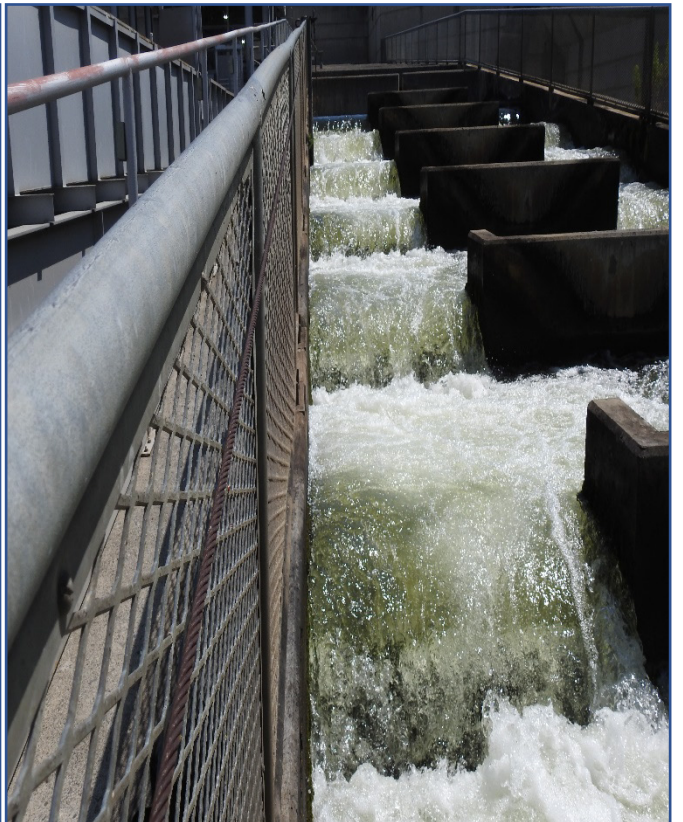
On the morning of July 5, an adult fish mortality was found on the ground below the the lower run fish ladder (see photos). Fish scales were found on the ladder walkway toe plate along the upper ladder near the location of the secondary dewaterer and the ladder exit. It appears the fish jumped from the fishway and over the chainlink-lined railing (56" height) to the walkway and then fell to the ground.

- A. Species – Chinook salmon *Oncorhynchus tshawytscha*
- B. Origin – Wild
- C. Length – 36 inches
- D. Marks and tags – None, adipose intact
- E. Marks and Injuries found on carcass – Descale, embedded and dried on gravel, underside postmortem levidity, wet blood pooled beneath the underside operculum where fish lay.

- F. Cause and Time of Death – Blunt force trauma, hypoxia. Estimated window for time of death from dawn to early sunrise the morning of July 5, 2023, based upon degree of rigor mortis and tissue desiccation.

- G. Future and Preventative Measures – LGS has experienced very few adult ladder jump mortalities, with an occurrence rate of approximately 1 every 3 years. Taller plastic mesh lining options at steeper ladder inclines are being considered, however addition of netting / mesh infrastructure presents major obstacles in regards to ladder access and fish rescue operations during annual unwatering activities in preparation for winter maintenance.
