THE DALLES AWS BACKUP DEBRIS MANAGEMENT EDR

FFDRWG 90% EDR MEETING

AUGUST 08, 2023

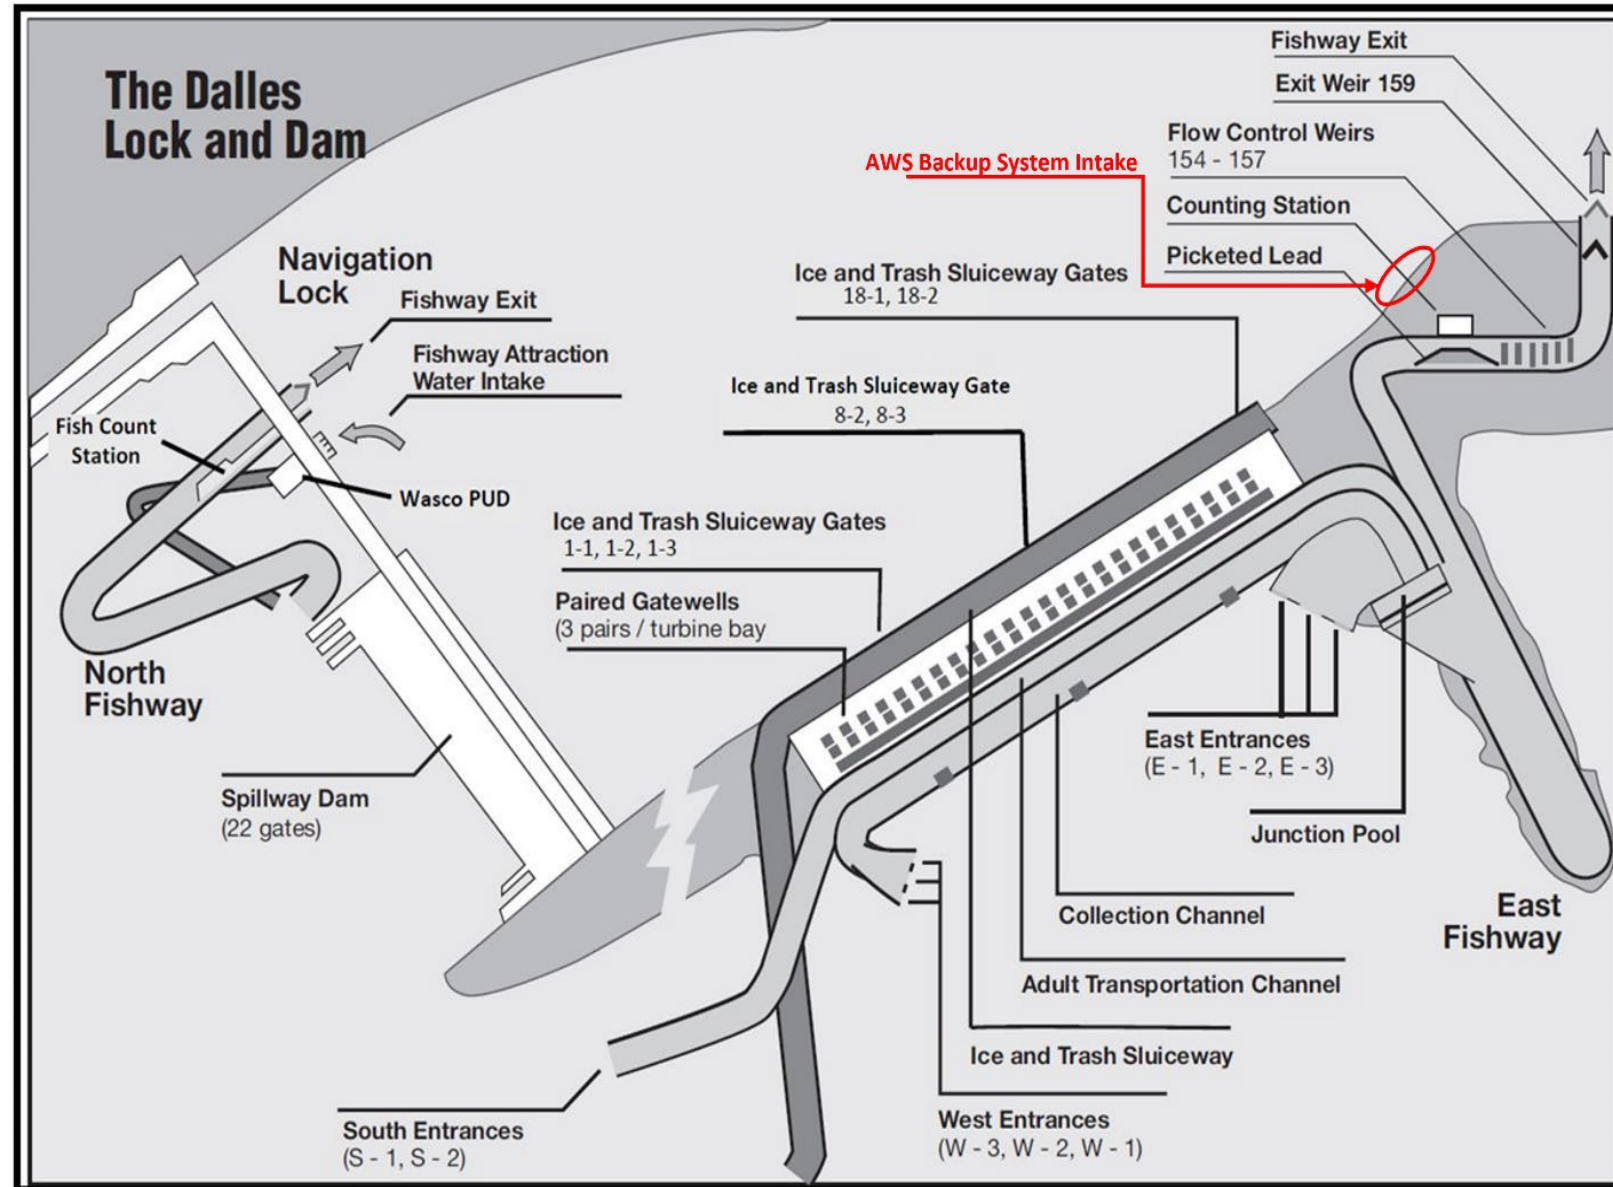
Two Fish Units

- supply 5000 cfs total.
- The AWS supplies water to the east, west, and south fish ladders entrances of the East Fishway.

The AWS Backup System (AWSBS)

- Flow range: 1400-1600 cfs
- Assures east entrances operate at FPP criteria.
- *Single FU Outage*
 - South & west entrances at less optimal flow.
- *Double FU Outage*
 - South & west entrances closed.

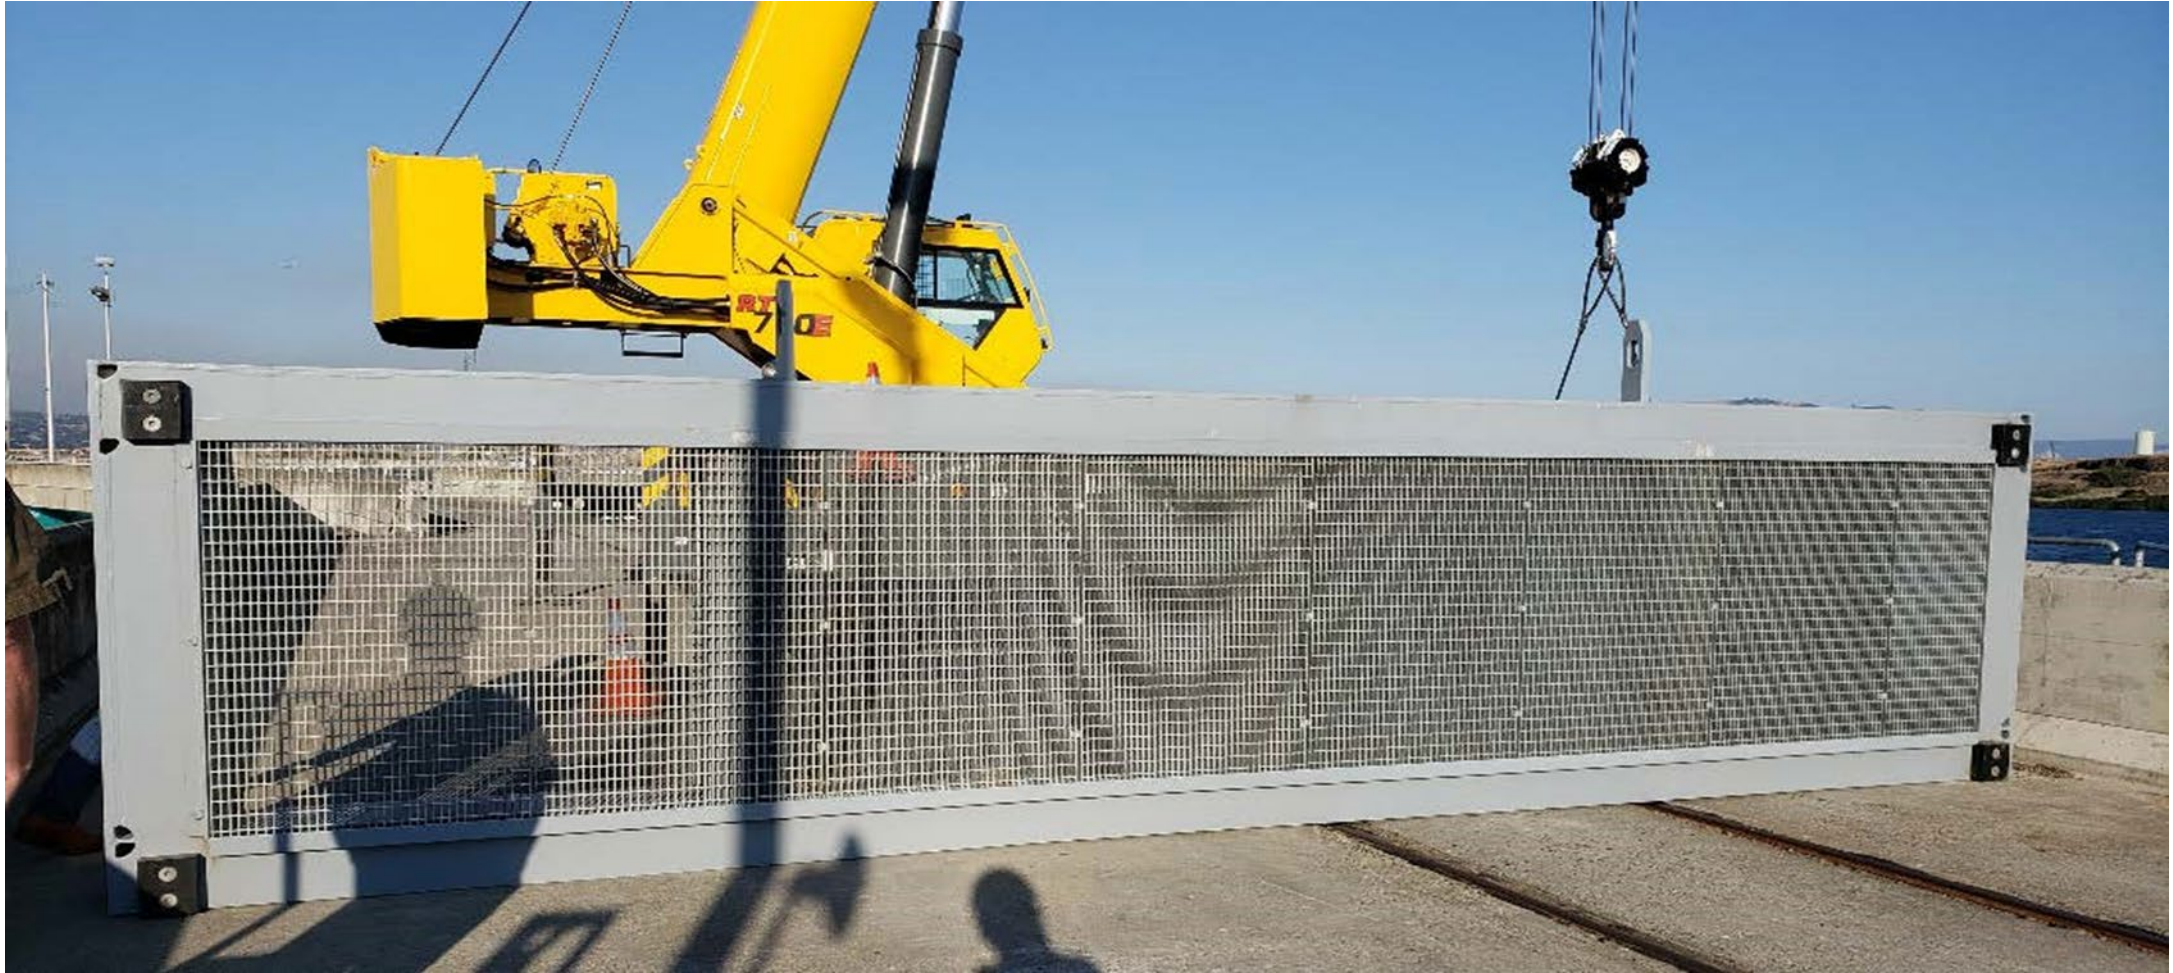
TRASH RACK PANEL

- Eleven 6' tall trash racks with $\frac{3}{4}$ " vertical bar openings.
- The trash rack screen is made of standard platform grating with horizontal members in the same upstream plane as vertical members.
- Angle brackets extend ~ 1 " in front of the grating.
- Brushing system: will have flexible bristles capable of passing over protrusions and grate openings.

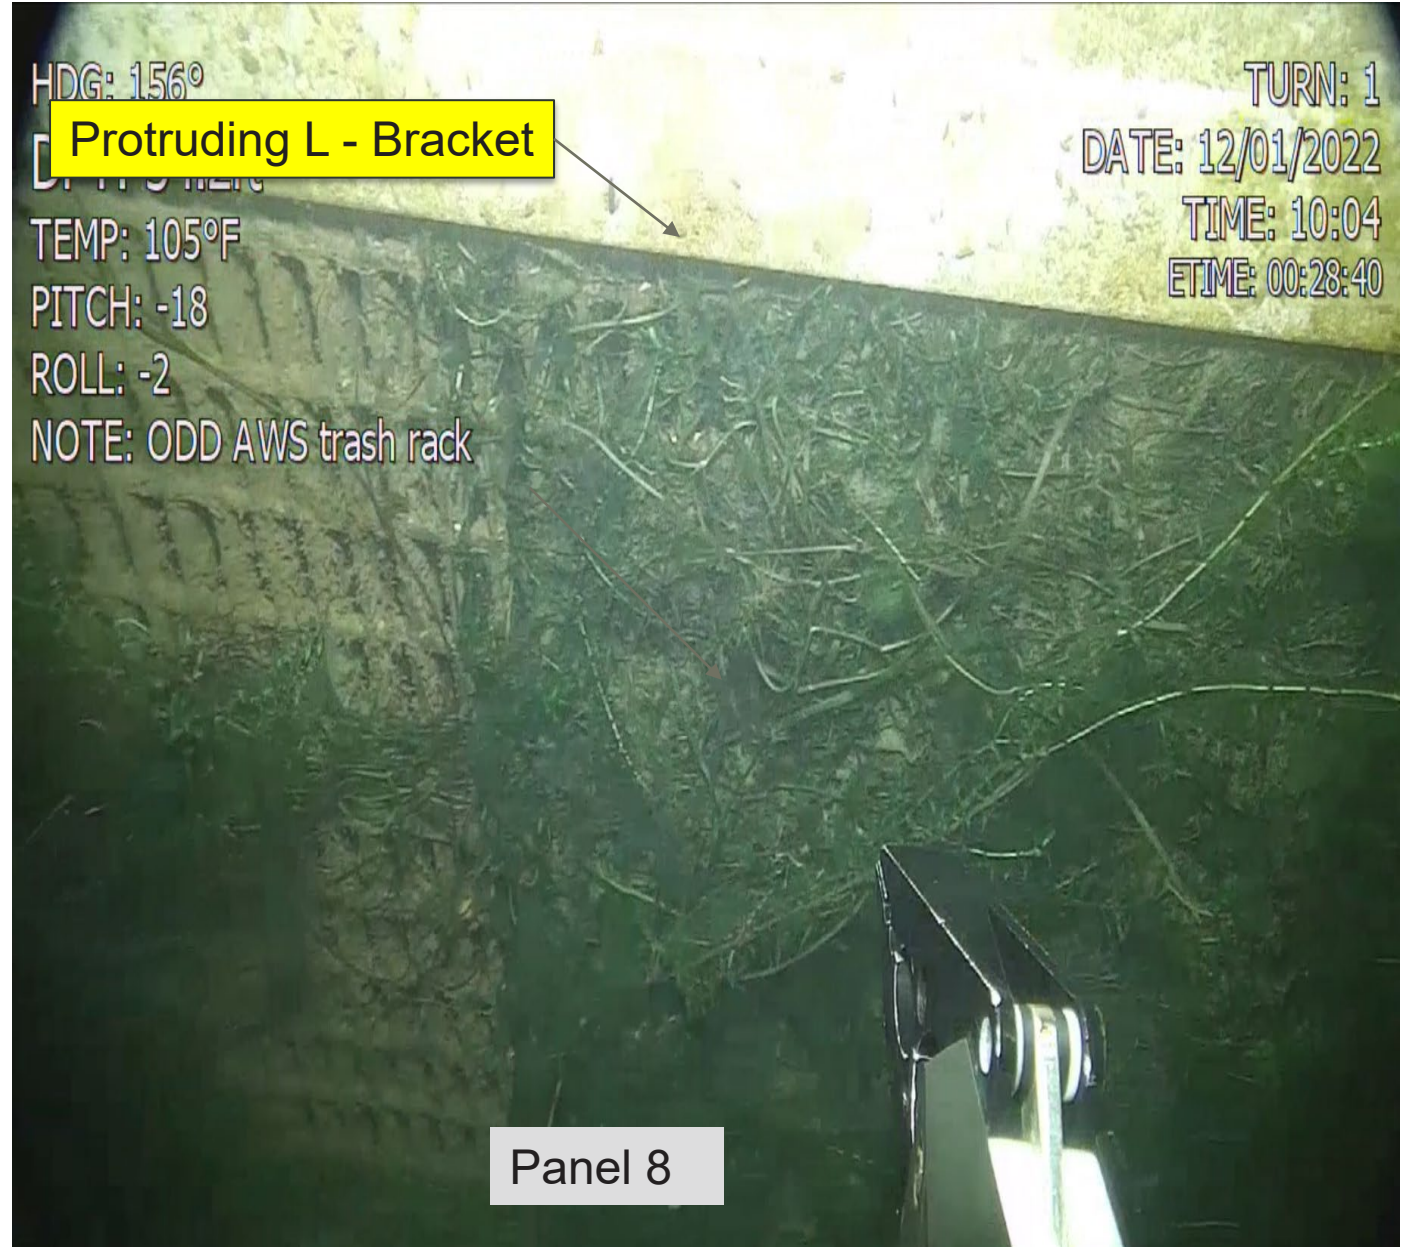
ROV FOOTAGE

Prior to ROV, AWSBS ran for 5 days

- Head Differential of 0.6' at shutdown with \approx 55% blockage
- After 9 hours of float time, head differential estimated at 0.25' with < 40% blockage based on visual observation.

Panels 6-8 sit above penstock opening & had the most debris build up.

Debris was aquatic plant species

- Egeria, Milfoil, Pondweeds, Eelgrass
- Soft, fragile, mostly derived of water
- Should break/tear easily

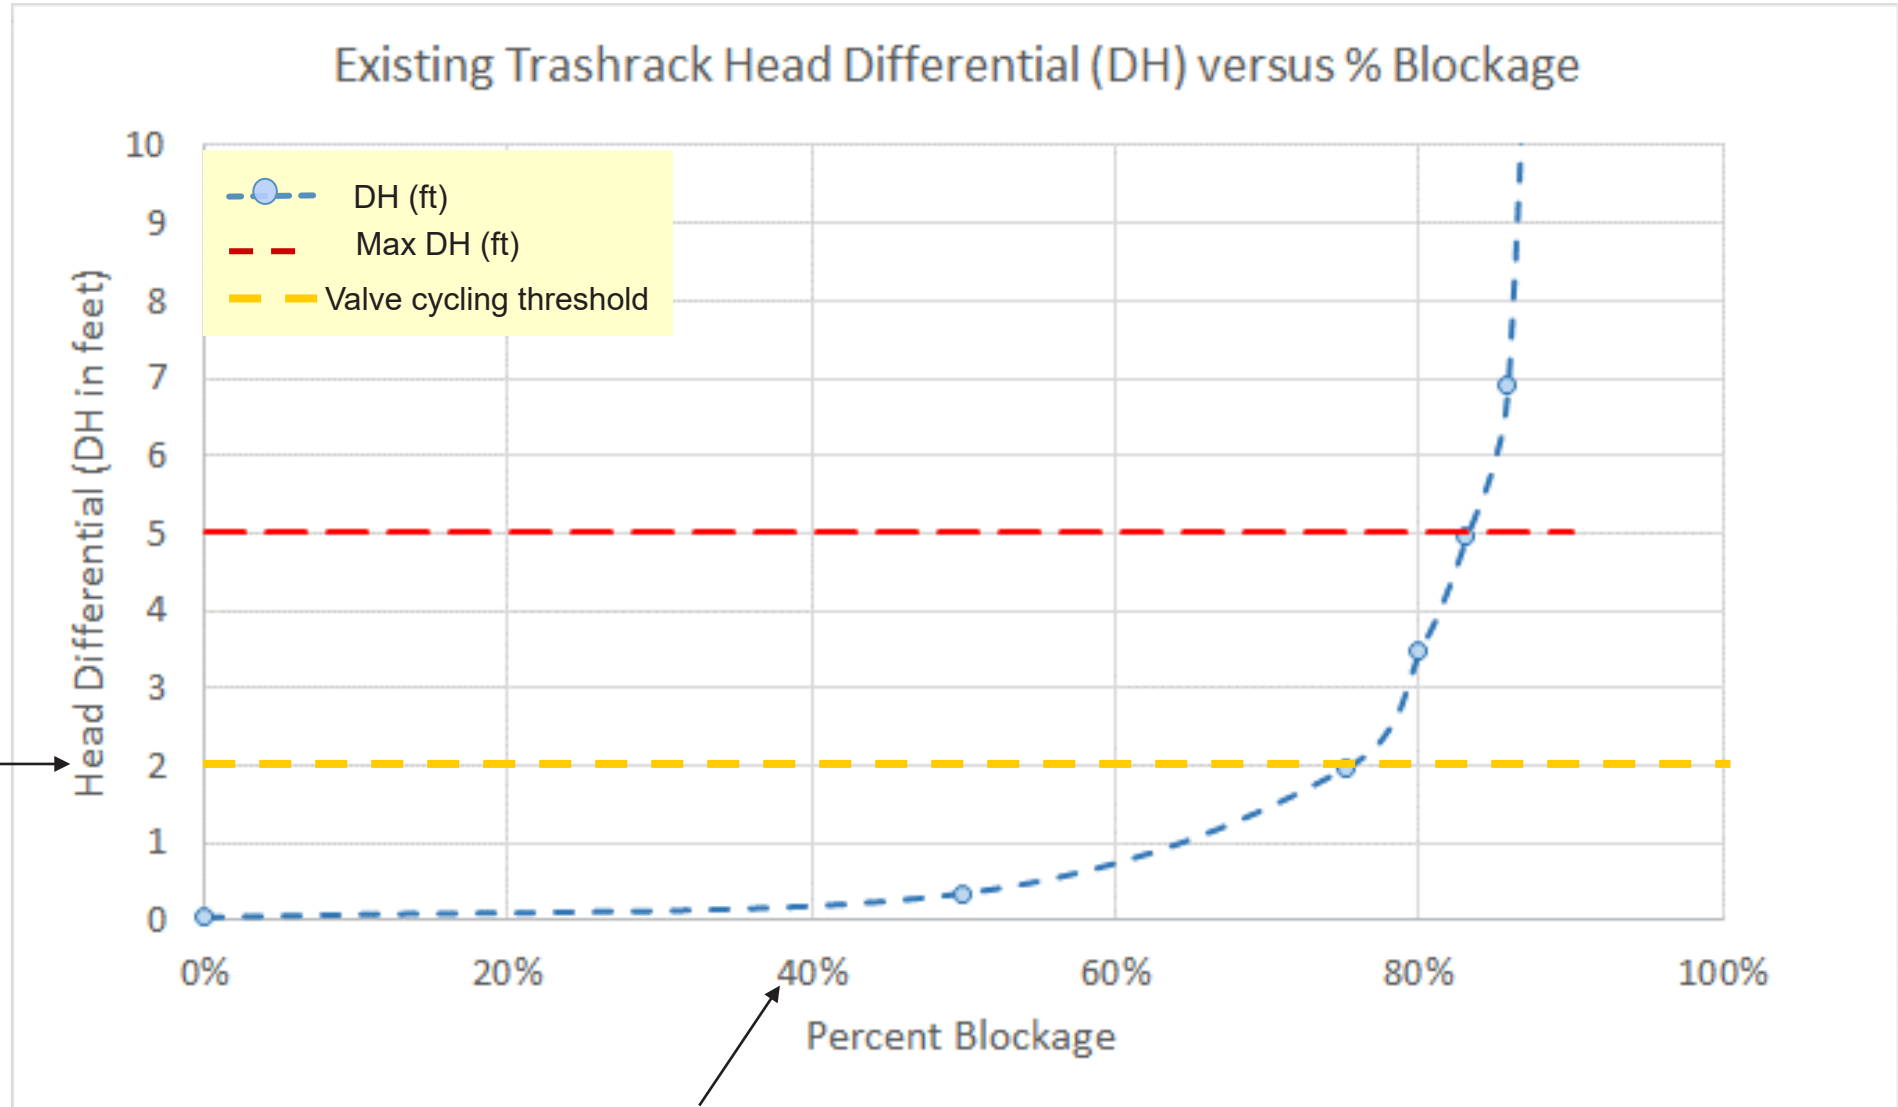
HEAD DIFFERENTIAL VS PERCENT BLOCKAGE

Valve cycling threshold

Estimated Blockage at ROV footage

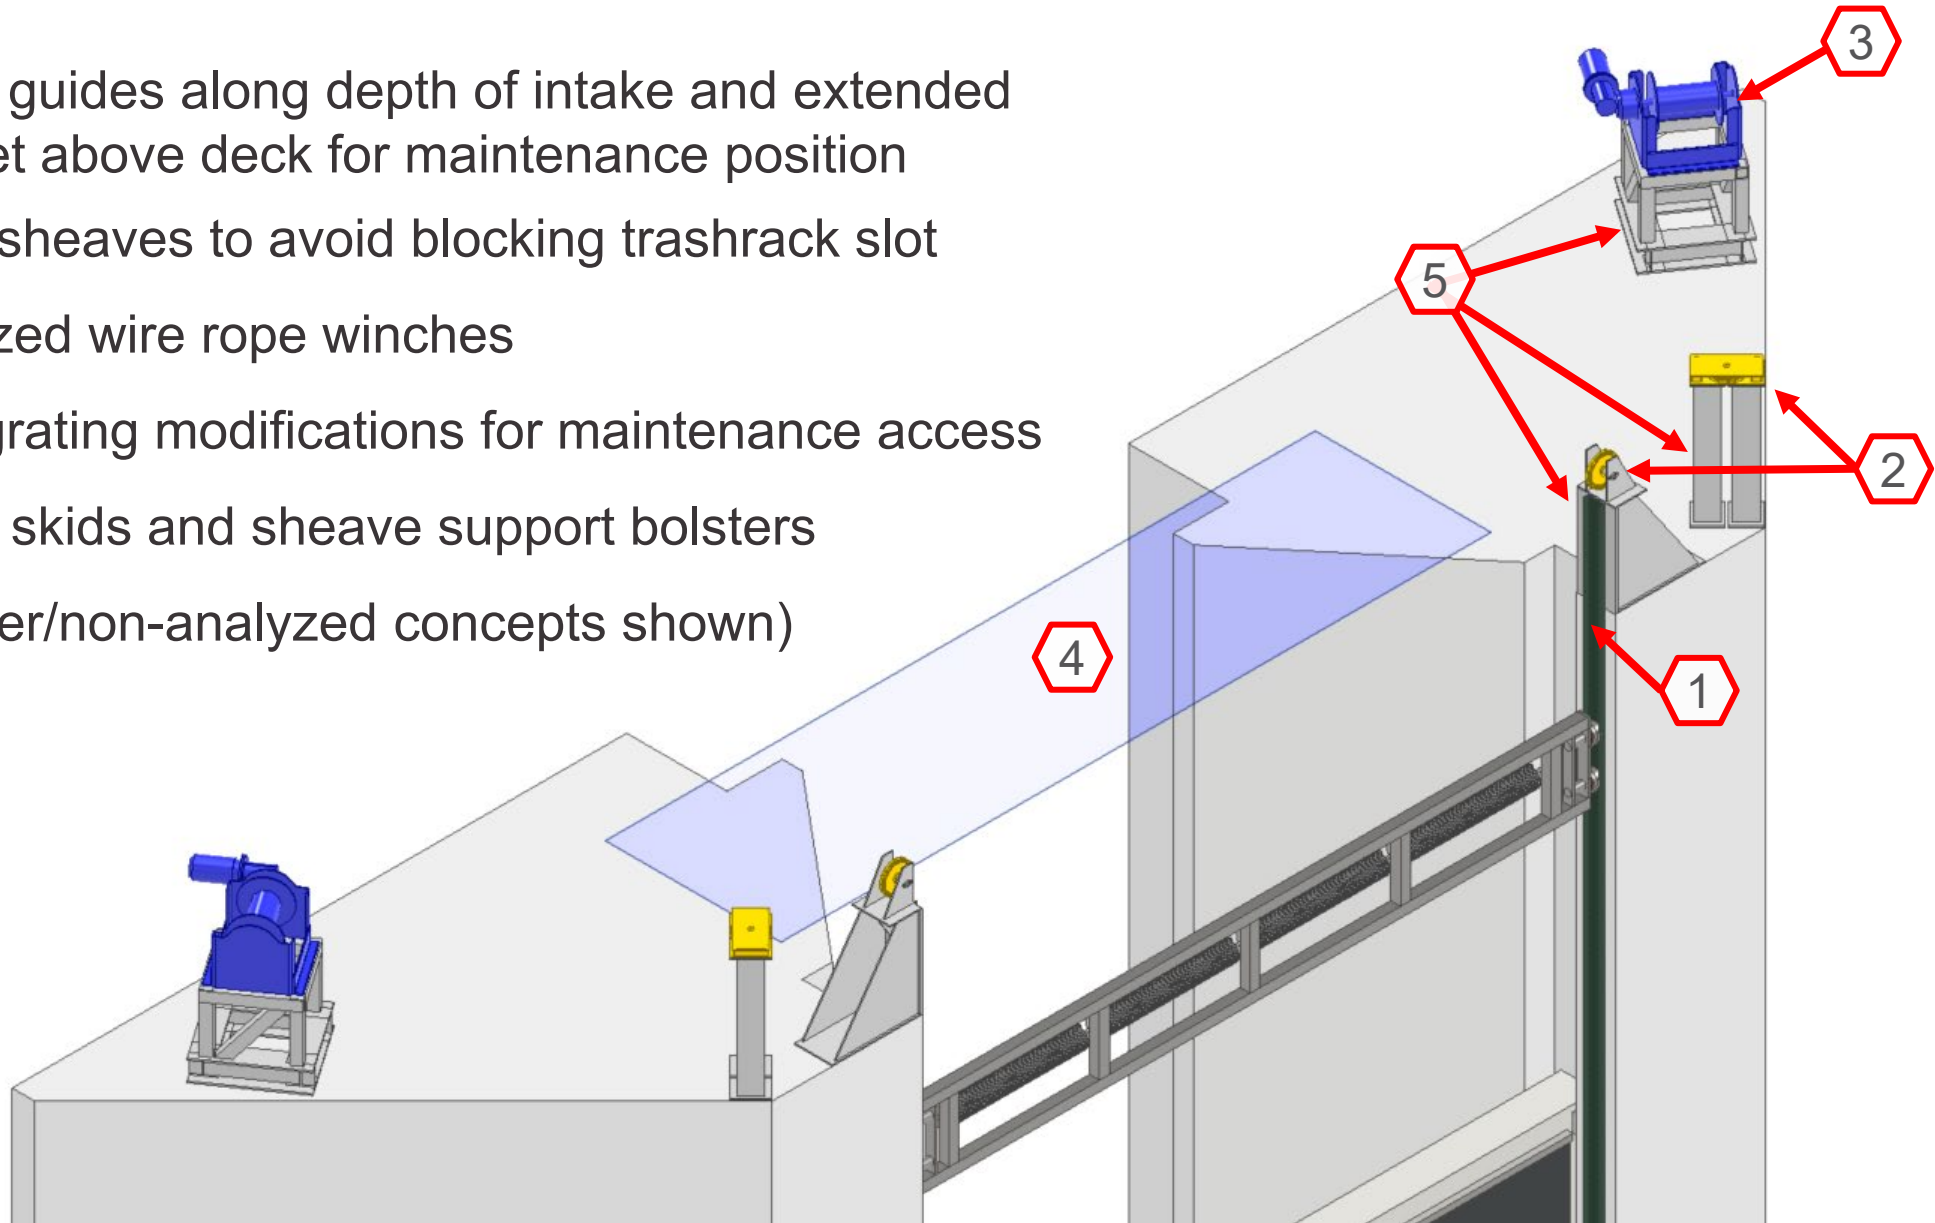
ALT 11: BRUSH FRAME HOISTING

1. C-channel guides along depth of intake and extended several feet above deck for maintenance position
2. Wire rope sheaves to avoid blocking trashrack slot
3. Synchronized wire rope winches
4. Walkway grating modifications for maintenance access
5. Machinery skids and sheave support bolsters
(placeholder/non-analyzed concepts shown)

A dedicated hoist has been selected to be used in both preferred and next best alternatives for hoisting the brush system instead of using the ODD mobile crane.

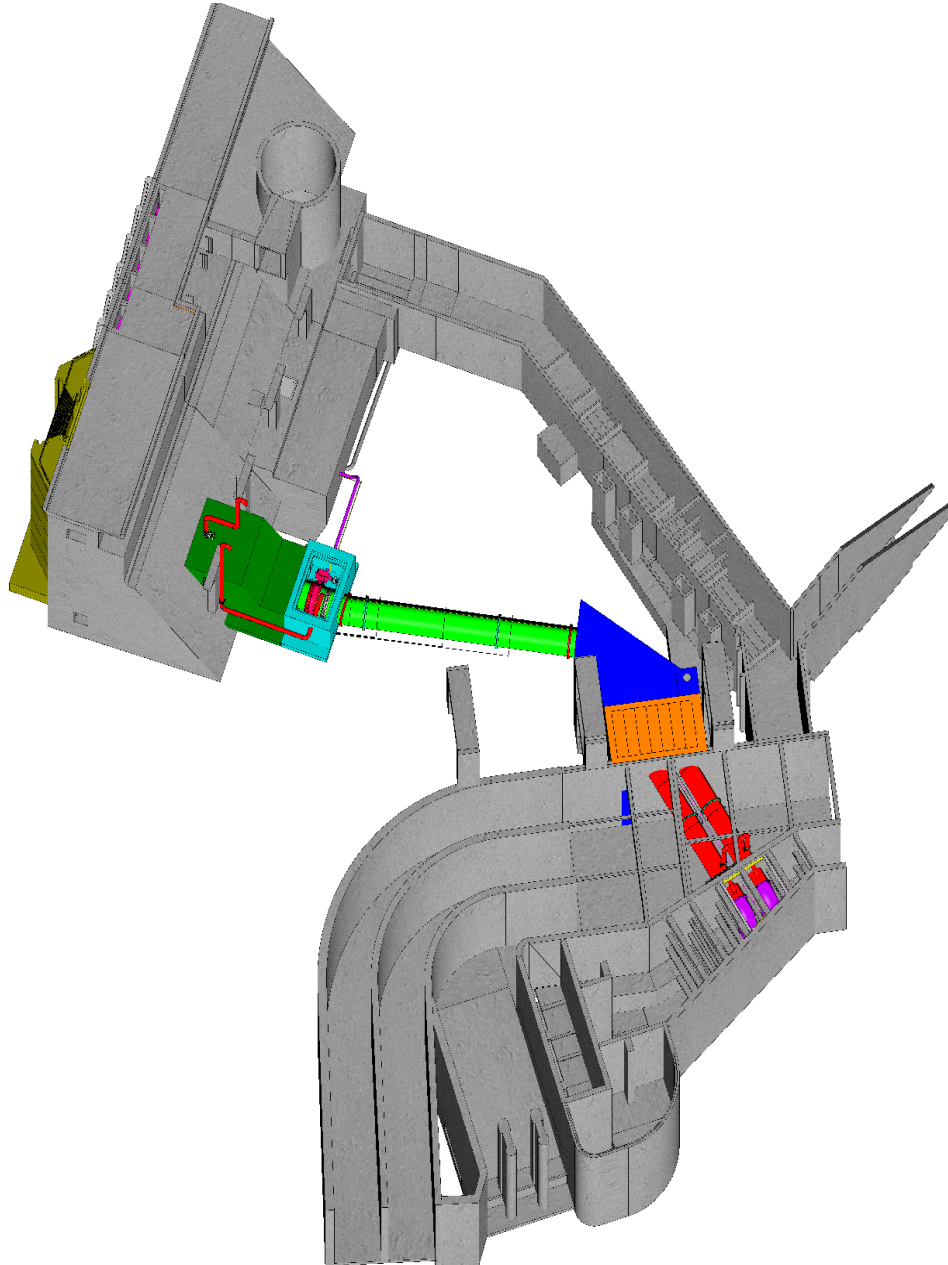
10 FOOT VALVE ROOM
-

THRUST BLOCK
-

7 FOOT VALVE ROOM
-

10 FOOT PIPE
-

7 FOOT PIPES
-

DEWATERING STRUCTURE
-

PENSTOCK OUTFALL
