# Bonneville Second Powerhouse B2 Auxiliary Water supply Trash Rake Special FFDRWG Meeting

5 September 2013

## Bonneville Second Powerhouse B2 Auxiliary Water supply Trash Rake

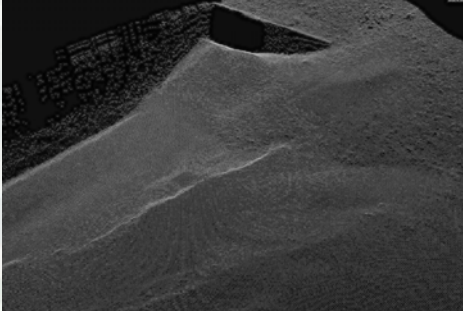
Before Dredging

Feb 1997- 2,850 CY Removed  
 Fall 1997- 4,550 CY Removed  
 Fall 2004- 2,000 CY Removed  
 Jan 2013- 6,000+ CY Removed

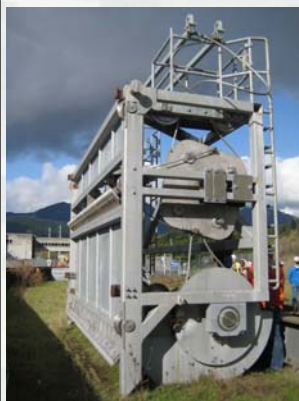
New Rake

- ▶ Manual Rake Modifications as necessary with new racks
  - Preliminary ranking closely follows semi-automated raking system
  - New or old rake is modified for use with the new racks
  - Rack replacement highest cost and uncertainty of benefits
  - Rack constructability issues with close bar spacing

- ▶ Raking should occur concurrent with VBS cleaning or at least once a week
- ▶ Minor modifications to the rake should be performed to improve its ability to remove matted grasses
