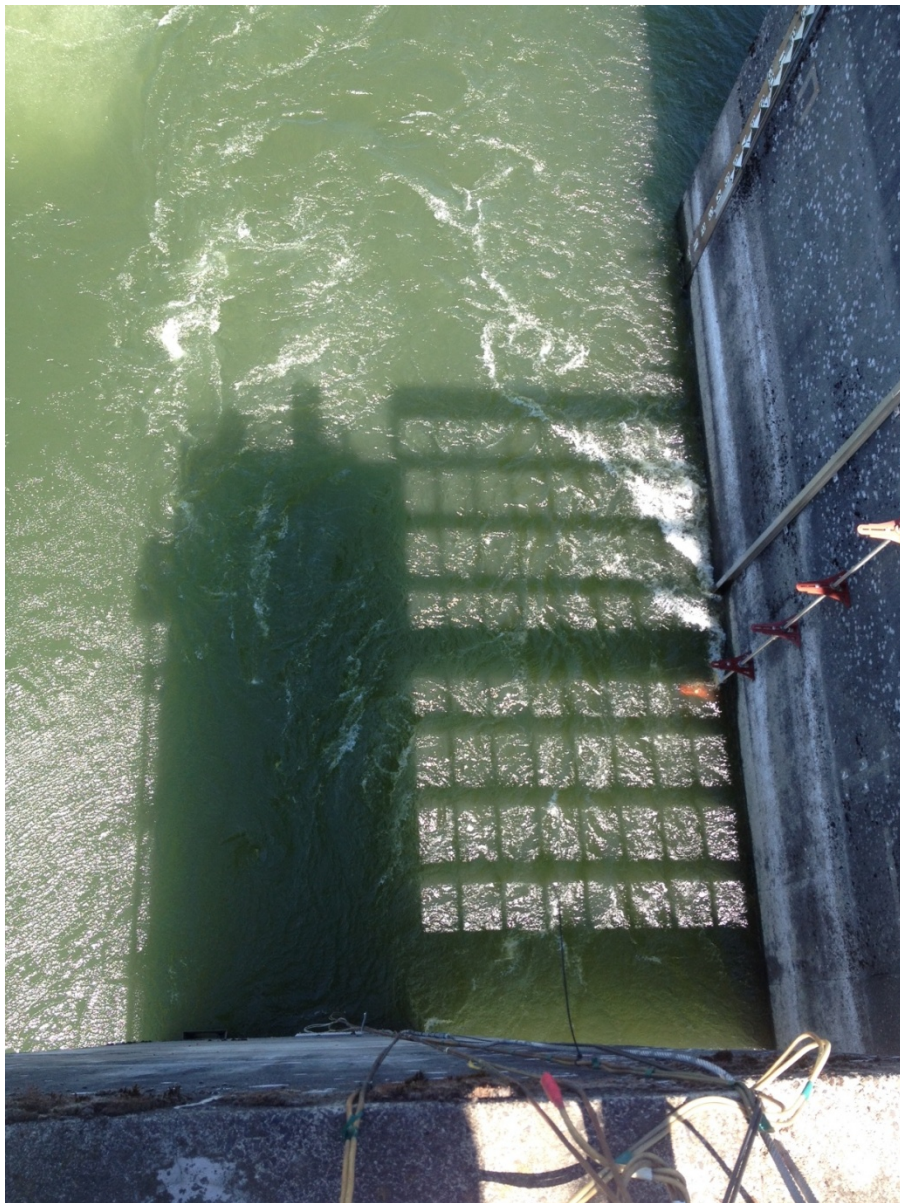
A. 24% valve opening on 7/9/14 (TW = 19 ft) . No visible bubbles from LFS entrances or main flume structure (south wall).

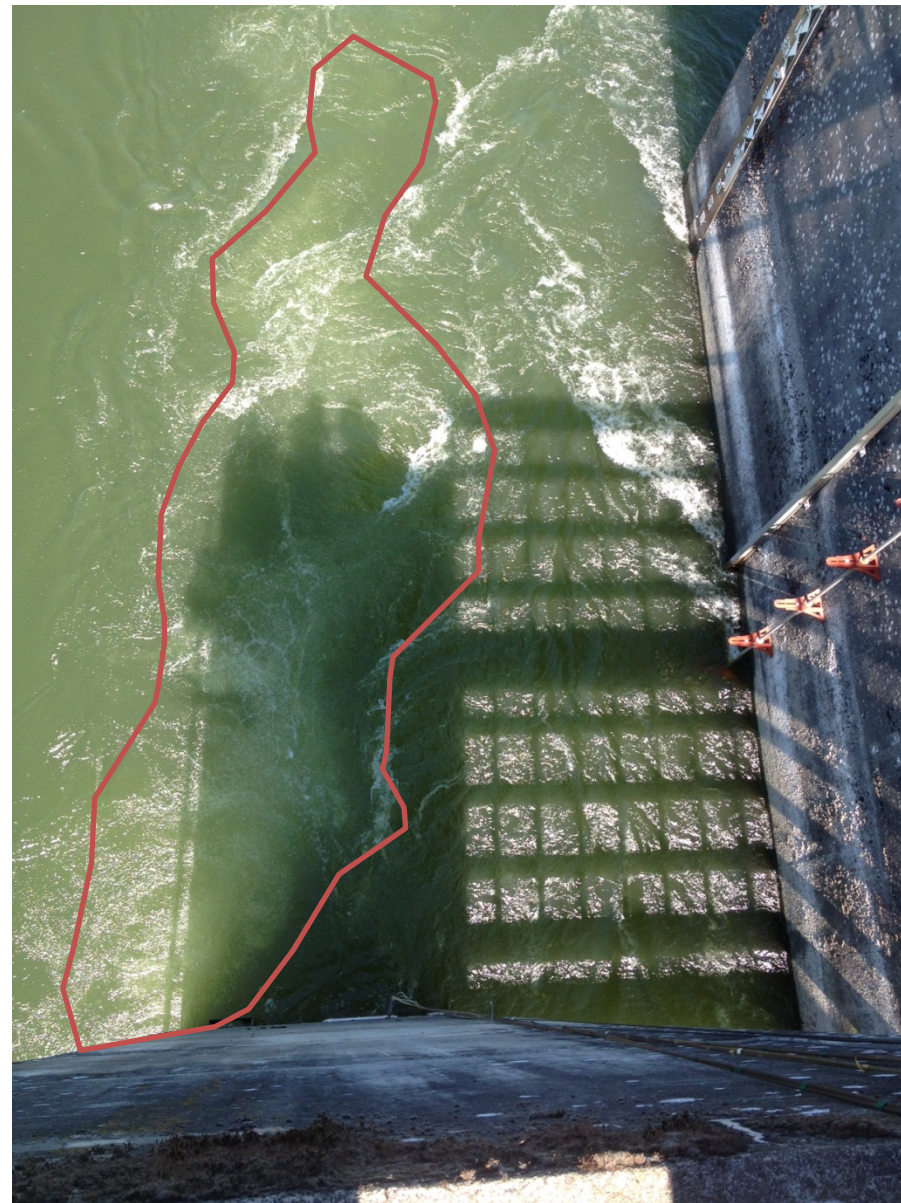
B. 50% valve opening on 7/9/14 (TW = 19 ft). Consistent discharge of entrained air from main flume structure, and intermittent bubble plume from LFS entrances, in vicinity of NDE. Similar to observed pattern on 6/18/14 FPOM site visit.
