MEMORANDUM FOR THE RECORD

SUBJECT: 14BON81 MFR BI bridge overlay follow on work

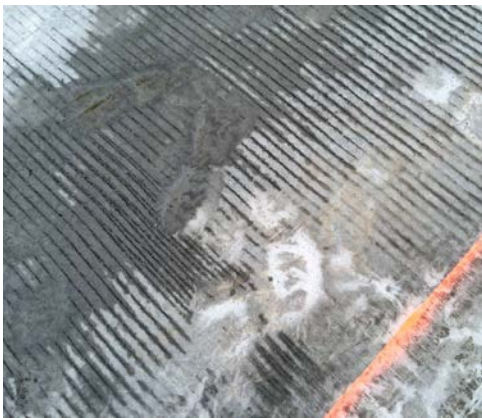
There is a section on the west approach, about 40 feet west of the fish ladder, encompassing about a 20 ft x 15 ft section that has footprints. Additionally, there is a 3 ft x 9 ft section on the bridge deck itself that is a low spot that will be addressed in order for the water to drain off that portion. In these two sections, the Contractor has proposed to remove the top 2 inches of concrete and overlay the concrete with the same concrete mix as was placed on the bridge deck.

Picture 1. Footprints in the concrete.

The method proposed to achieve this solution is to saw cut the 2 inches below the surface around the perimeters of the affected areas. Additional saw cuts will be made to create a grid. The pieces of concrete will be hand chipped with a 15 lb mechanical hammer. If hand chipping does not produce the desired profile, a grinder will be brought in to create an even surface. The grinder is about 3 feet wide and produces minimal noise and vibration.

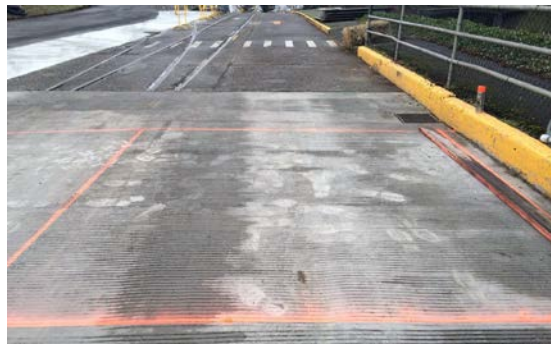
Picture 2. Westbound lane repair area. The drain is located 50' from the fishway.

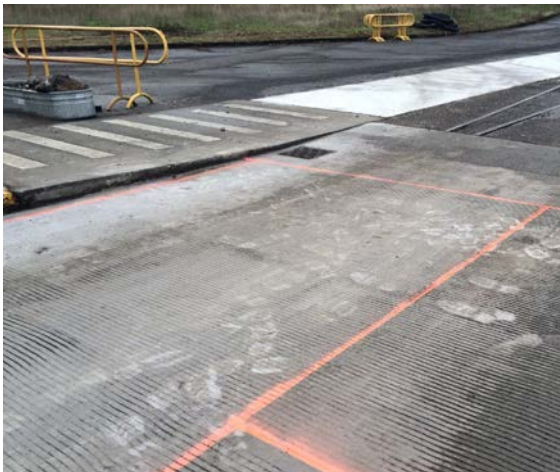
Picture 3. Eastbound lane repair area. The drain is located 50' from the fishway.

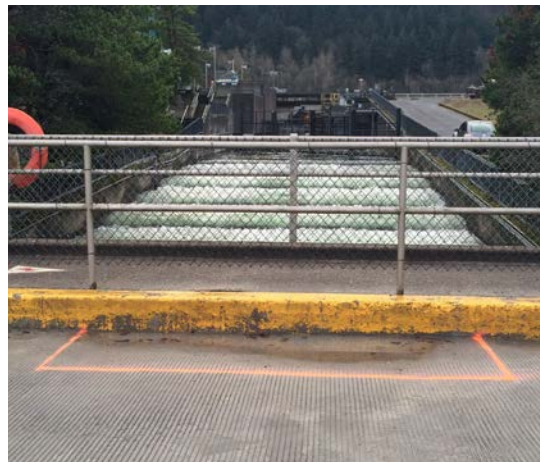
Picture 4. Low spot in the center of the bridge.

On the bridge deck, while the section is being addressed, boards will be erected in order to prevent any debris going into the fish ladder. The concrete that will be chipped will be contained and hauled offsite.
