OFFICIAL COORDINATION REQUEST FOR NON-ROUTINE OPERATIONS AND MAINTENANCE

COORDINATION TITLE- 16BON03 COORDINATION DATE- 2/1/2016 PROJECT- Bonneville Dam RESPONSE DATE- 2/11/2016

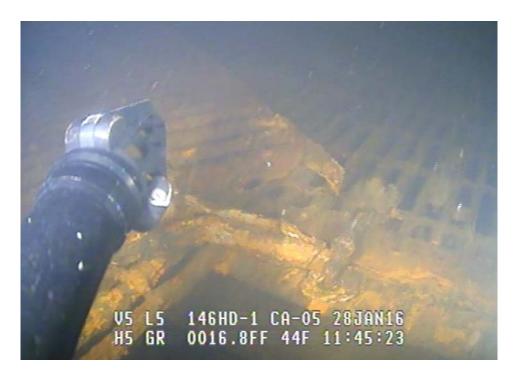
Description of the problem – A recent ROV inspection discovered that a diffuser panel has blown off in the PH2 collection channel at diffuser C4 (photo below), which sits in the middle of the collection channel. Currently the project has closed diffuser C4, which is the only opening between the diffuser pit (which sits underneath the grating) and the AWS conduit. Thus fish are currently able to enter the diffuser pit but not the AWS conduit.

1) Bring in divers to repair while watered up. This would require a partial shutdown of the ladder to install transverse bulkheads in the south half of the collection channel. Floating orifice gate would also likely need to be closed in that section or perhaps a change in unit priority to create non-turbulent work environment. The south fishway entrances would not be viable fish passage routes during this work window. The scope of the repairs (cutting off studs and attaching new grating) means the USACE dive office will not be able to do this work. Professional divers will need a contract, putting the potential time for dive repairs in mid-March at the earliest.

- 2) Isolate the area and dry it up. This would also make the south entrances impassable. It is likely the longest outage as it could take 7-10 days to isolate, repair, and water back up. It does, however, allow for the best repair. BON Project estimates this option would take 7-10 days and cost ~\$30,000-35,000. Due to a lack of personnel availability due to ongoing winter maintenance at Bradford Is, the earliest this repair could occur is early March.
- 3) Continue the current operations (fish valve C4 closed) and wait until next winter maintenance (winter of 2016-17) to repair in the dry. This would do away with any attraction flow so it would likely not draw fish into it, and if they did go in they could only go into the immediate diffuser area.

11 Feb 2016 FPOM: FPOM supports option #3, leaving diffuser C4 closed and waiting until the 2016/17 winter maintenance period for repairs. The project will attempt to cover the diffuser opening in March 2016.
