MEMORANDUM FOR THE RECORD

SUBJECT: 17BON19 MFR – Pacific Lamprey mortalities at Bonneville’s Upper Washington Shore LPS.

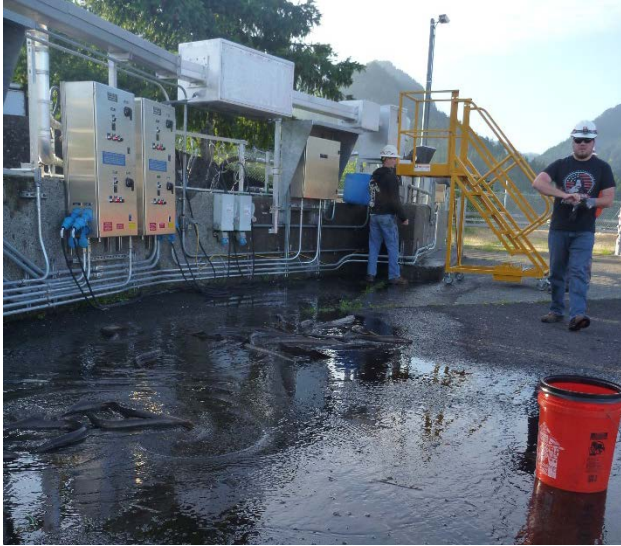
Picture 1:

At ~0700 on 21 June 2017, work crews alerted Project Fisheries to the fact that the upper Washington shore LPS, located in and below the auxiliary water supply channel (AWS), was overflowing and numerous lamprey were on the ground next to the structure (Picture 1). Upon arrival, Bonneville Fisheries recovered 30 alive lamprey and released them to the exit channel. Two additional fish were already dead (Picture 2). The fish mortalities were saved for later analysis by USFWS Fish Health.

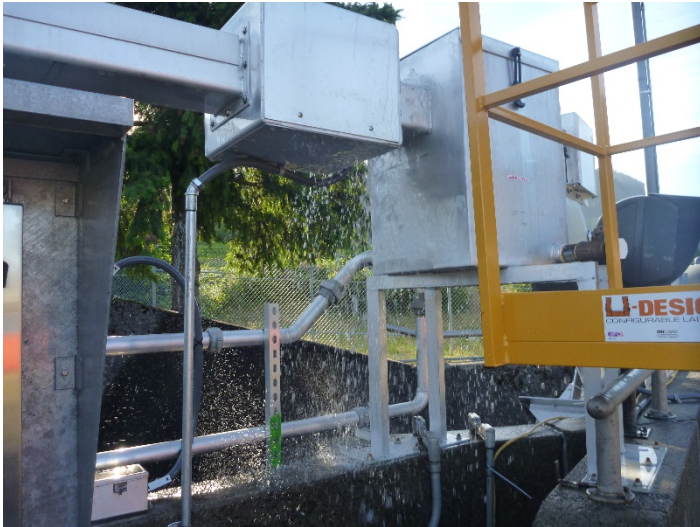
Picture 3:

Upon inspection, it’s believed that the number of lamprey in the final (original) portion of the LPS were so numerous that they caused the water to back up, overtopping the last rest box before the exit and the final flat traversing section (Picture 3). It’s unknown from which exact point in the LPS the lamprey came from. A fyke net in the final rest box was packed with lamprey (Picture 4) and was the most obvious bottleneck spot. The fyke net was then removed completely, meaning that lamprey entering that rest box may now stay in that box longer than originally intended, but allowing more lamprey to occupy that space. Inspection of other areas of the LPS show that there are many, many lamprey at all points in the LPS, suggesting the system may be at capacity.

What we observed was that there were so many fish that the final fyke had become compromised and fish were freely swimming in the final upwelling box. The number of fish prevented water to flow out towards the exit as well as back down towards the final rest box. This caused the upwelling box to flood as well as the traversing section between the rest box and the upwelling box. Along all the LPSs there are not latches on these traversing sections as there has never been a need. The flooding and large quantities of fish I believe pushed these lids up and fish began to pour out. We plan to fasten these down in some fashion, i.e. ratchet strap, rope, etc.
