MEMORANDUM FOR THE RECORD

SUBJECT: 23BON013 MFR BON FG6-18 Diffuser Hatch Failure

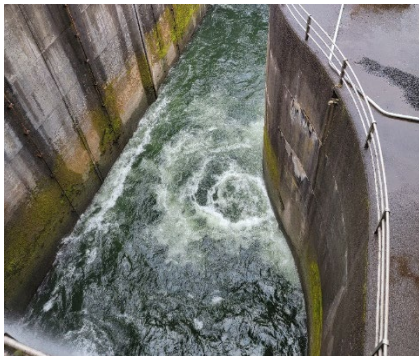
At approximately 0830 on 25MAR2023 Project Biologists discovered very turbulent water near Cascades Island diffuser FG6-18 in the Cascades Island Entrance Bay (Figure 1). BON adjusted flow through FG6-18 by opening FG6-18 and closing FV5-4 from 85-90% open to 40% open. Water flow from FG6-18 remained turbulent. Project Biologists suspected a blown grating above the diffuser pit.

Figure 1. Turbulent water in CI Entrance.

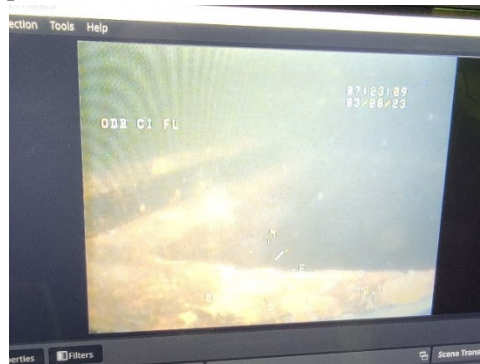
The FG6-18 diffuser chamber access hatch was blown out of place (Figures 2 and 3). The Project is planning for the removal of the hatch, via ROV, on 30 March. Repairs will follow as soon as possible. BON Project Fisheries and Operations will continue to monitor the fishway conditions closely.

Figure 2. CI FG6-18 diffuser missing hatch.

Future and Preventative Measures – fix and/or replace hatch hole cover and continue close monitoring

We got an ROV in there today and retrieved the broken hatch. A new one will be made and installed by our newly formed dive team (j hill) on Wednesday of next week. Outage today ~ 1 hour at 1100.

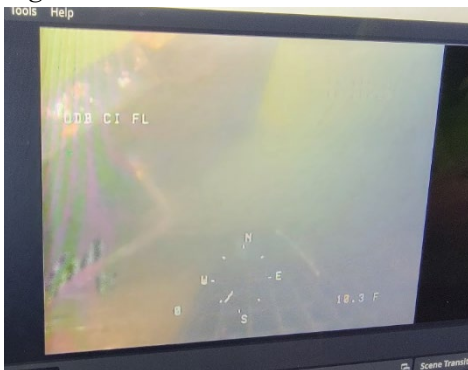
Figure 3. CI FG6-18 diffuser dislodged hatch.
