MEMORANDUM FOR THE RECORD**SUBJECT: 24BON018 MFR WA Shore AWS LPS RB1 and RB2 Pacific Lamprey Mortalities**

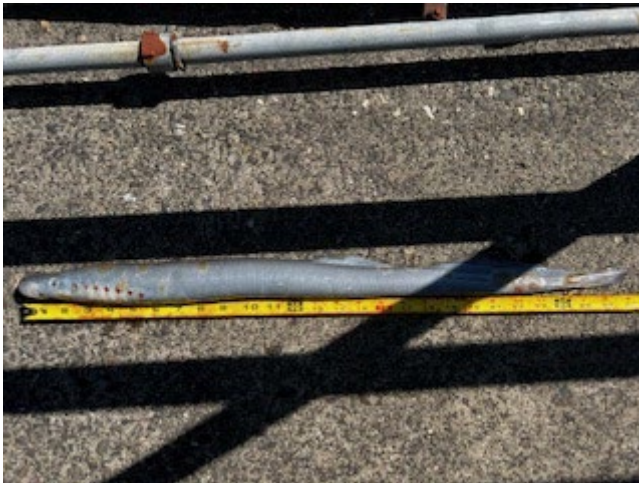
1. WA Shore AWS LPS RB2

- A. Species – Pacific Lamprey (*Entospehnus tridentatus*)
- B. Origin – Unknown
- C. Length – 67.95cm
- D. Marks and tags – None
- E. Marks and Injuries found on carcass – Fungus, some abrasions to caudal fin that potentially could be mouth marks from other lamprey, and hemorrhaging from gill holes.
- F. Cause and Time of Death – Unknown
- G. Future and Preventative Measures – N/A

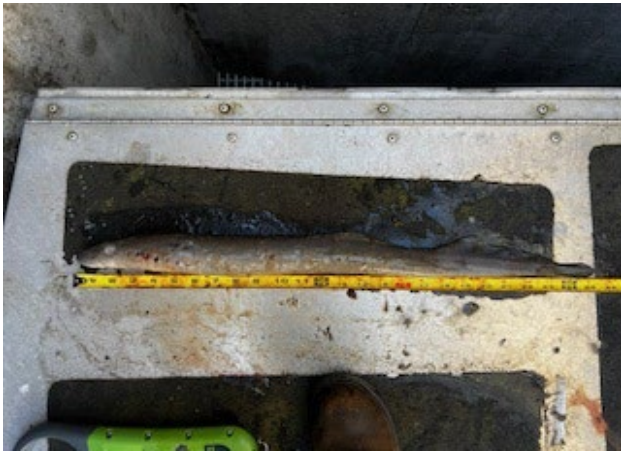
a.

- A. Species – Pacific Lamprey (*Entospehnus tridentatus*)
- B. Origin – Unknown
- C. Length – In order from a to d: 64.14cm, 74.93cm, 72.39cm, and 72.39cm
- D. Marks and tags – None
- E. Marks and Injuries found on carcass – No injuries found, fungus on c. and d., hemorrhaging from gill holes on all fish.
- F. Cause and Time of Death – Unknown
- G. Future and Preventative Measures – N/A
