MEMORANDUM FOR THE RECORD

SUBJECT: 17JDA08 MFR – Two dead adult and three dead juvenile chinook found on the PH tailrace deck next to spillway # 20, within the last 4 days.

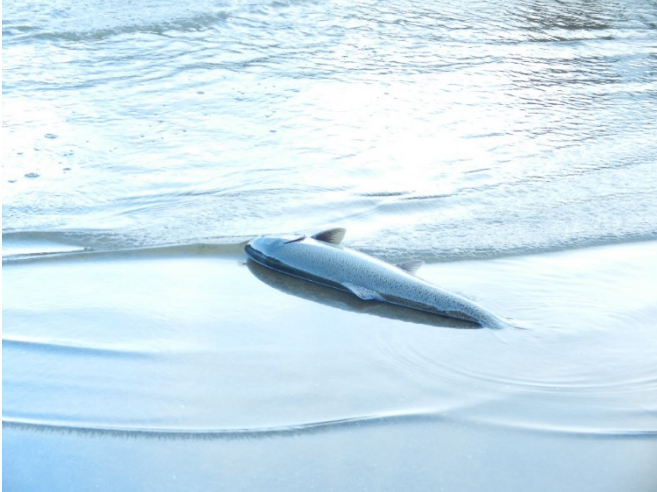
On May 23, AM, one dead adult, clipped chinook was found on the PH tailrace deck, next to spillbay 20. Another adult, unclipped chinook was found in the same spot, same day early PM. Additionally, 3 juvenile chinook mortalities were found there over the weekend: one clipped on May 19, another clipped plus one unclipped on May 20. Plus, there was one clipped juvenile steelhead mortality found in late April as well. All fish appeared to have come from spillbay 20, which is currently discharging a high volume of turbulent flows. JD Fisheries inspects this area at least twice per day and is able to detect mortalities in that area quickly. There had been similar mortalities, one adult steelhead (JD MFR 3) and one juvenile chinook mortality (JD MFR 4) found next to spill bay 20 in April.

Current photo from 23 May 2017.

- F. Cause and Time of Death – Asphyxiation due to stranding on deck
- G. Future and Preventative Measures – After the second adult chinook mortality was found today, 23 May PM, the JD Fisheries imposed an immediate 3 stop limit at spill bay 20 to reduce its excessive and violent flows. A long term measure could be adding a small size mesh's screen on top of the hand rail. Probably up to extra 10 feet in height should be sufficient in preventing fish from being thrown over the current, low hand rail (pictured below.)
