MEMORANDUM FOR THE RECORD**SUBJECT: 22JDA06 MU-1 Temporarily Offline (STS Camera Lodged in Gatewell)**

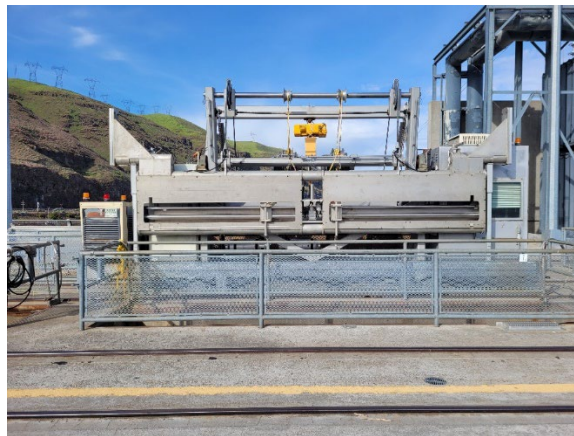
Figure 1: STS inspection camera system
