MEMORANDUM FOR THE RECORD 15-IH-009

SUBJECT: A jack Chinook mortality found on July 1 and an adult Chinook found on July 9 near south fish ladder, and juvenile steelhead found near juvenile collection channel on July 8.

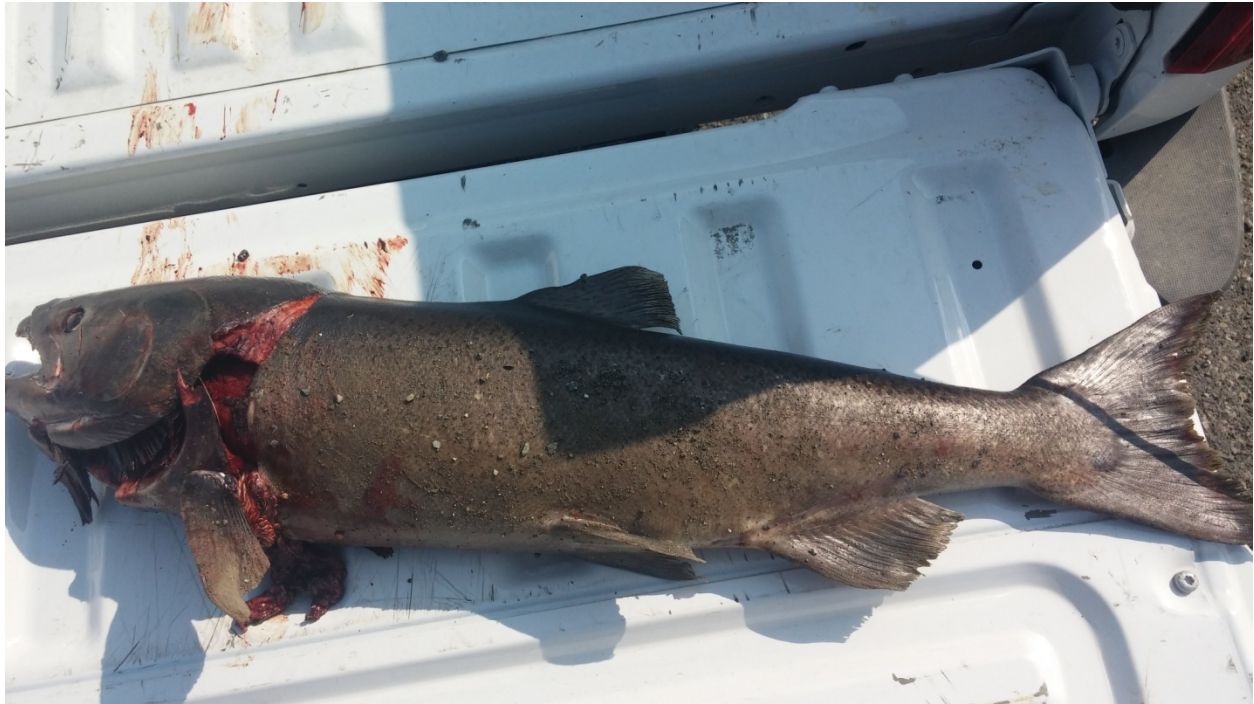
31.5" Chinook

- D. Marks and tags – all clipped.
- E. Marks and injuries found on carcass – The jack Chinook was decomposed, with only the skin, fin, and head left, with the head separated from the body. The 31.5” Chinook had a severe head laceration. The juvenile steelhead had a caudal fin injury and descaling.

- F. Location – The two Chinook were on the ground at the base of the stairs to the south picketed leads. The larger fish was on the walkway grating above the juvenile channel, near orifice 6CS.

- G. Cause and time of death – The two Chinook probably jumped out of a small gap in the bottom of the jump-netting attach to the top of the fence at the upstream overflow weir section of the south fish ladder. The head injuries were caused by the impact of hitting the ground. The jack probably jumped out during the weekend before, and was not discovered until July 1. There was uncertainty how it got there and speculation that it actually died in the fish ladder and was removed. However, the second Chinook (probably jumped out the night before it was found) at this location indicates they were both jumpers. The steelhead probably jumped (some time in the middle of the day that it was found) through a very small gap in the bottom of the jump-netting that is attached to the handrail and grating. Its injuries were probably caused by contact with the grating.

- H. Future and preventative measures – After these incidents, additional cable ties were added to the bottom of the netting in both locations to eliminate gaps where fish could fit through. These locations will be monitored to affirm that the coverage of the netting is sufficient to prevent future jumpers.
