**MEMORANDUM FOR THE RECORD 16-IH-xx**

**SUBJECT:** Adult white sturgeon mortality on September 23, 2016 at the Ice Harbor south shore fish ladder picketed leads.

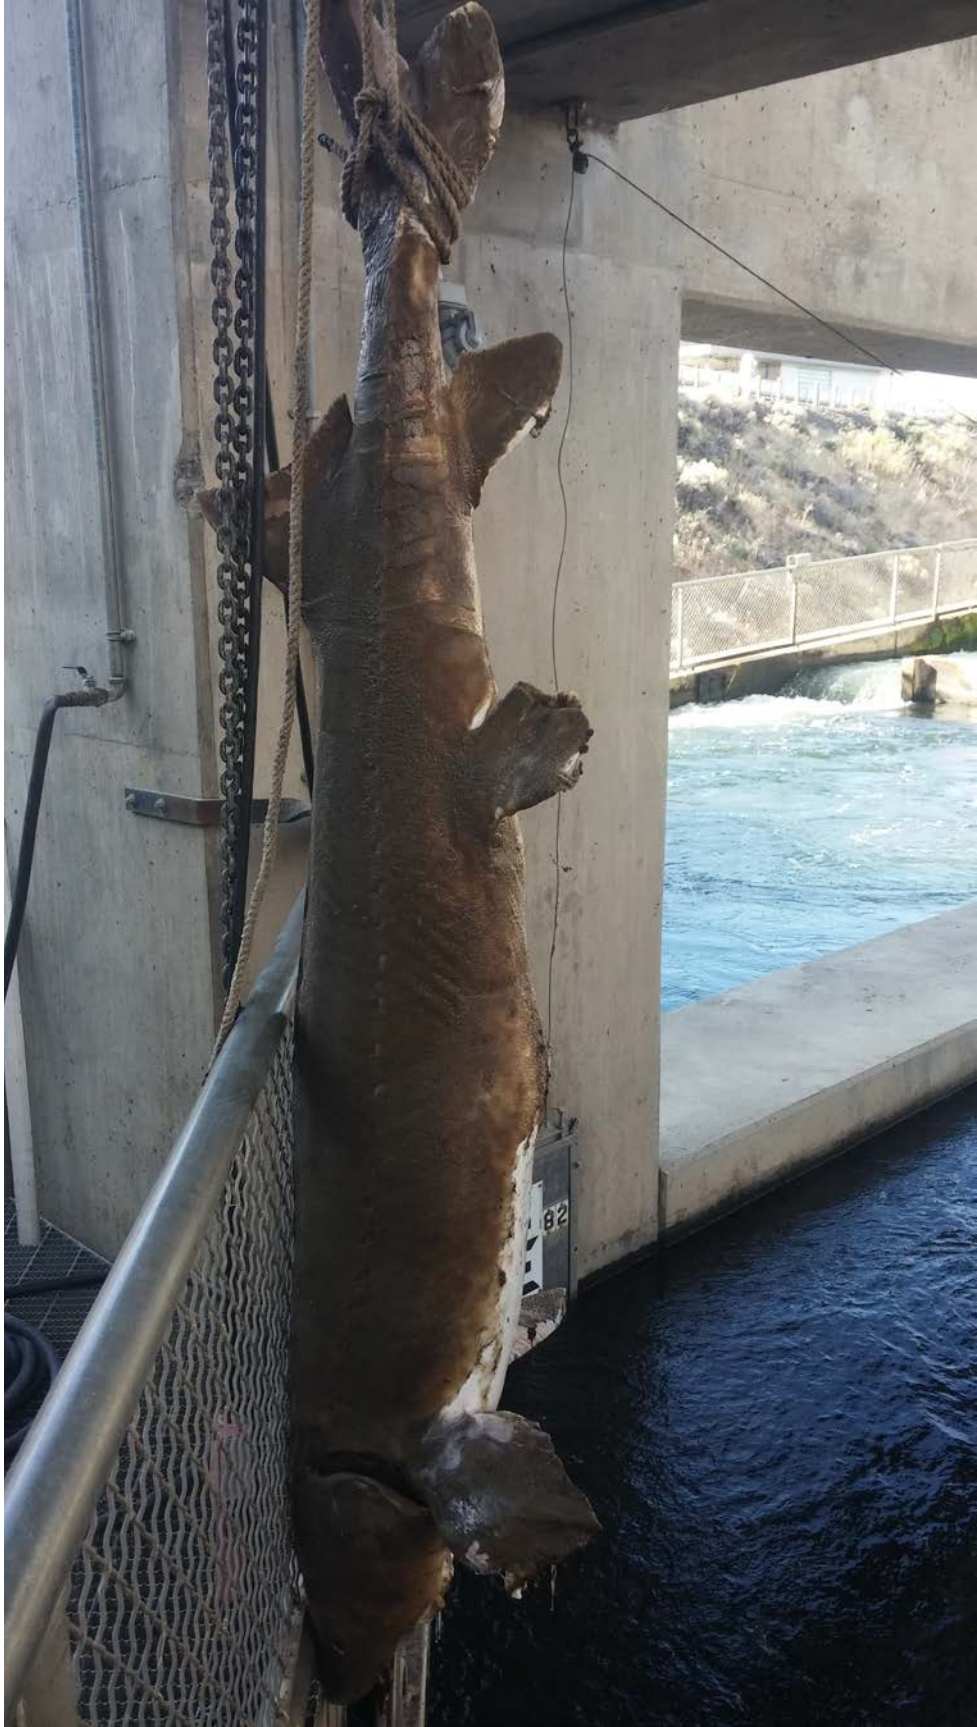
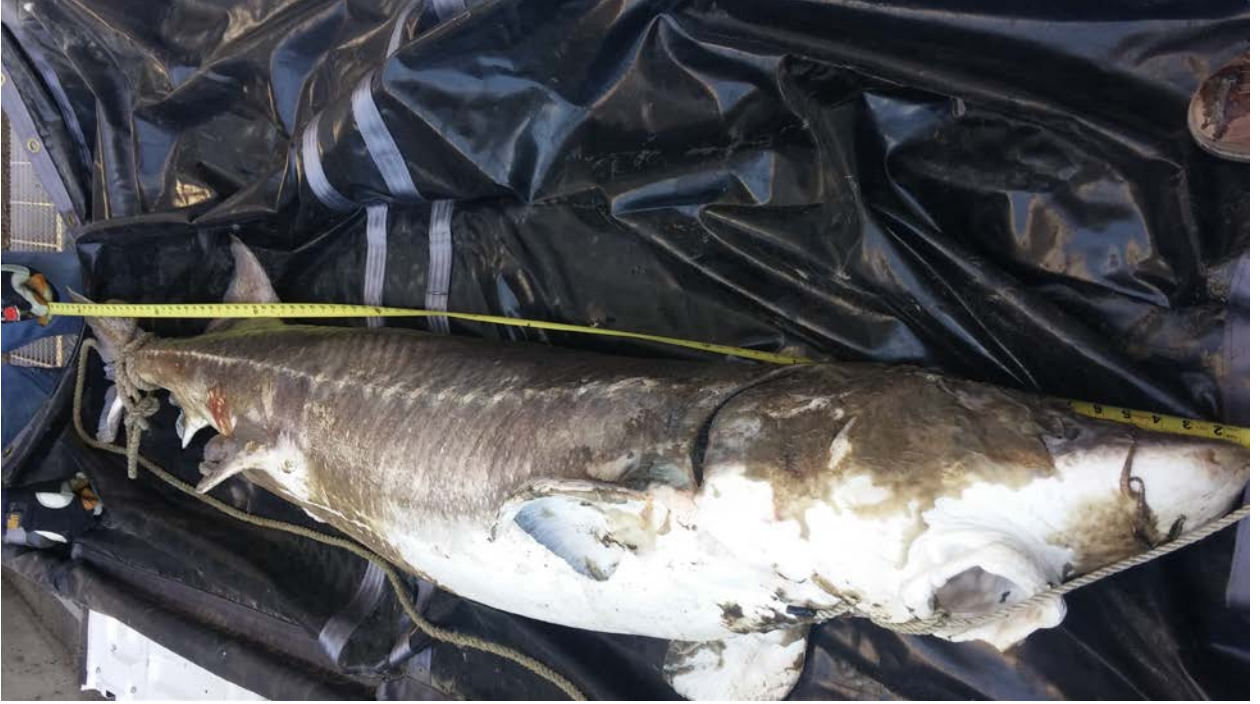
- I. Pictures included – see below.

- A. Species – *Acipenser transmontanus*.
- B. Origin – Unknown.
- C. Length – 87” total length
- D. Marks and tags – None
- E. Marks and injuries found on carcass – vertical compression mark on the body from bottom of picketed lead. The carcass was removed from the water at the south shore count station on September 26 and was observed to be in the mid-stages of decomposition. The carcass was put back in the river downstream of the dam.

- F. Location – At the south shore fish ladder picketed leads.
- G. Cause and time of death – The picketed leads for the south fish count slot were being routinely cleaned of filamentous algae. One of the upstream leads was raised up and being sprayed off. This lead was then lowered slowly down with the hoist to the floor of the count station. The picketed lead was not sitting level on the floor, so the lead was partially raised, and a rake was used to push what appeared to be a large dead fish out from under the lead. The dead sturgeon was then seen through the fish viewing window. It is not certain that the fish was killed by the force of the picketed lead being placed on it. The fish may have already been dead, as the carcass appeared to show signs of bloating, although there was not clear visibility of the fish through the window. Also the picketed lead was lowered very slowly as it approached the floor to avoid striking or smashing fish.

- H. Future and preventative measures – Air bubbles and a water spray jet are always used to scare fish away from the leads when they are being cleaned. Personnel will continue to be very careful when lowering the picketed leads in the cleaning process, so as not to harm fish. The frequency of cleaning is currently about every two or three days to keep the head differential across the picketed leads within criteria. As the water temperature continues to cool, the algae accumulation on the leads will continue to lessen, and the leads will require less frequent cleaning.
