MEMORANDUM FOR THE RECORD - 16 IHR 010

SUBJECT: Adult steelhead mortality found on October 21, 2016, at the juvenile fish collection channel.

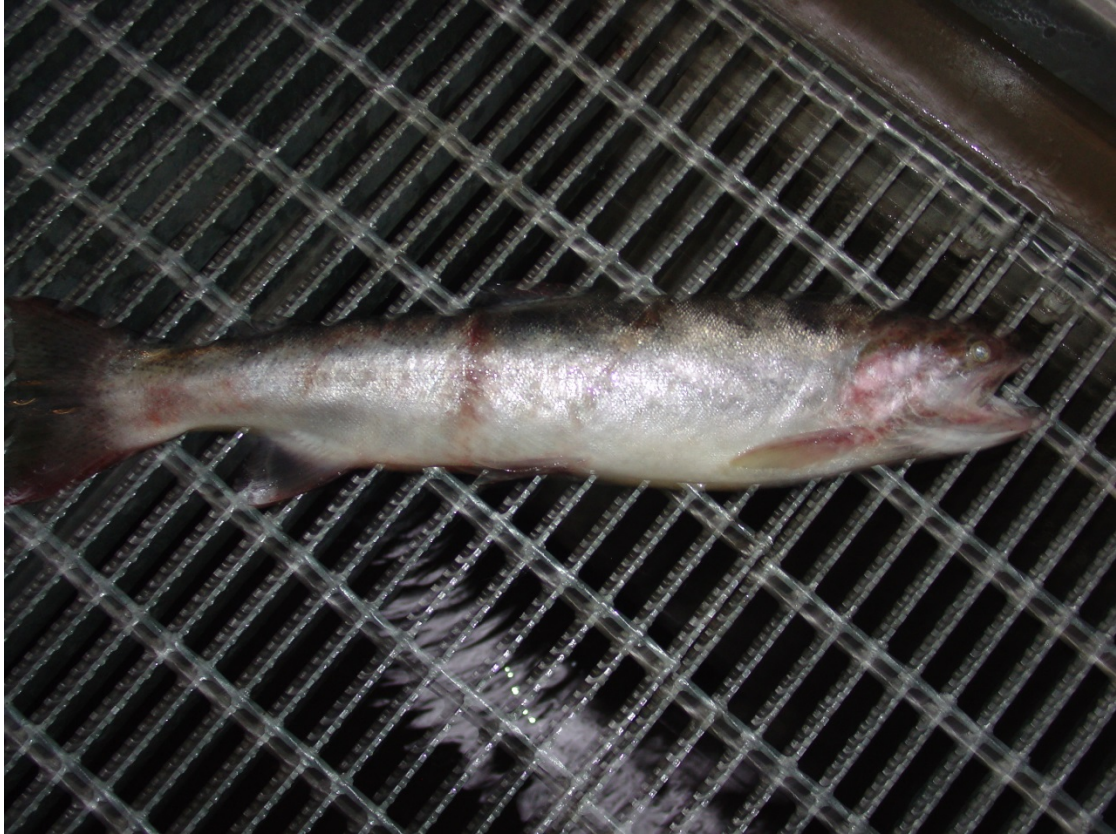
- A. Species – *Oncorhynchus mykiss*.
- B. Origin – unknown.
- C. Length – 28.5”
- D. Marks and tags – none, unclipped.
- E. Marks and injuries found on carcass – contusions and hemorrhaging, most likely from the fish flopping around on the grating.

- I. Pictures included below. The first photo is of the fish turned over, to show the injuries that were only on the side of the fish that was against the grating. The second photo shows the plastic mesh above orifice 5AN and behind the orifice light. The mesh has been repaired in this photo. The tear in the mesh was near the base of the light, where the mesh was also unattached to the toe board.

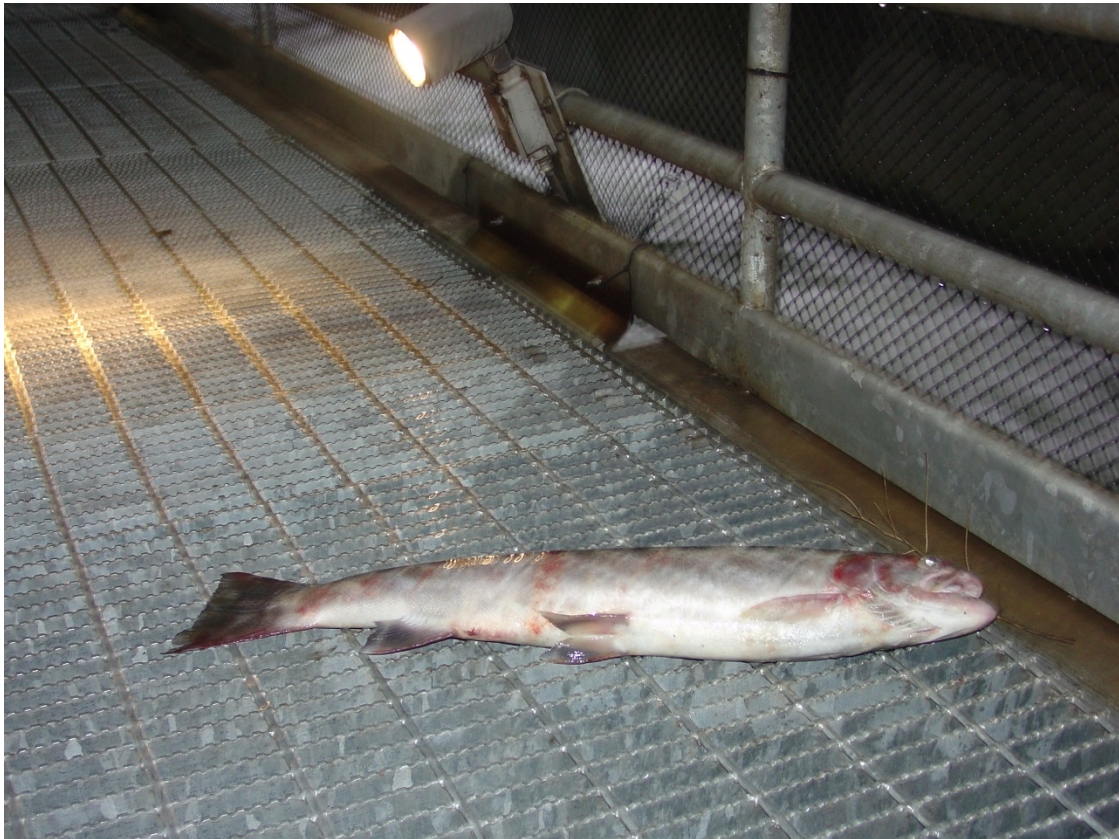
- F. Location – The fish was found on the walkway grating of the juvenile fish collection channel, above and adjacent to orifice 5AN.
- G. Cause and time of death – The fish had jumped out of the channel sometime over the past day. The existing jump-netting extends 11-12’ above the water surface. There is plastic mesh attached all along the hand rail, from the jump netting down to the toe board. However, there was a tear in the plastic mesh above orifice 5AN large enough for the fish to squeeze through.

- H. Future and preventative measures – All of the plastic mesh under the jump netting was examined and three or four additional tears/gaps smaller than the one at 5AN were found. They were all mended with plastic cable ties. The plastic mesh is slowly deteriorating and will need to be eventually replaced in kind or with some other type of barrier material that will not injure fish that jump against it.
