MEMORANDUM FOR THE RECORD - 17 IHR 13 [updated August 8, 2017](#)

SUBJECT: Adult lamprey mortality found on July 26 [and August 7](#), 2017, at south shore fish count station.

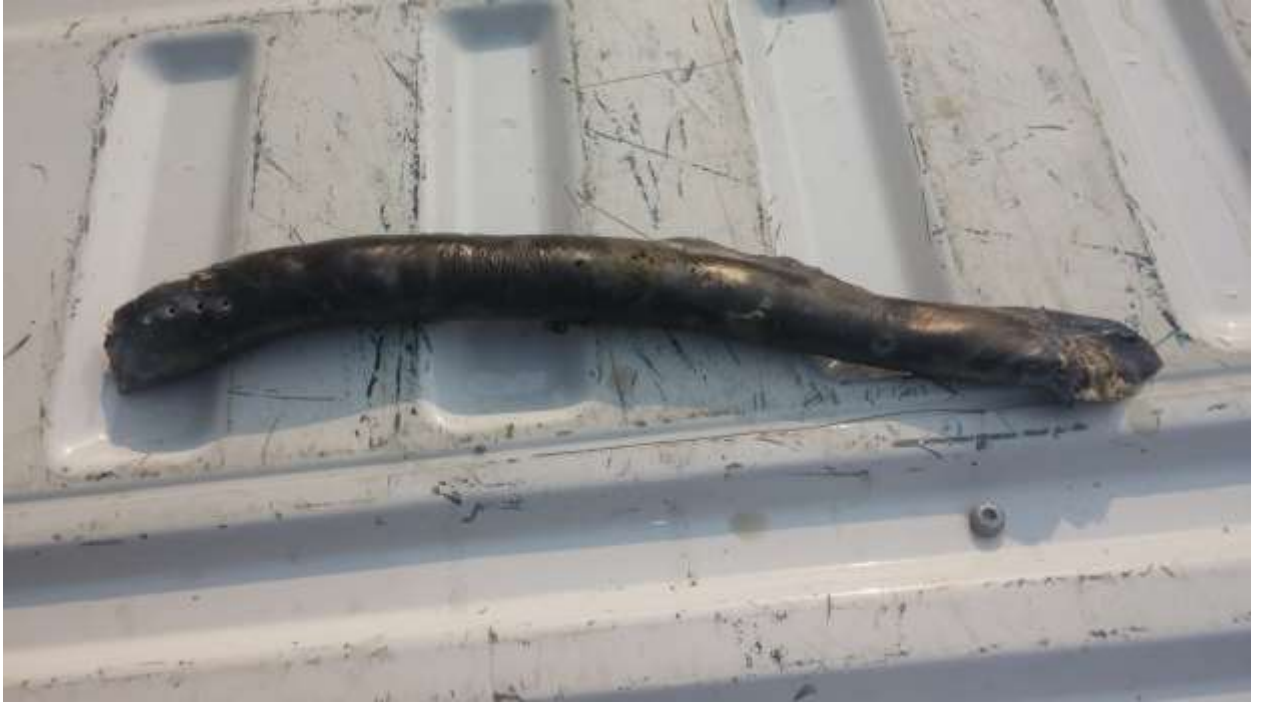
- D. Marks and tags – No marks or tags seen.
- E. Marks and injuries found on carcass –None seen [on July 26](#). [The lamprey found on August 7 had indentations from the bars of the picketed lead \(see photo below\)](#).

- F. Location – South shore fish count station at the picketed leads.
- G. Cause and time of death – On July 26, at about 0815 hours, fish facility staff began to clean the picketed leads. While raising one of the [downstreamupstream](#) picketed leads, he briefly observed a dead adult lamprey with its head stuck between the vertical bars of the lead ([head facing upstream](#)), before the lamprey fell off into the water. It is uncertain how long the lamprey was dead, because he did not get a good look at its condition. At the time, the picketed leads were being cleaned once a day, so the lamprey was stuck in the lead for up to 1 day. Although it is not certain, the lamprey may have died as a result of being stuck in the picketed lead. [On August 7, at about 0745 hours, a dead adult lamprey was found stuck between the vertical bars of one of the downstream picketed leads \(head facing upstream\) while cleaning it. The lamprey appeared to be dead for at least 1 day and was missing its head and tail \(see photo below\)](#).

- H. Future and preventative measures – The picketed leads are raised approximately 2” off the floor of the fish ladder for lamprey passage. The spacing between the vertical bars of the picketed leads is 1”. However, the actual spacing between the bars is effectively less than 1” in areas where filamentous algae collects on the bars of the leads before being cleaned. This may create areas where the spacing between the bars is harder for lamprey to squeeze through. Currently, the picketed leads need to be cleaned twice a day to not exceed the criteria for head differential across the picketed leads. The frequency of required cleaning will most likely continue to increase in the next few weeks as more filamentous algae comes down the fish ladder. While cleaning the picketed leads, personnel will monitor the leads for any more lamprey to assess whether this continues to be a problem. [Temporary lighting will be installed soon at the south shore count station so the picketed leads can be safely cleaned at night. The picketed leads will be cleaned once during the day time and once at night for the twice a day cleaning. The night time cleaning will help keep the leads clean at night when lamprey are passing.](#)
