MEMORANDUM FOR THE RECORD 21-IH-10

SUBJECT: Adult Chinook salmon mortality found near the south fishway count station

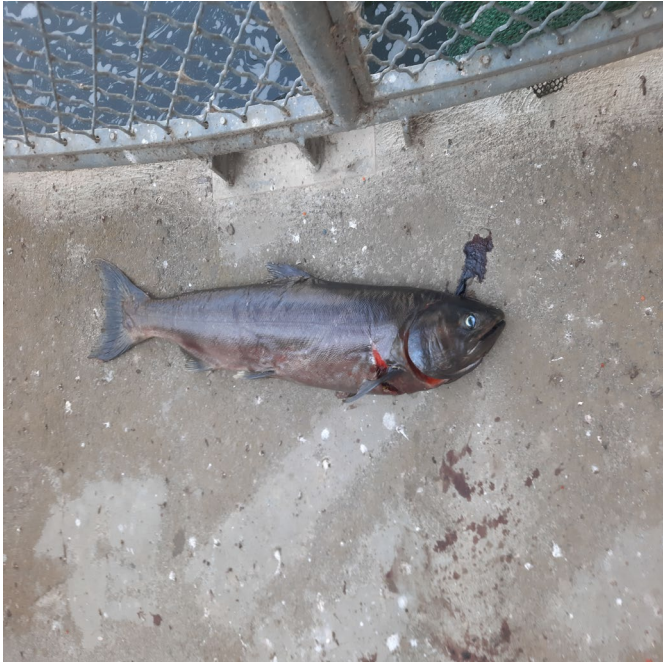
- G. Cause and time of death – The Chinook was found at approximately 0830 hours on July 15. Judging by the severity of the wound on the body (see photo below), the fish is presumed to have jumped out of the fish ladder just downstream of the upper diffuser and landed on the deck below (see photo). The fish likely jumped out the day previous to when it was found.

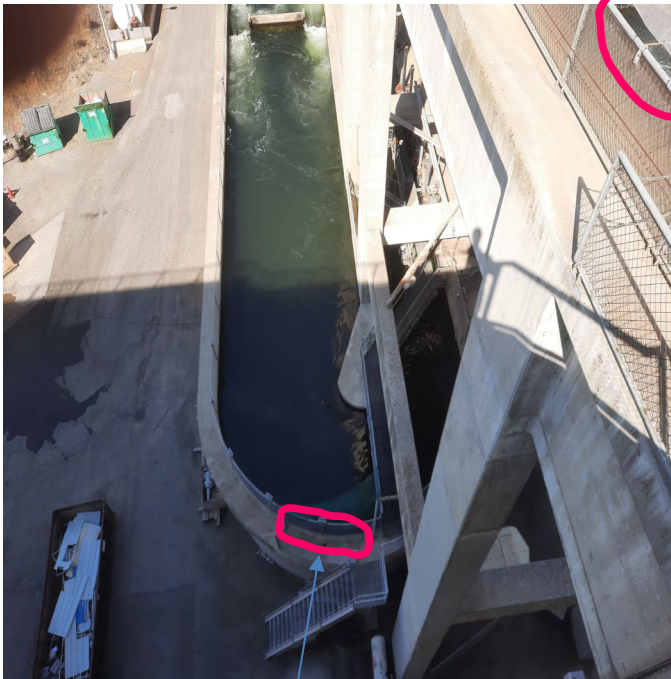
Gap in netting

Fish found here

- H. Future and preventative measures – The deteriorating fish-jump netting at the upper south fish ladder was replaced last winter. However, some of the netting has already become detached from the fish ladder handrail from wind and weathering, creating a few gaps where fish can jump through (see photos). The netting will be reattached or new, stronger netting or perforated plate will be purchased that will hold up better in the weather. Personnel access to repair the netting in-season is difficult because of the fall hazard on the outside of the ladder. Access from the inside of the ladder is only possible when the ladder is unwatered, such as during the annual winter maintenance period for the ladder. The feasibility of using a crane/man basket to access the netting in-season will be determined.

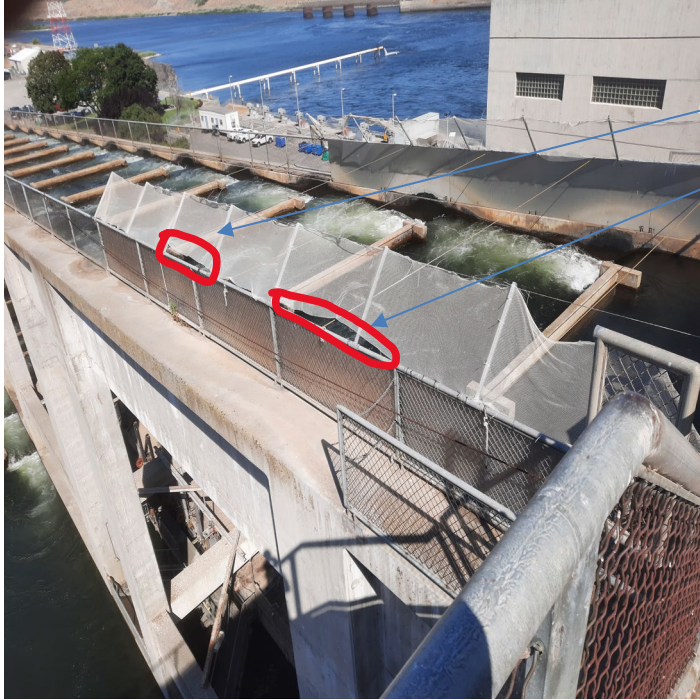
Gaps in netting
