**MEMORANDUM FOR THE RECORD 21-IH-14**

**SUBJECT:** Jack chinook mortality found near the juvenile fish channel

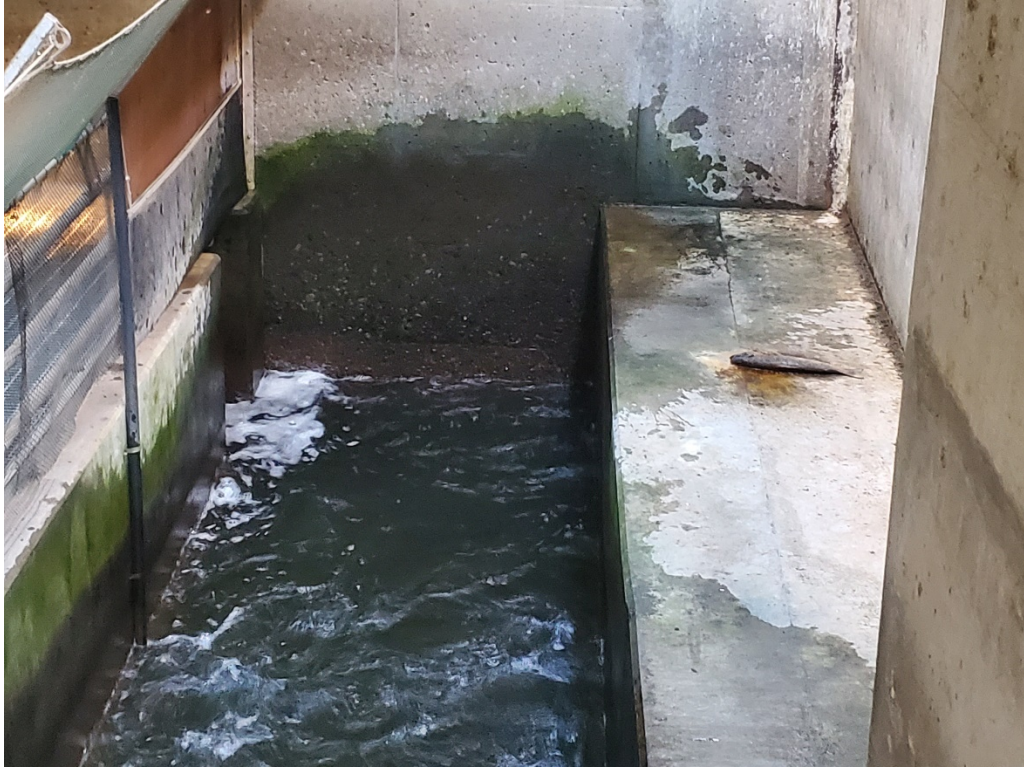
- A. Species – *Oncorhynchus tshawytscha*.
- B. Origin – Unknown.
- C. Length – 16”.
- D. Marks and tags – Adipose clip
- E. Marks and injuries found on carcass – None.
- F. Location – On the concrete ledge of the east wall of the juvenile fish channel, in the area across from 6C orifices (see photos below).

- G. Cause and time of death – The Chinook was found on September 16. Judging by how dried up the fish was, it must have been dead for several days or more. The fish is presumed to have jumped out of the channel and gotten stranded on the ledge.

- I. Pictures included – Yes. The first photo shows the dead fish and the area where orifice 6CN water jet would be shooting out of the gap at the end of the left wall. (Unit 6 orifices were closed at the time this photo was taken to accommodate STS inspections).

- H. Future and preventative measures – The ledge that runs along the east side of the channel is about 3’ wide and 3’ above the channel. Fish occasionally jump against the orifice flow, where there is netting installed on the hand railing to prevent fish from getting stranded on the walkway grating. Fish rarely jump in the other direction and get stranded on the concrete ledge. The last time that happened was about 10 years ago. There is no jump-barrier to prevent fish from getting stranded on the ledge. A jump barrier cannot safely be installed while the channel is in operation, but could possibly be anchored into the concrete during the winter maintenance period.
