**MEMORANDUM FOR THE RECORD – 21 LGS 08 MFR Adult Chinook salmon
Mortality**

SUBJECT: One dead Chinook salmon found below primary dewaterer.

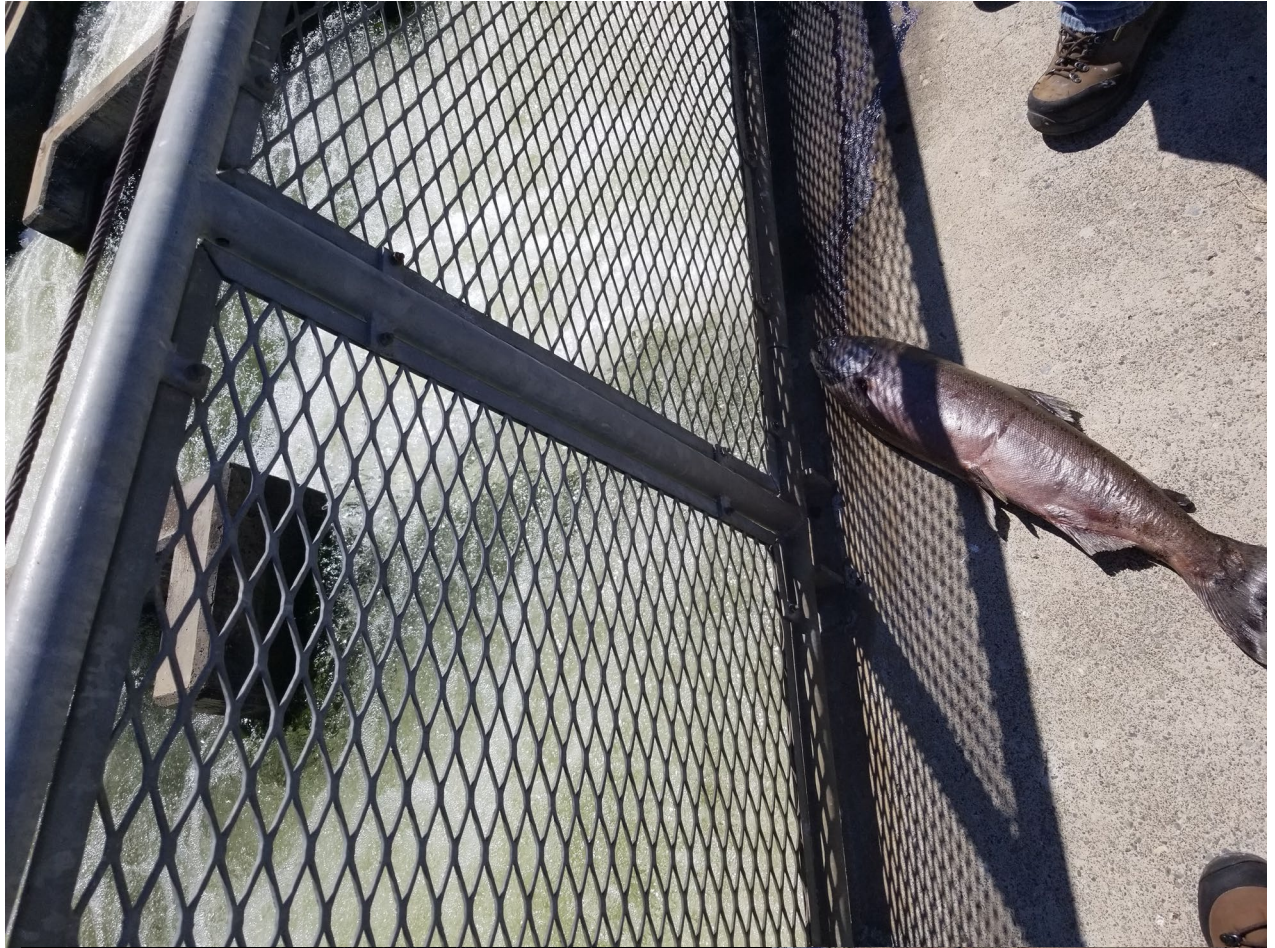
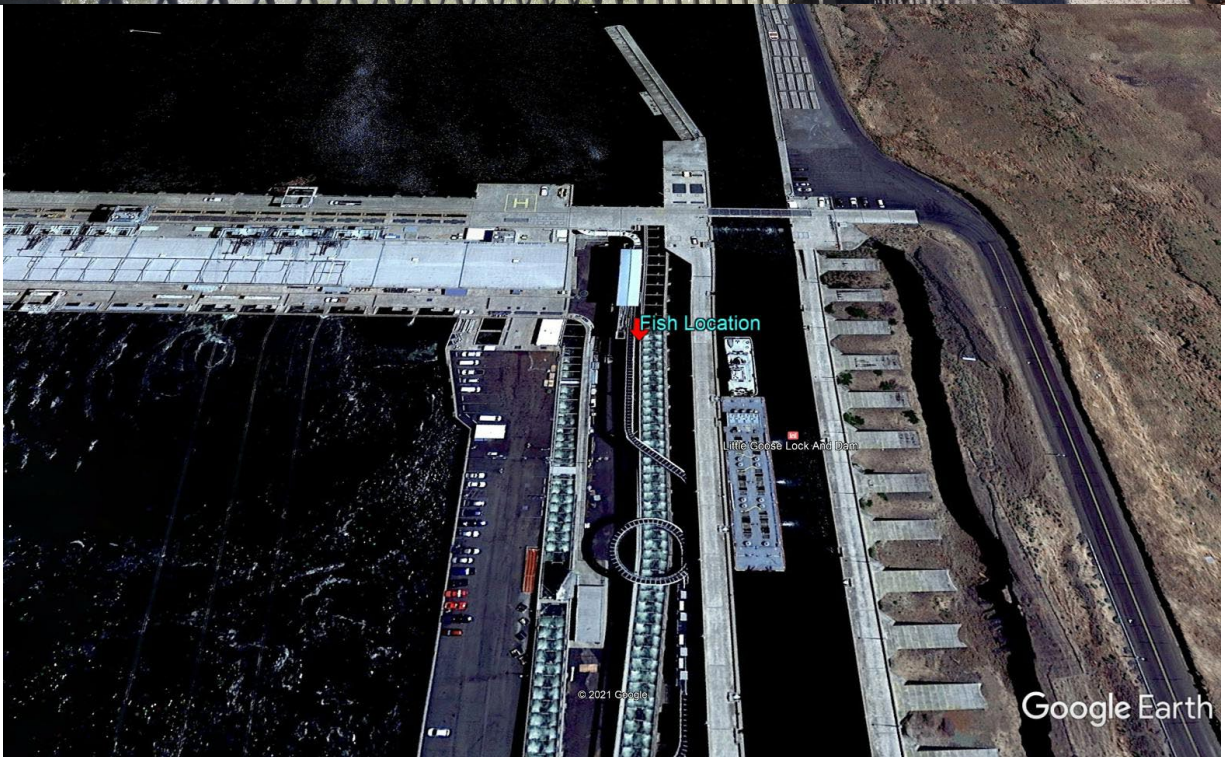
During a routine juvenile facility inspection, one adult Chinook salmon was discovered on the fish ladder walkway downstream of the primary dewaterer on 06/28/2021. The unclipped adult Chinook was approximately 30” long. The fish was very desiccated due to high ambient air temperatures, but most likely recently jumped out of the fish ladder. The fish was scanned for a PIT tag and returned to the river. See photo of fish and approximate location below.

- A. Species – Chinook salmon, *Oncorhynchus tshawytscha*
- B. Origin – Wild
- C. Length – 30”
- D. Marks and tags – None
- E. Marks and Injuries found on carcass – None
- F. Cause and Time of Death – Fish likely jumped out of the ladder just downstream of upper diffuser #13 between June 27-28.
- G. Future and Preventative Measures – Further efforts are underway to determine the location and necessity of netting to prevent future mortalities.
