MEMORANDUM FOR RECORD: 17 LWG 11 Emergency Debris Spill

Subject: Emergency Spill Operation for Log Removal

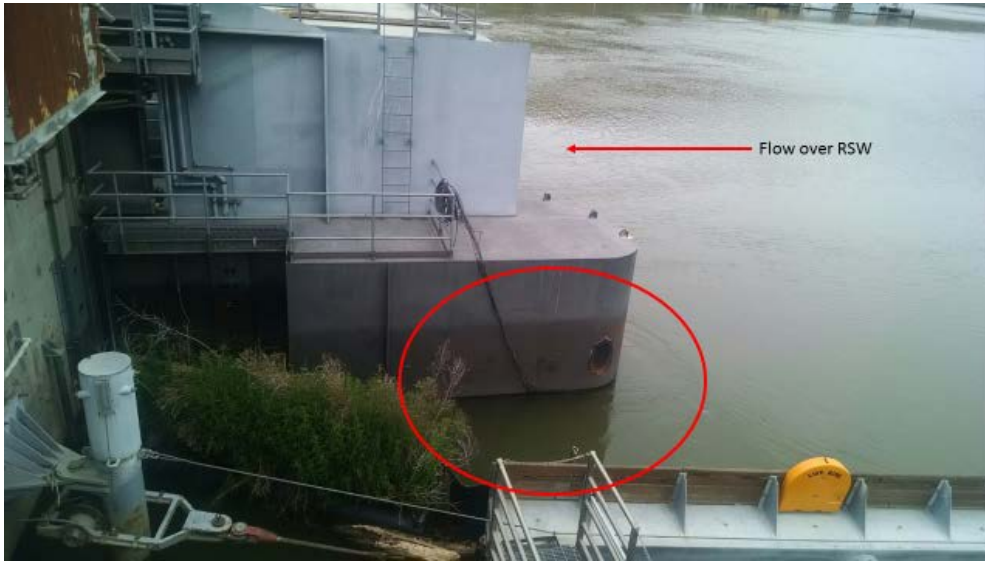
Photo 1. Southeast corner of RSW and northeast corner of forebay debris boom.

Debris in the Lower Granite forebay continues to accumulate in front of the spillway and powerhouse. Large logs wedged between the RSW and debris boom resulting in mats of debris is a reoccurring problem. June 14 a mat of debris behind a wedged log covered about 1/3 of the area in front of the RSW. From 1045-1208 hours June 14 the Project closed the RSW and opened spillway 3 to remove the wedged log and debris. Operations deviated from the Fish Passage Plan (FPP) spill pattern with RSW closed and spillway 3 full open during the emergency spill. Spill volume remained unchanged during the debris spills.

I. Photos – The red circle in the photo below shows the area where logs have been getting wedged.

- A. Species – N/A
- B. Origin – N/A
- C. Length – N/A
- D. Marks and tags – N/A
- E. Marks and Injuries found on carcass – NA
- F. Cause and Time of Death – N/A
- G. Future and Preventative Measures – The Project will continue to implement emergency debris spills when debris accumulates in front of the RSW as described in FPP (LWG-31 5.2. Emergency Debris Spills) to prevent obstructions to fish passage. A diversion boom is being designed for installation during winter maintenance to prevent logs from floating into the problem area.
