MEMORANDUM FOR RECORD: 17 LWG 15 Adult Trap Shad Issue:

Lower Granite Adult Trap Overflow – 10 July 2017

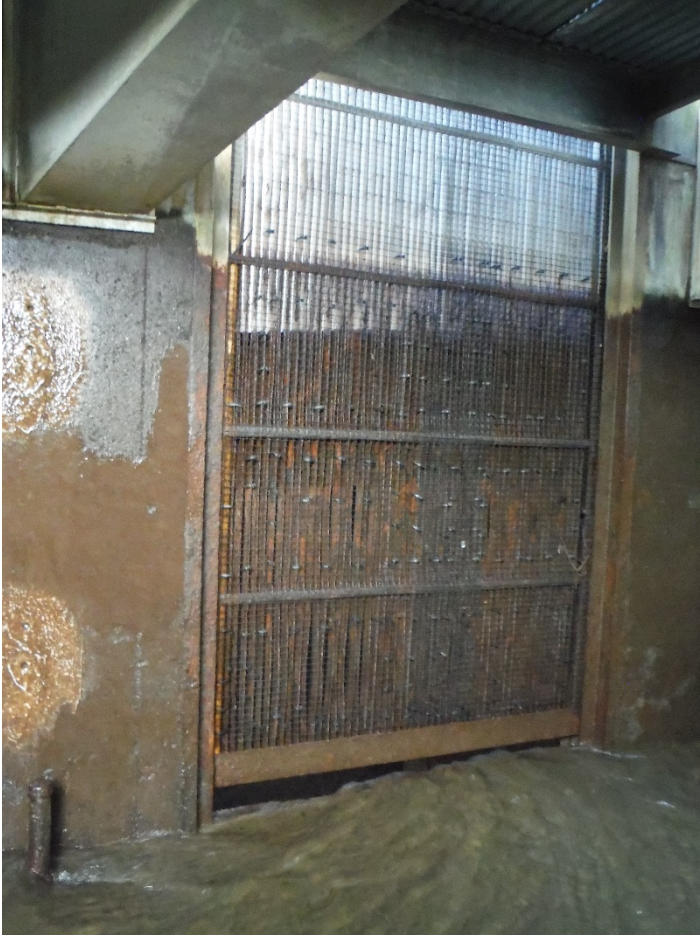
Description of the problem: Current adult trap operation includes changing to non-sample mode from Friday afternoon through Sunday morning with the turnpool diversion gate remaining in the trapping position. At about 0500 hours July 10 Corps personnel noticed water overflowing from the adult trap recovery pool into the parking lot below. NOAA personnel were notified immediately and arrived at about 0510 hours. The problem was identified as adult shad mortalities accumulating on the recovery pool screen located below the fish sample basket (see photo). Shad were flushed from the screen without impacting adults in the trap sampling system to regain control of water flow. After sample fish were worked up the trap was completely flushed (see photos). No salmonid mortalities occurred. Shad counted over Lower Granite have increased (see graph) resulting in blockage of adult trap drain screens over the last couple seasons. Modifications in adult trap operation including daily trap flushing and changing the turnpool gate position to remove shad has been used to mitigate this problem. The adult trap will be flushed daily after working the morning sample until observed shad mortalities decline or other actions are warranted. Corps night shift biological techs will monitor the adult trap every 1.5-3 hours (depending on personnel availability) and notify the Corps and NOAA fisheries biologist of any issues until Lower Granite shad passage declines.

Photo 1. Adult trap recovery pool looking towards the sample basket and screen that plugged with shad mortalities during dewatering for shad July 10, 2017.

- A. Species – NA
- B. Origin – NA
- C. Length – NA
- D. Marks and tags – NA
- E. Marks and Injuries found on carcass – NA
- F. Cause and Time of Death – NA
- G. Future and Preventative Measures – Lower Granite Corps and NOAA biologist agreed the preferred method is to continue to operate as described above until shad mortalities are reduced. An additional method of operation if flow cannot be managed considered by Lower Granite Corps and NOAA biologists considered would be to change to daily waterup and dewatering of the trap.
- H. Photos – See below.

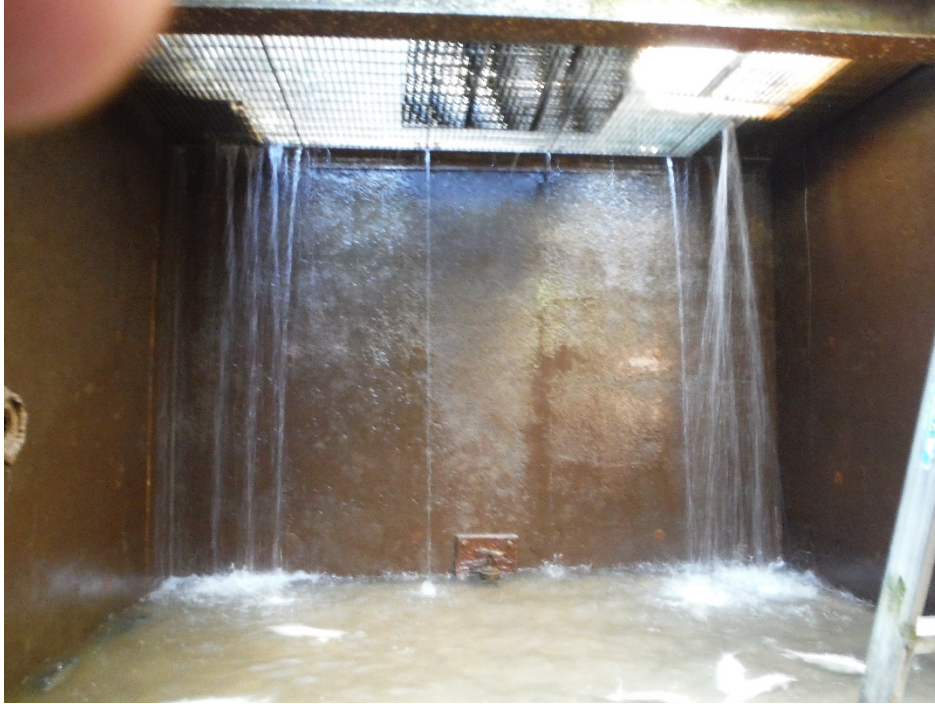
Photo 2. Adult trap recovery pool looking towards attraction pool during dewatering for flushing shad mortalities July 10, 2017.

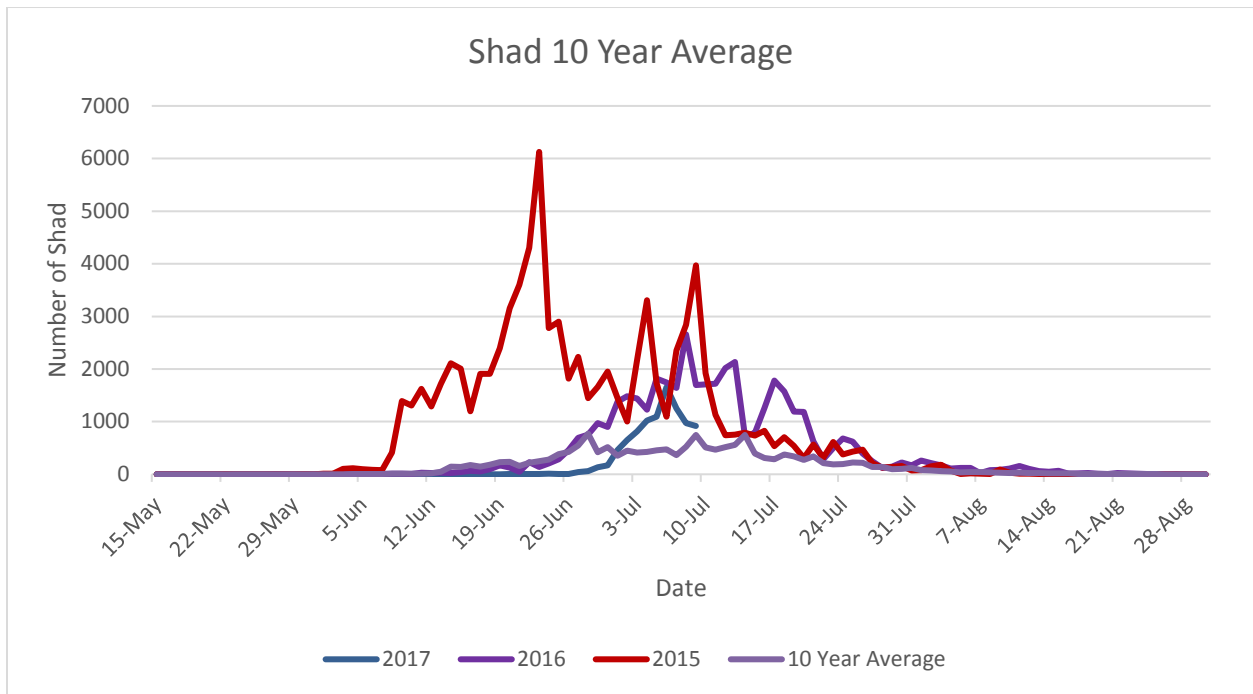
Graph 1. Lower Granite ten year average shad passage with 2015, 2016, and 2017 shown separate.
