**MEMORANDUM FOR THE RECORD 17 MCN 003 Oregon Ladder Exit Screens**

**SUBJECT:** Removal of Oregon shore ladder exit traveling screens from service.

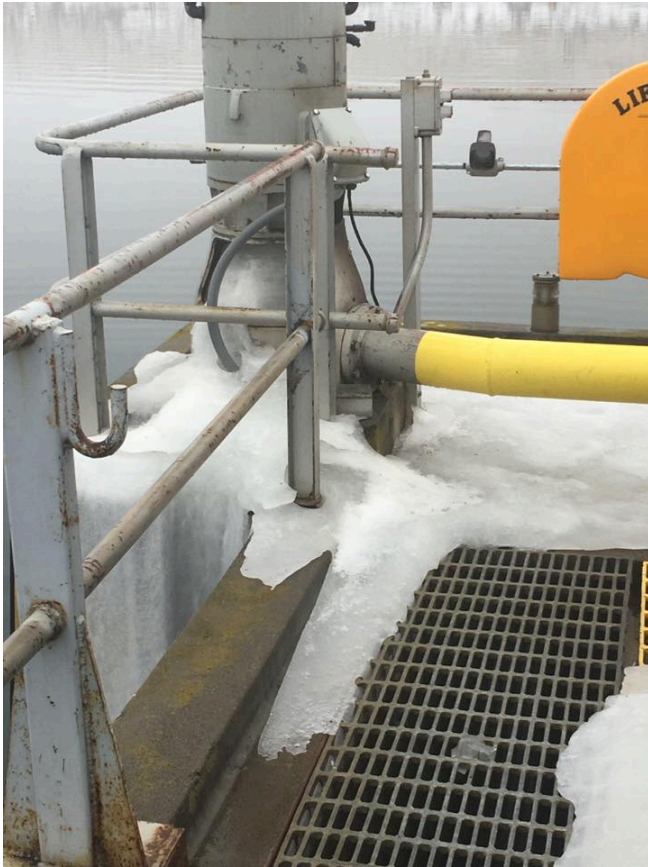
On December 16, the roving operator found the wash pump supply and discharge lines frozen. See photos below. The pump flushes debris from the travelling screens' debris trough to the river. The pump and traveling screens were set to run for 20 minutes once every 6 hours. Without this pump, debris can accumulate in the trough and possibly jam the screens. The operator used the PLC to turn the wash pump and both travelling screens off. Trash rack and screen differentials before and after the screens were removed from service measured 0.0 to 0.3 feet. On December 23, the operators also used to the screens' switches to insure the screens remained off. The biologists will continue to monitor the differentials until the Oregon shore ladder is removed from service on January 27. Debris loads are minimal so a change in differential recordings is very unlikely. Also, it is highly doubtful the pipes will thaw out before January 27. The NOAA weather website, <http://forecast.weather.gov/>, shows highs from 28 to 34 degrees F and lows from 19 to 22 degrees F for the 23<sup>rd</sup> to 27<sup>th</sup>. Please see photos below.

Photo 1: Wash Pump.

- A. Species – NA
- B. Origin – NA
- C. Length – NA
- D. Marks and tags – NA
- E. Marks and Injuries found on carcass – NA
- F. Cause and Time of Death – NA
- G. Future and Preventative Measures – Purchase of a new wash pump is scheduled for the near future. Possibly relief from freezing can be installed with the new pump. Debris loads in the winter are minimal. Possibly the pump and screens should be removed from service during cold weather and differentials monitored closely. Then only run the system when needed.

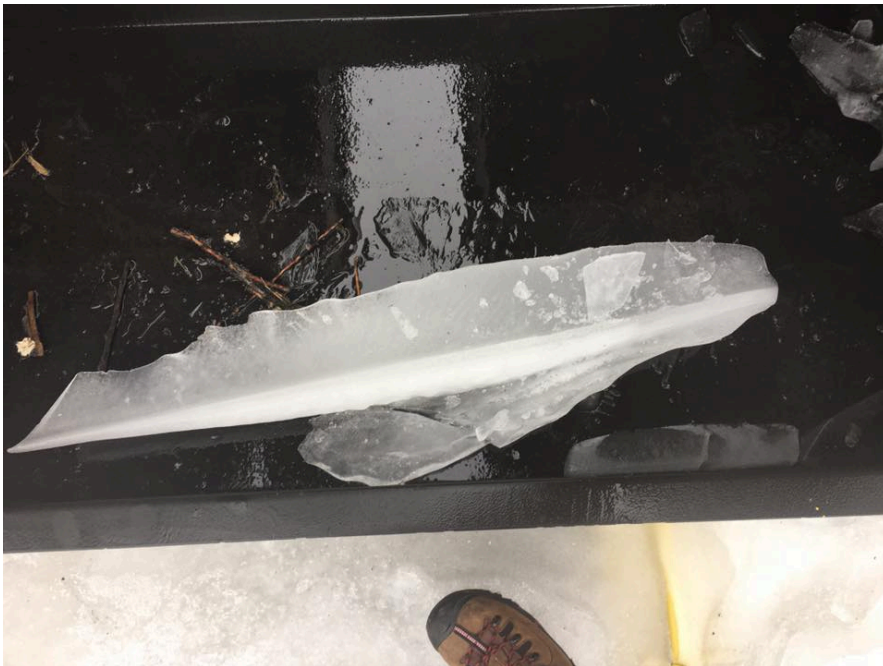
Photo 2: Debris Trough.

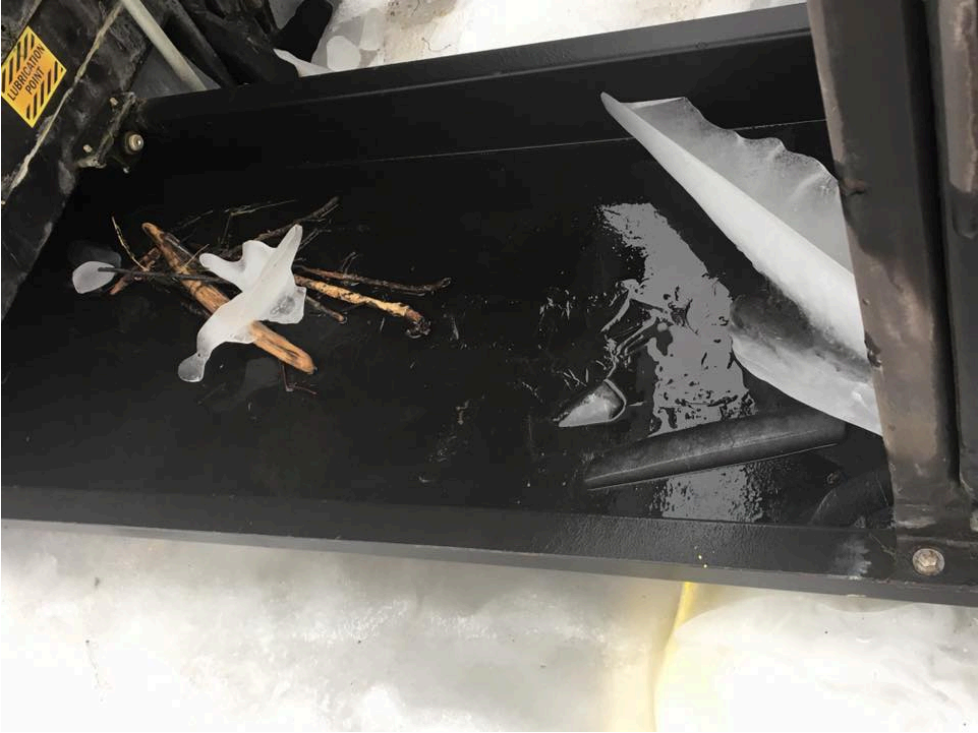
Photo 3: Debris Trough Again.

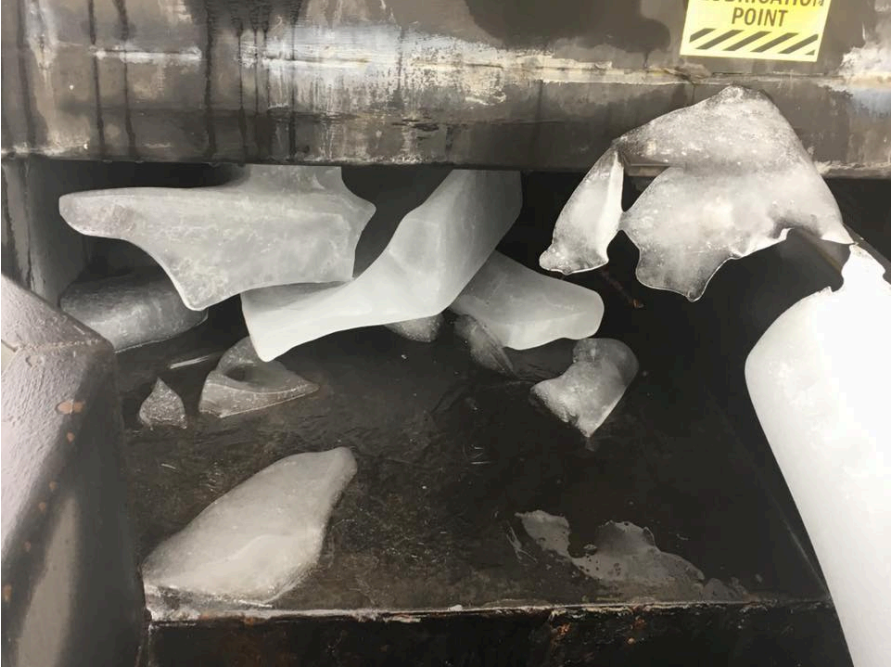
Photo 4: Debris Trough Exit.

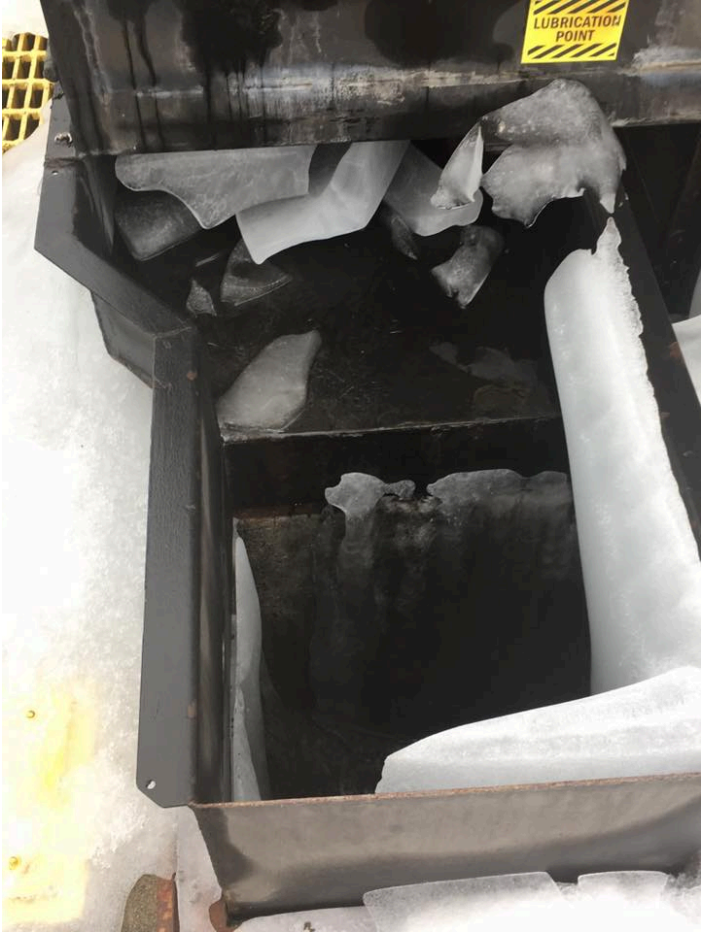
Photo 5: Debris Trough Exit Again.
