Water Temperature Near the Ladder Exit and in the Forebay at the Edge of the Spray
Lower Granite Dam Post-passage Temperature Study

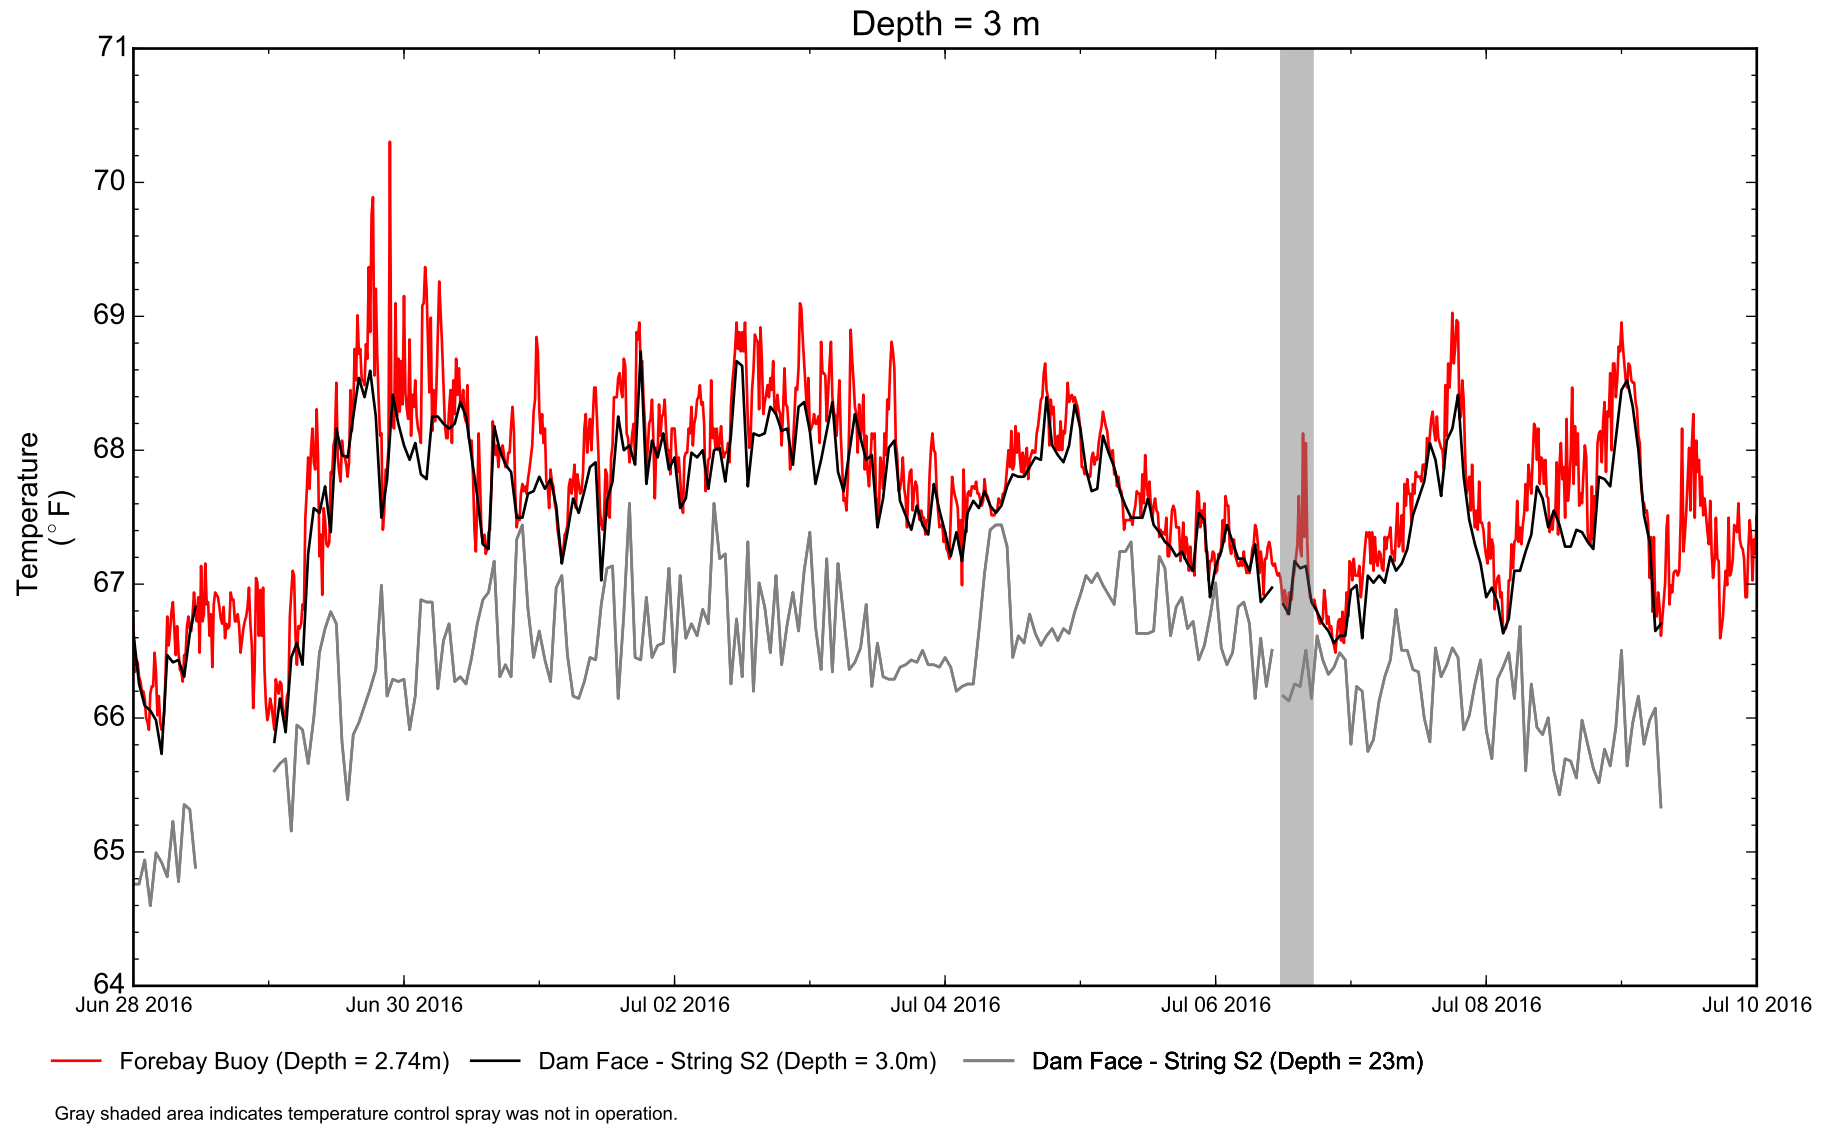
**Figure 2**

Water Temperature Near the Ladder Exit and in the Forebay at the Edge of the Spray
Lower Granite Dam Post-passage Temperature Study
