Use of Lamprey Passage Structures at Bonneville and John Day Dams
2016 Annual Report

**U.S. Army Corps of Engineers
Portland District, Fisheries Field Unit
Cascade Locks, OR 97014**

3 July 2017

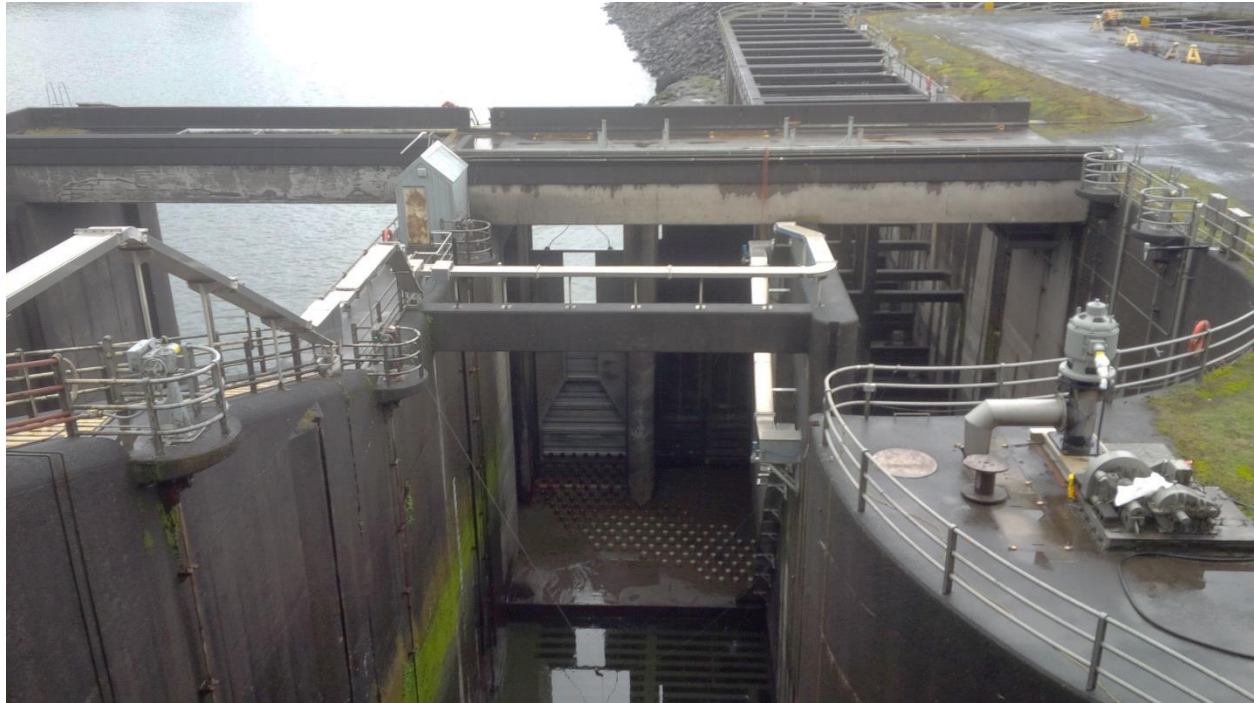
On the cover: *Cascades Island fishway entrance (dewatered for maintenance) and Lamprey Passage Structure at Bonneville Dam. Bollards have been attached to the concrete to create heterogeneous flow and lead lamprey to the LPS entrance. The variable width weir can be seen in front of the bulkhead. It is designed to cause reduced water velocities, to help lamprey enter lower in the water column, and maintain salmon attraction velocities higher in the water column.*

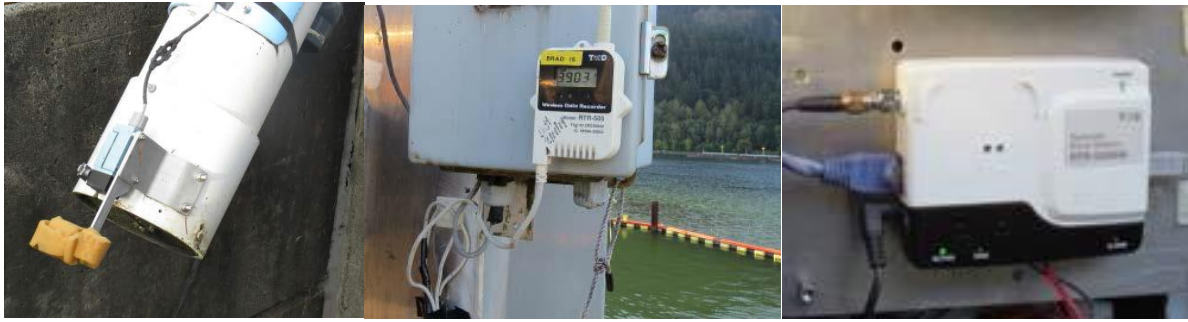
Figure 3. Mechanical counter components used to enumerate lamprey passage including the limit switch attached to exit paddle and cushion, wireless data recorder, and network base station (from left to right).

Volitional lamprey passage events were recorded at BI-AWS, CI-DE, and WA-AWS from 5 April, 2016 (8 April at CI-DE) through 27 October 2016. The counting system consisted of an eight inch diameter, light weight perforated plastic paddle at the terminus of an eight inch PVC exit pipe, limit switch (Honeywell Heavy Duty Limit Switch model numbers: LSA1A-4M & LSA1A), a data recorder (T&D Corporation RTR-505 Wireless Data Recorder), and a network base station (T&D Corporation RTR-500NW) (Figure 3). As lamprey exited the LPS the paddle was physically triggered and the limit switch connected to the paddle completed a voltage circuit. This voltage pulse was recorded by the wireless data recorder, which reported the time and date at pre-set intervals (60 seconds) along with the number of pulses (passage events) during that interval.

During LPS inspections, tests were conducted to ensure the counting system was functioning properly. The paddle was actuated ten times by hand and the counts on the data logger digital display were verified. The date, time, and number of these test pulses were recorded in a log book so they could be removed from the data set before analysis. The 3.6 volt batteries of the wireless data recorder were also monitored and replaced as necessary (about once a month). Finally, passage data was downloaded bi-weekly from the base station via a USB connection to a laptop computer and T&D RTR 500W software.

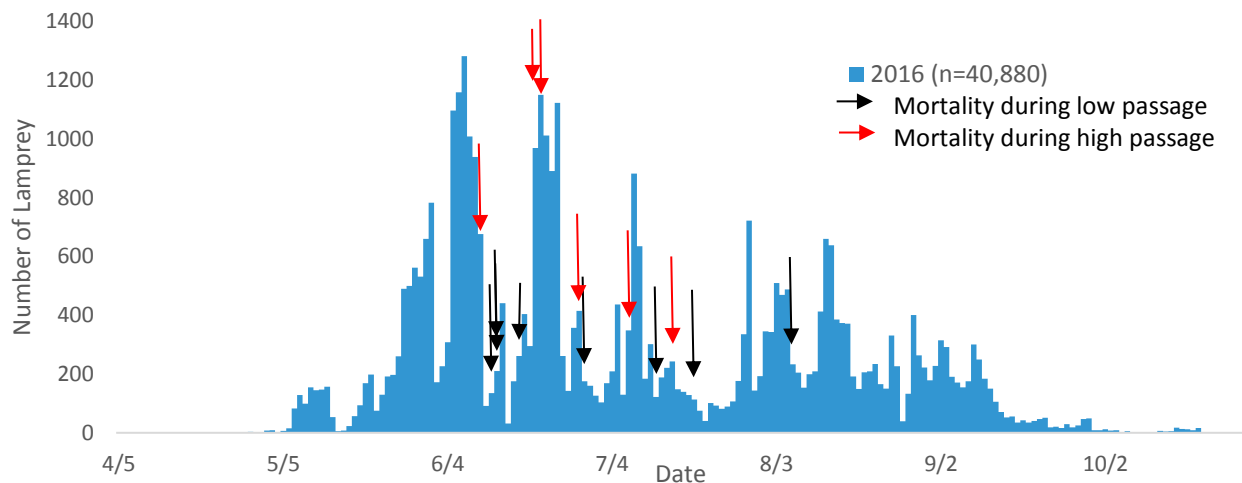
Figure 7. Corrected daily lamprey passage counts at Bonneville Dam Washington auxiliary water supply lamprey passage structure during 2016. Arrows indicate when lamprey mortalities were found in the structure or near the structures entrance.

A total of 14 lamprey mortalities were removed from WA-AWS LPS. Passage was relatively high ($n \geq 244$) on six days when mortalities were removed (Figure 7, red arrows), and passage was relatively low ($n \leq 232$) on eight days when mortalities were removed (Figure 7, black arrows).

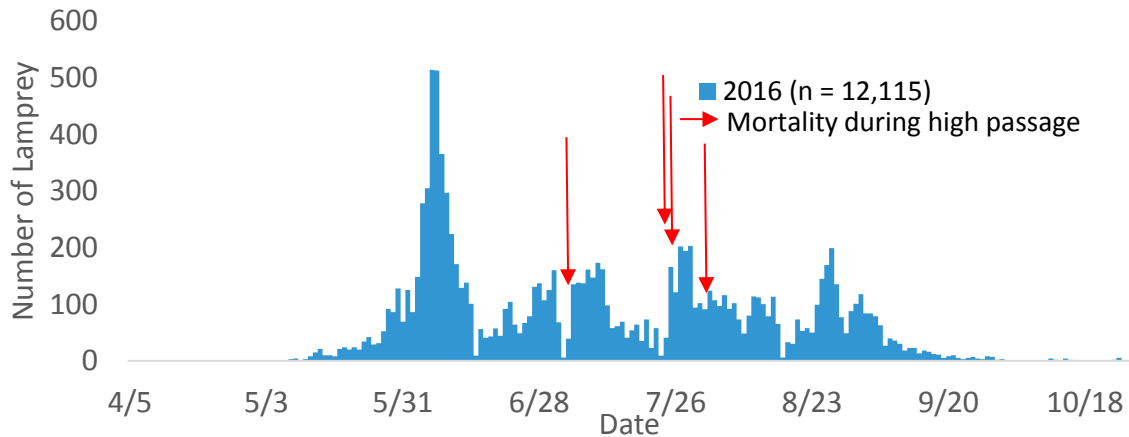
Figure 8. Corrected daily lamprey passage counts at Bonneville Dam Bradford Island auxiliary water supply lamprey passage structure during 2016. Arrows indicate when lamprey mortalities were found in the structure or near the structures entrance.

A total of four lamprey mortalities were removed from BI-AWS LPS (Figure 8). Passage at this location was relatively high ($n \geq 108$) on all three days when mortalities were removed.

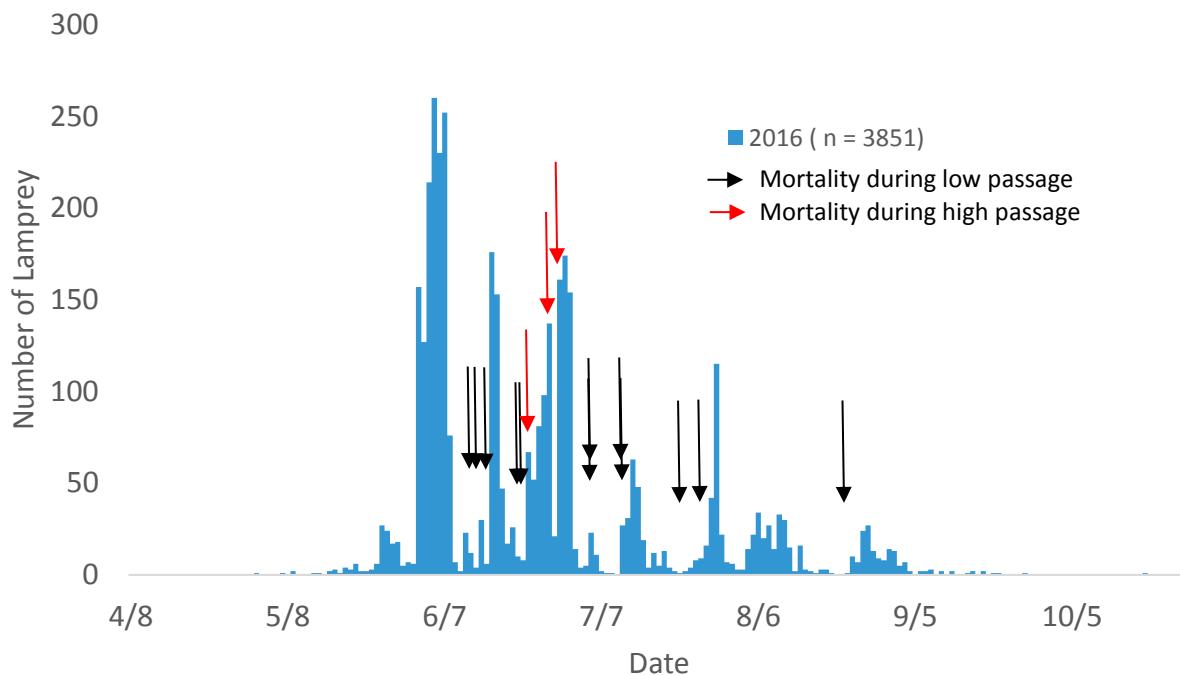
Figure 9. Corrected daily lamprey passage counts at Bonneville Dam Cascades Island downstream entrance lamprey passage structure during 2016. Arrows indicate when lamprey mortalities were found in the structure.

A total of 15 lamprey mortalities were removed from CI-DE LPS (Figure 9). Passage was relatively high ($n \geq 68$) on 3 days when mortalities were removed, indicated by red arrows. Passage was relatively low ($n \leq 26$) on 10 days when mortalities were removed, indicated by black arrows.

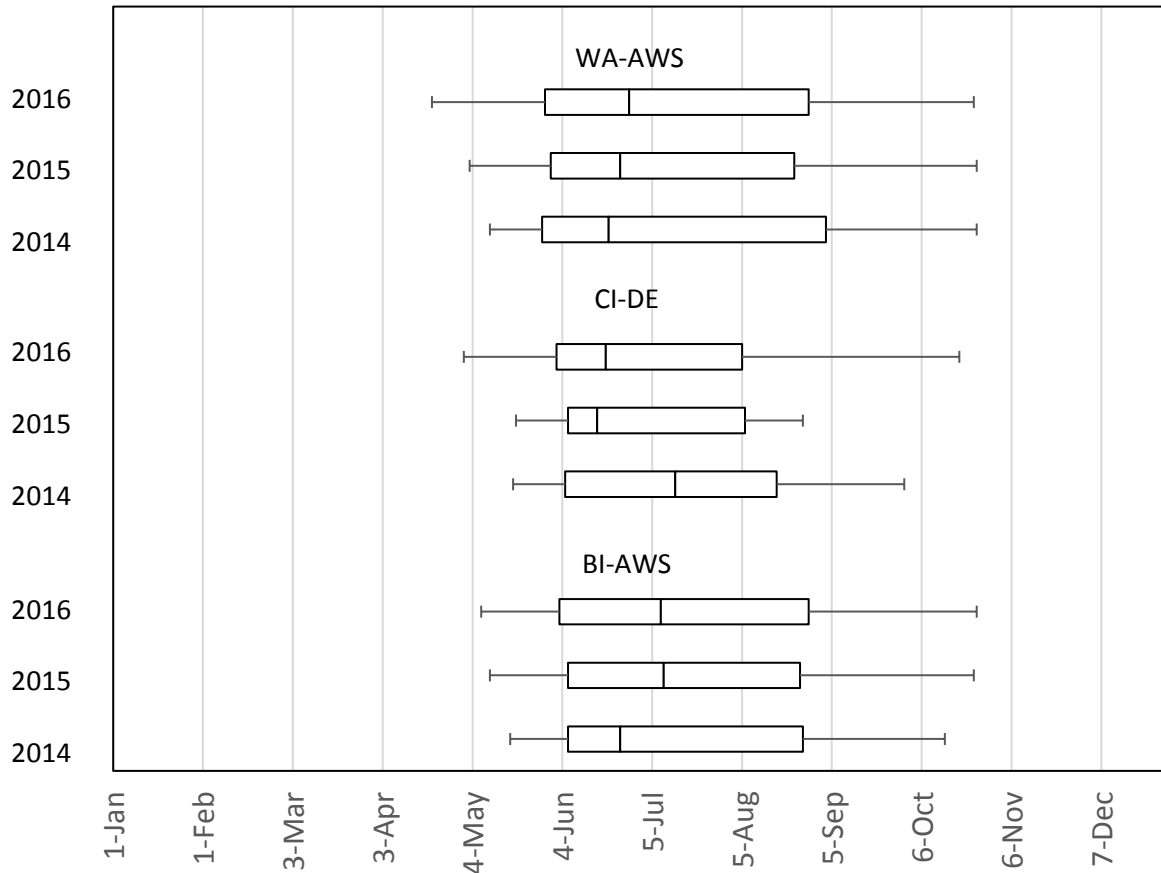
Figure 10. Run timing of Lamprey passing Bonneville Dam Lamprey Passage Structures from 2014-2016. Whiskers show dates of first and last fish passage, box plot quartiles depict the 10%, 50% and 90% passage dates.

From 2014-2016, the LPSs were started during March (2015), April (2016), and May (2014), and operated through late October. Similar correction methods were used to adjust LPS counts during 2014-2016. During that time, the earliest a lamprey passed any of the LPSs was April 21, 2016 at WA-AWS. The latest passage event occurred on October 27 during both 2014 and 2015. The inspection schedule followed during 2016, and operation of the LPSs beginning in early April and running through the end of October provided passage opportunity to the earliest and latest migrants (Figure 10). From 2014-2016, the earliest upstream migration at any of the adult fish ladders (non-LPS routes) at Bonneville Dam was 6 April (<http://www.fpc.org/environment/home.asp>).
