Use of Adult Pacific Lamprey Passage Structures at Bonneville and John Day Dams  
*2017 Annual Report*

**Nathan A. Zorich, Karrie M. Gibbons, and Kristen N. Bayley**

U.S. Army Corps of Engineers  
Portland District, Fisheries Field Unit  
Cascade Locks, OR 97014  
August 14, 2018

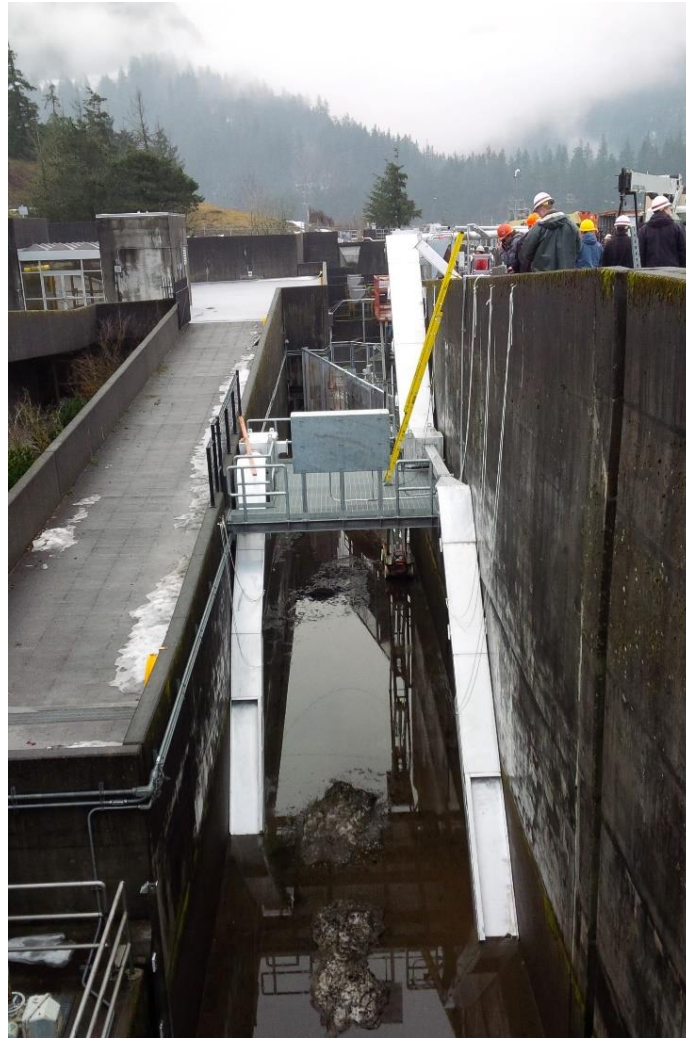
***On the cover:*** Two entrance ramps which feed into the Washington Shore Upstream Migrant Tunnel Junction Lamprey Passage Structure (WA-UMTJ LPS). This LPS was installed during the winter of 2016/17 and feeds into the existing Washington Shore Auxiliary Water Supply Lamprey Passage Structure (WA-AWS LPS). System names are determined by where the entrance ramps are located.

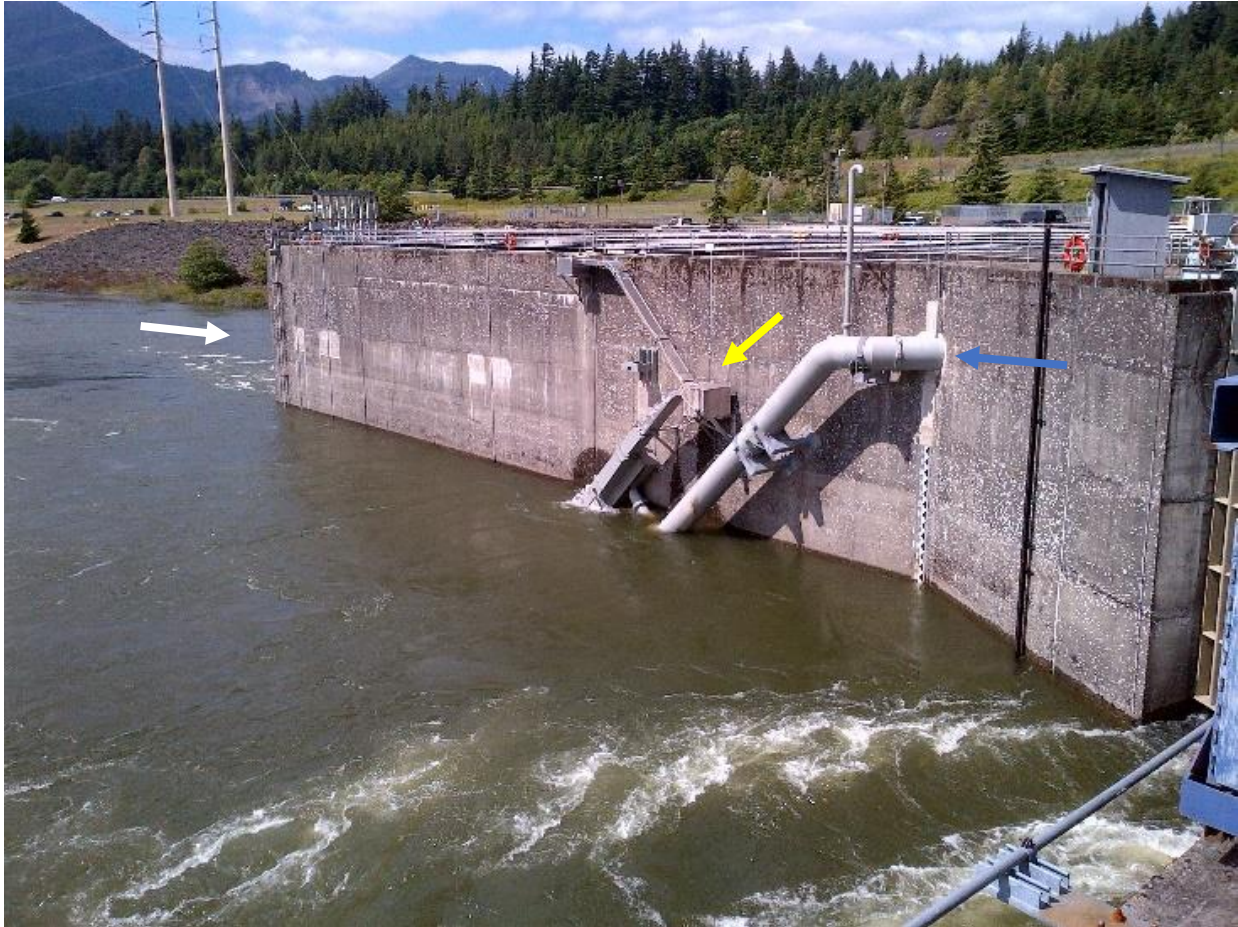
**Figure 2.** Lamprey Flume Structure (LFS) meets with rest box one (yellow arrow) and auxiliary attraction water grey pipe (blue arrow). Washington shore's north upstream fishway entrance at right and north downstream entrance (white arrow).

The Lamprey Flume System (Figure 2) was operated from 22 June to 24 August 2017 and inspected daily. Two well pumps mounted the NDE monolith provided water to the trap box and upper (LPS like) section of the flume while a large butterfly valve controls gravity feed attraction water that flowed through the lower LFS. This valve was varied from 15 to 60 percent open throughout the season to determine which setting would attract the most lampreys.

A missing access hatch was discovered in the fall of 2015 and the LFS was not operational again until 2017. Replacement took place the winter of 2016/2017 and internal changes were made to the water supply side of the flume to prevent water velocities that may have been too high for some lampreys to pass. When adding new material to these structures it can reduce passage until the material has time to season.

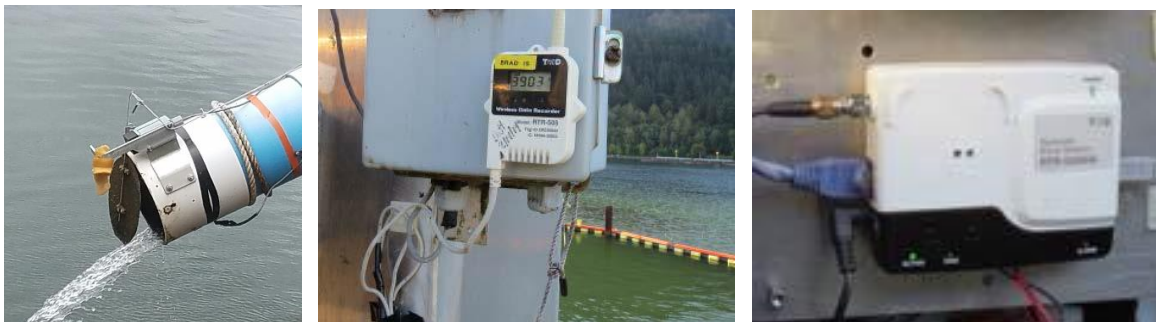
**Figure 3.** Mechanical counter components used to enumerate lamprey passage at Bradford Island AWS and Cascades Island Entrance including the limit switch attached to exit paddle and cushion, wireless data recorder, and network base station (from left to right at BI-AWS LPS).

The components of the counting system were similar at BI-AWS and CI-ENT with a variance in paddle placement. They consisted of an eight inch diameter PVC pipe, light weight perforated plastic paddle, attached to a limit switch (Honeywell Heavy Duty Limit Switch model numbers: LSA1A-4M or LSA1A). When a lamprey activated the switch, a pulse signal was sent to a data recorder, and a network base station (T&D Corporation RTR-500NW) was used to download the counts to a laptop (Figure 3).

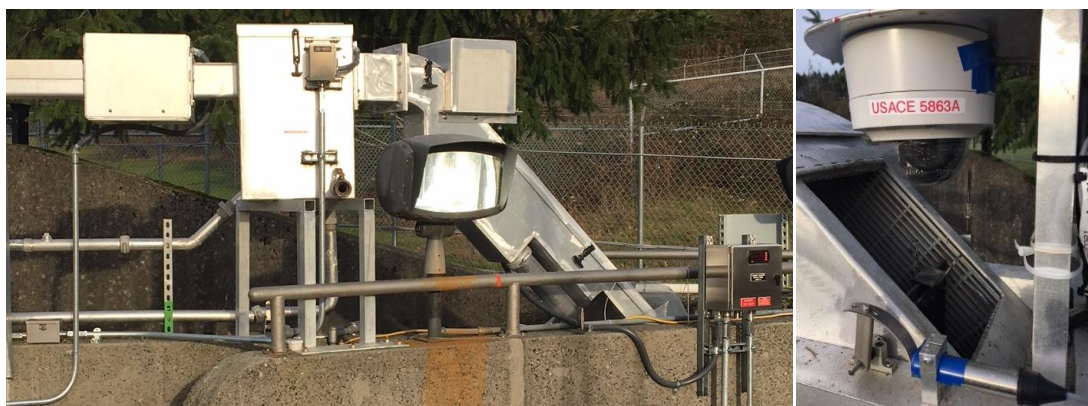
**Figure 5.** WA-AWS LPS exit showing (left to right) PIT antenna, upwelling box with black latch, camera box & paddle, and Dwyer counter display with red warning tags. Right panel shows camera box with lid removed, globe camera, and proximity detector with blue tape pointed at curved metal tab indicating position of paddle (open/closed).

At the WA-AWS, WA-UMTJ, and CI-ENT LPSs we used a Pelco DX4708HD (DVR) connected to a Pelco Sarix IMP319-1ERS globe camera mounted above the paddle counters (Figure 5 and Figure 6).

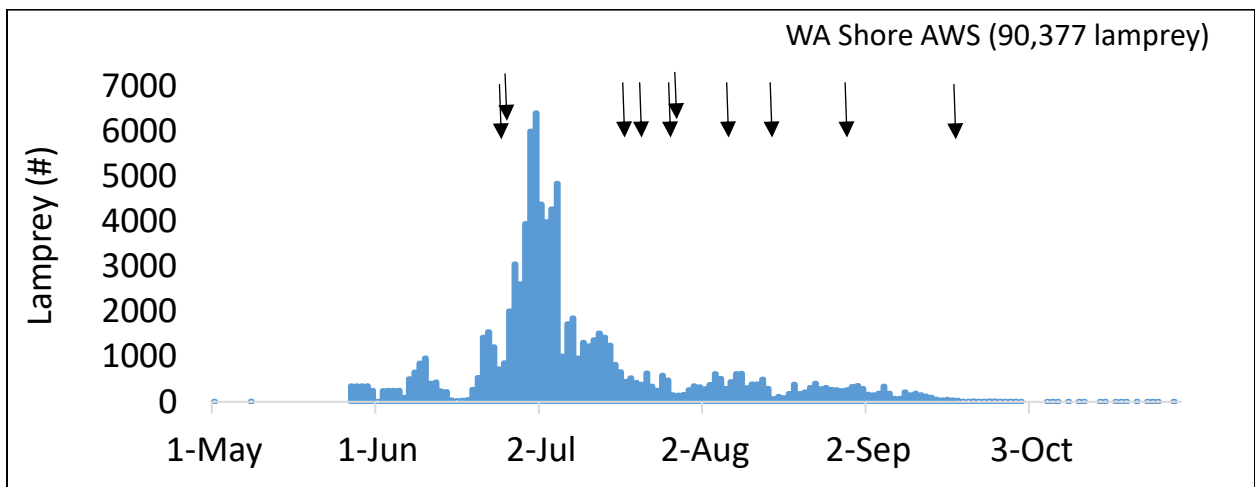
**Figure 7.** Daily lamprey passage estimate (corrected) at the Washington Shore UMT Junction LPS (top) which feeds into the Washington shore auxiliary water supply (WA AWS, bottom). The WA UMTJ lampreys do not add to the passage total. Arrows indicate when lamprey mortalities were found in the LPSs or on the grating nearby (e.g. jumped out). **Note changing y-axis.**

Daily lamprey passage fluctuated greatly at each of the LPSs with most fish passing in June and July (Figure 7 and Figure 8). The WA-AWS, CI-ENT, and BI-AWS LPSs accounted for 74.0%, 2.4% and 23.6% of total passage, respectively. The LFS passed 51 fish, or less than 1% of total passage. At most LPSs the highest daily passage occurred during the end of June and early July with a pulse of fish in late August (Figure 7 and Figure 8).

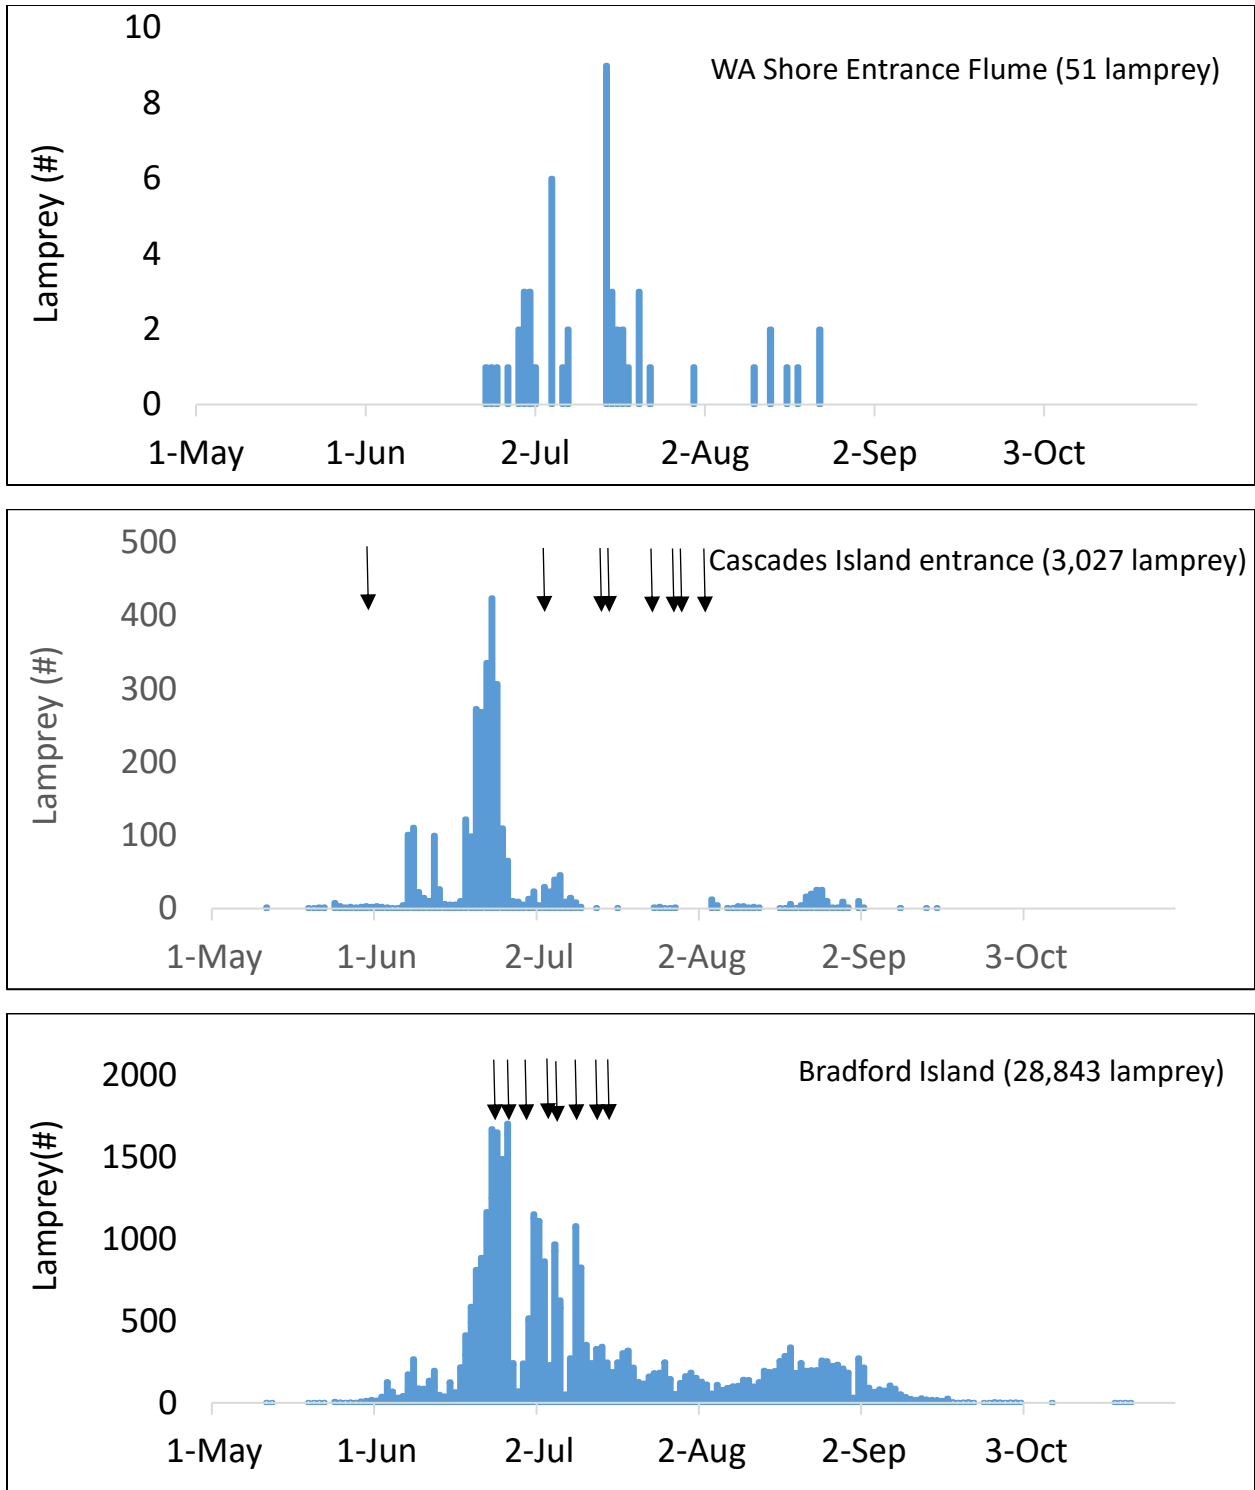
**Figure 8.** Daily lamprey passage at the Lamprey Flume System (LFS counts), Cascades Island entrance (CI ENT LPS estimate), and Bradford Island auxiliary water supply (BI AWS LPS estimate). Arrows indicate when lamprey mortalities were found in the LPSs or on the grating nearby (e.g. jumped out). The LFS operated from 22 June to 24 August, 2017, no mortalities were found. **Note changing y-axis.**

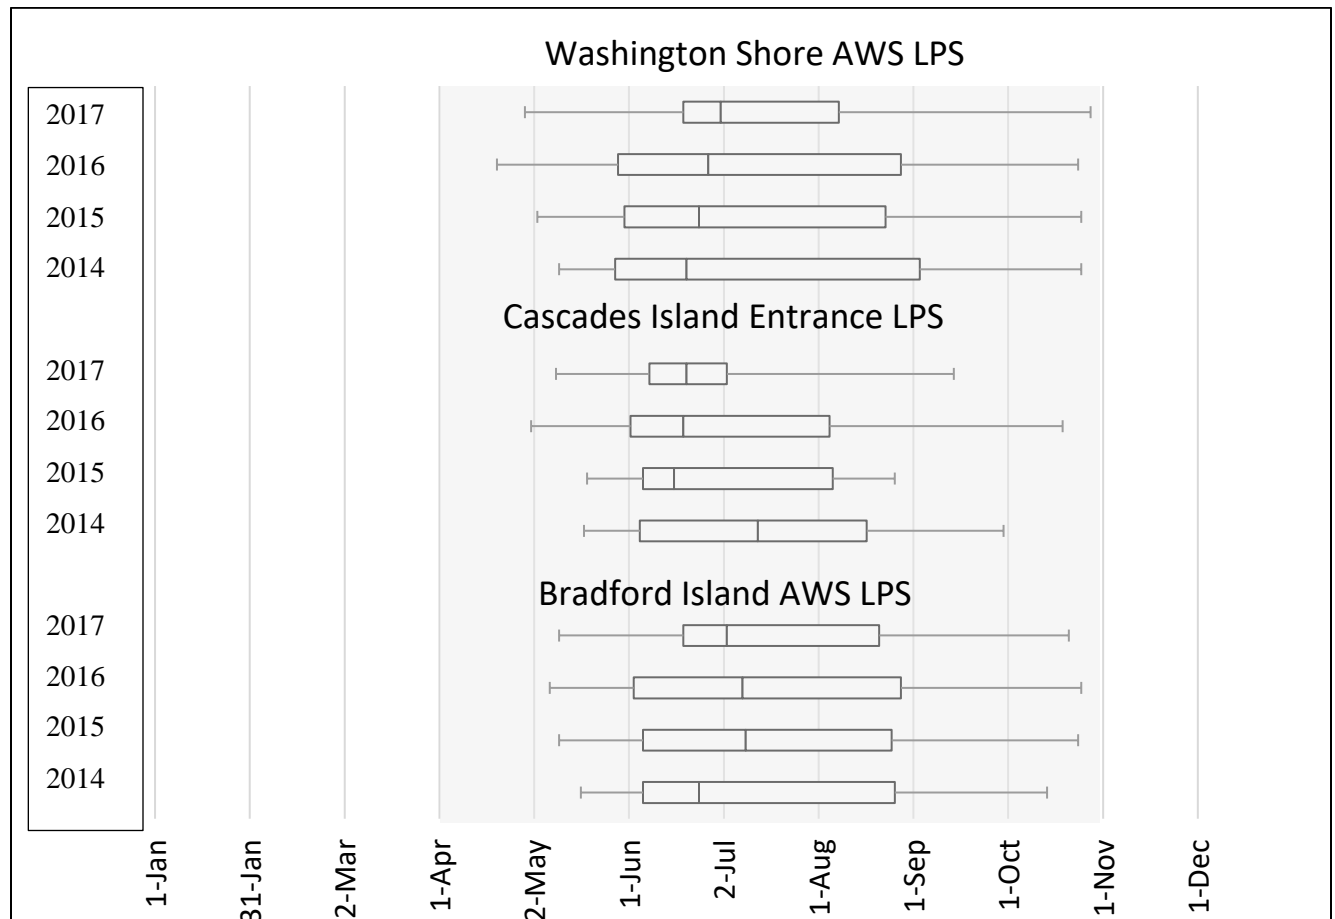
**Figure 9.** Run timing of Pacific Lampreys passing Bonneville Dam Lamprey Passage Structures during 2014-17. Whiskers are dates of first and last fish passage, boxes show 10%, 50% and 90% run completion dates. Grey box indicates typical dates of LPS operation (1 April to 31 October).

Lamprey run timing through the LPSs was similar to previous years with the exception of the 50<sup>th</sup> percentile at the CI-ENT LPS which was about four weeks later than previous years (Figure 9). The first lamprey of the season passed through the WA-AWS on 1 May and the last lamprey passed 30 October, one day prior to the LPSs being dewatered and shut down for the season. Diurnal passage through the LPSs is very similar for WA-UMTJ, WA-AWS, and BI-AWS with passage increasing at dusk and throughout the night and decreasing at dawn (Figure 10). However, passage at CI-ENT showed a more gradually decreased after dawn.

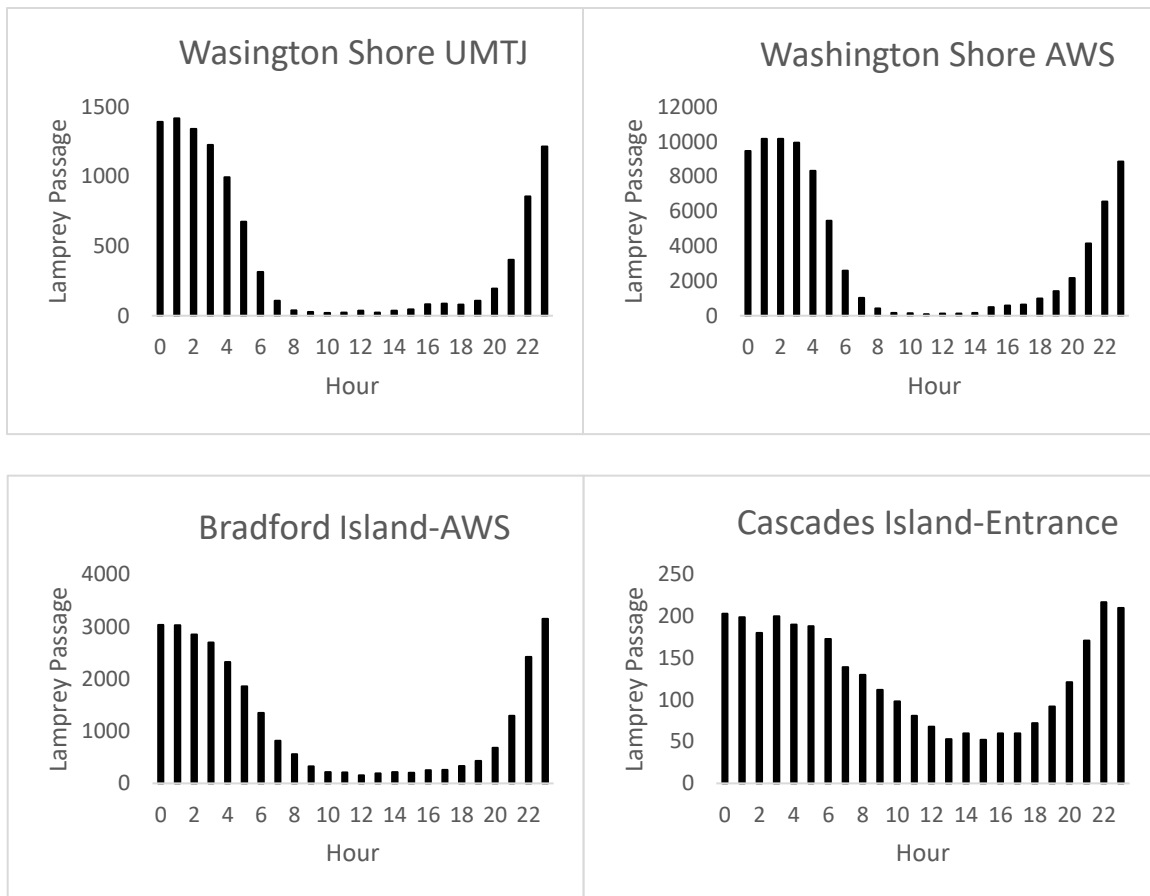
**Figure 10.** Diurnal distribution of lamprey passage by hour through LPSs at Bonneville Dam 2017. The LFS does not have a mechanical counter or time stamp so is not presented here. Note changing y-axis.

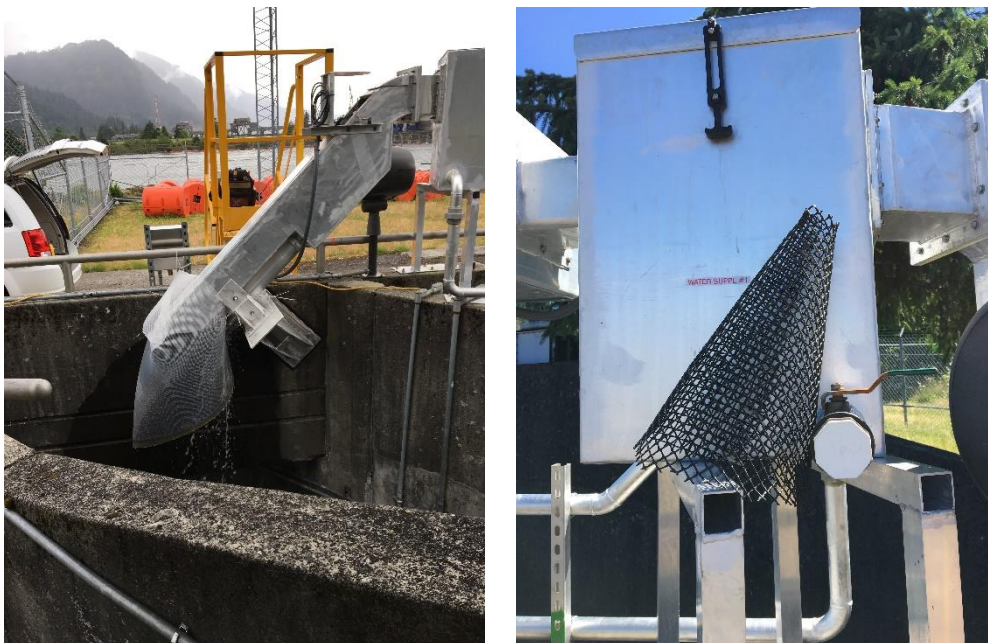
**Figure 11.** A cone of fish screen material was used to prevent lampreys from grazing the bridge wall or the opposing fishway wall (left image). Fyke that clogged with lampreys was removed from AWS upwelling box to allow fish to exit on 6/21/17 (right image).

Prior to the installation of the globe type cameras, external Arm Bullet Color Camera and GANZ DVR were used to record video of the exit pipe at the WA-AWS LPS. While reviewing this video it was determined that some lampreys were grazing the bridge wall as they fell from the LPS. To prevent injury a piece of old submersible traveling screen was fashioned into a cone directing lampreys to the center of the fishway (Figure 11). Additional video confirmed this modification was successful at protecting lampreys from grazing the bridge and fishway wall.

On the morning of June 21, 2017 project biologist informed the FFU that several lampreys had spilled out of the final traversing section of the WA-AWS LPS. It was determined that the final fyke had become clogged with lampreys and as more moved into the traversing section behind them water piled up, pushing up the lids on the traversing section and allowing lampreys to spill onto the concrete deck. The fish were rescued and when the fyke was removed they began to rapidly pass. This is the first instance where the capacity of an LPS to pass lampreys has been exceeded.

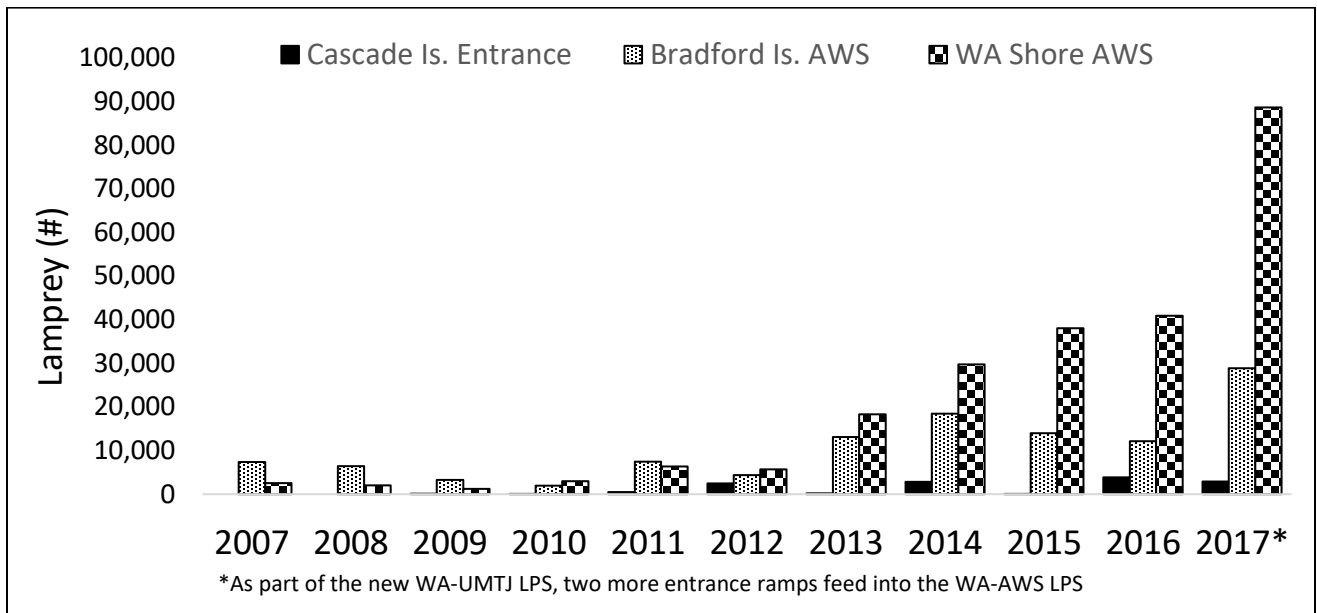
**Figure 13.** Annual lamprey passage estimates shown for CI-ENT, BI-AWS, WA-AWS lamprey passage structures from 2007-2017. CI-ENT was operational in 2009.

entrance ramps were installed during winter 2016-17 below the count slot. These are the WA-UMTJ entrances which feed into the WA-AWS potentially allowing it to pass more fish. Lamprey passage has generally increased at this location since 2010, combined with window counts, 2017 recorded the highest passage since installation of LPSs (Figure 13). In its first year of use the two new entrances of the WA-UMTJ LPS collected 10,705 lampreys that then swam past the counter and into rest box three of the WA-AWS LPS. Lamprey passage at BI-AWS more than doubled from 12,115 in 2016 to 28,843 in 2017(138%). Surprisingly passage decreased at CI-ENT by 24% from 3,851 in 2016 to 3,027 in 2017. However, 2017 is the second highest at CI-ENT and the highest lamprey passage recorded since installation of BI-AWS (Figure 13).
