Use of Adult Pacific Lamprey Passage Structures at Bonneville and John Day Dams  
*2018 Annual Report*

**Nathan A. Zorich, Karrie M. Gibbons, and Kristen N. Bayley**

U.S. Army Corps of Engineers  
Portland District, Fisheries Field Unit  
Cascade Locks, OR 97014  
June 27, 2019

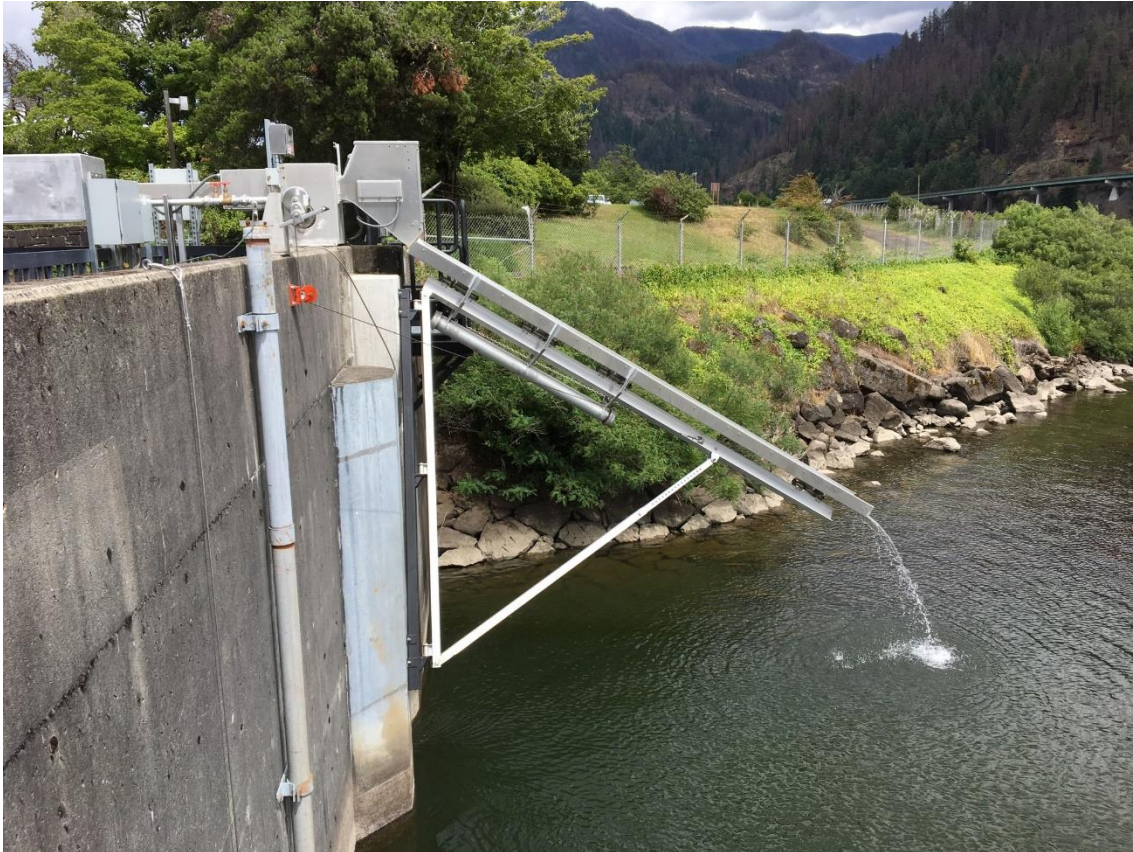
***On the cover:*** The Bradford Island LPS adjustable exit slide and new camera box which contains an in-line paddle counter. The exit slide is twice as long as the previous PVC pipe and is lined with 1/8" grooved ultra-high molecular weight (UHMW) density plastic in an attempt to prevent lamprey attachment.

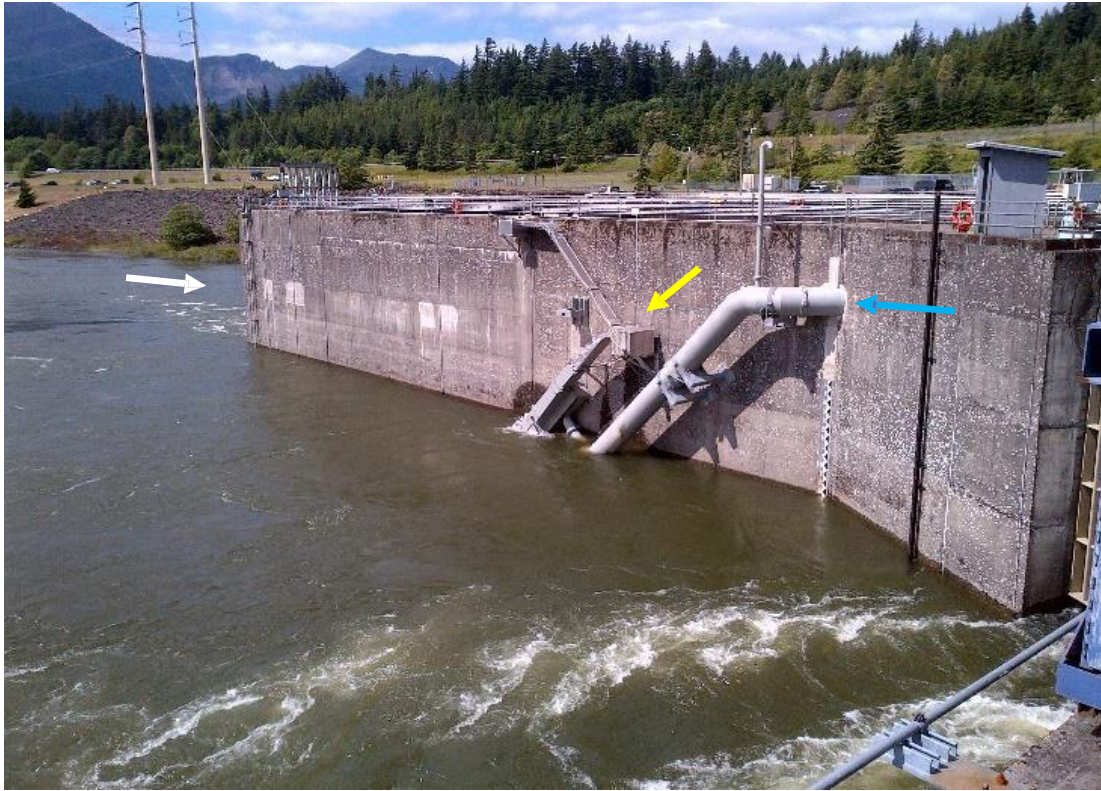
**Figure 2.** Lamprey Flume Structure (LFS) meets with rest box one (yellow arrow) and attraction water grey pipe (blue arrow) feeds in from below. Washington shore's north upstream fishway entrance at right and north downstream entrance (white arrow).

In 2018, the Lamprey Flume System (Figure 2) was operated by the University of Idaho, from April to August, and was inspected daily as a potential collection point for research. The attraction water butterfly valve was held constant at 60 percent open and the upper entrance knife gate was held at 36" open, as measured from the top of the screw to the top of the black gear casing. Results of this trapping effort were provided by the University of Idaho and summarized here to be consistent with previous reports.

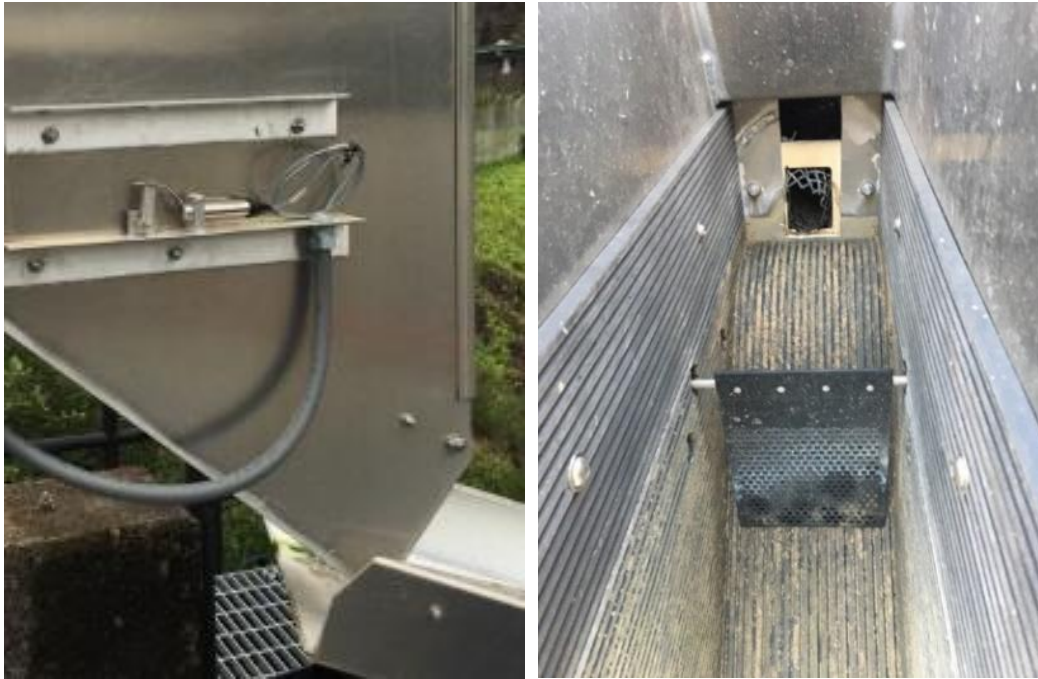
**Figure 3.** Bradford Island LPS mechanical counter components new for 2018. Left, proximity detector and ferrous tab (cover removed). Middle, inside of camera box showing black paddle, 1/8" grooved PVC, upwelling box fyking, and smooth face near the fyking where some lamprey attached. Not shown Dwyer counter display and DATAQ DI-161 data logger installed in the count station.

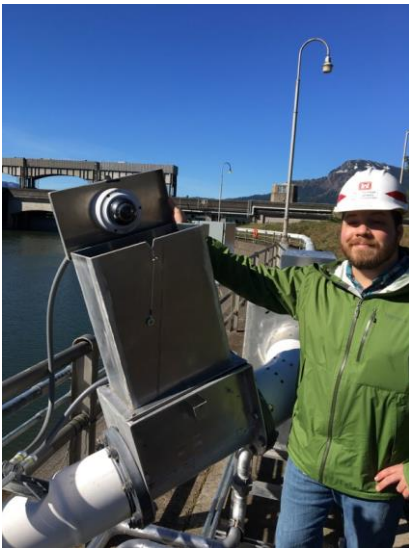
**Figure 5.** CI-ENT LPS exit camera box (left) and in-line paddle and limit switch (right).

Figure 5 shows a close up view of the CI-ENT LPS mechanical counting system. It is included here due to the small correction factor typically associated with this simple system. It has fewer moving parts than the newer design, the paddle has not needed adjustment, and the limit switch is more easily available compared to a proximity detector.

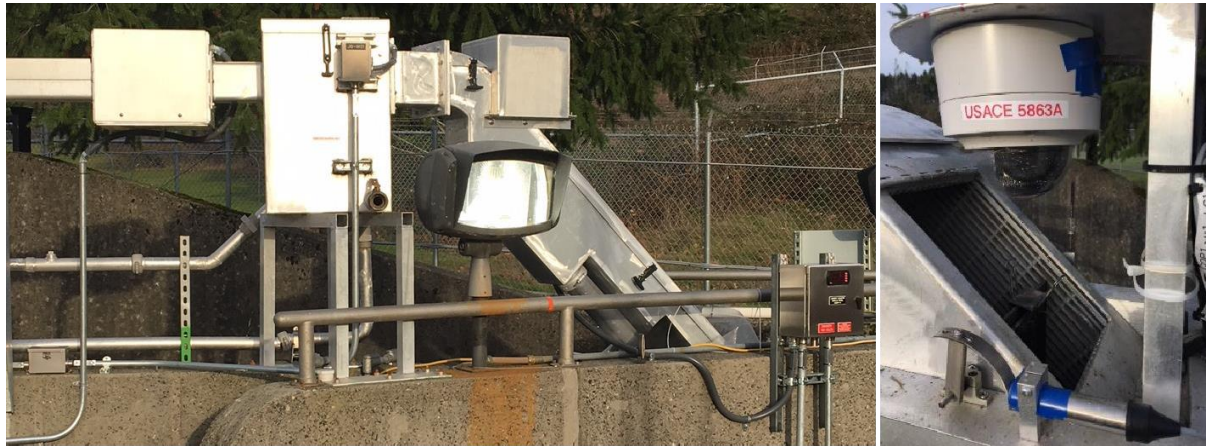
**Figure 6.** WA-AWS LPS exit showing (left to right) PIT antenna, upwelling box with black latch, camera box (covering the paddle), and Dwyer counter display with red warning tags. Right panel shows camera box with lid removed, globe camera, and proximity detector with blue tape pointed at curved ferrous tab indicating position of paddle (open/closed).

To collect video at the LPSs we used an IP camera with infrared lights (Pelco Sarix IMP319-1ERS globe) mounted above the paddle counters (Figure 6 and Figure 7) attached to a DVR or NVR (Pelco DX4708HD (DVR) or a HIK Vision DS-7204HQI-K1 Network Video Recorder at BI-AWS and CI-ENT LPSs and a Pelco Digital Sentry DS SRV2 Series DVR at WA-AWS and WA-UMTJ).

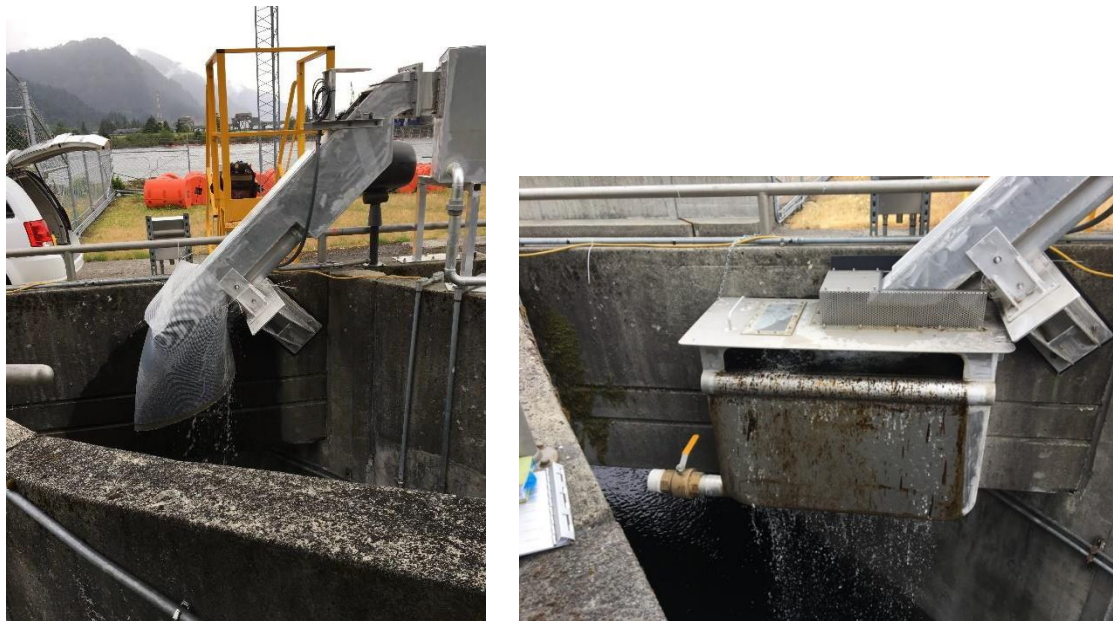
**Figure 8.** At the WA-AWS exit a cone of fish screen material was used to prevent lamprey from grazing the bridge wall or the opposing fishway wall (left image 2017). In 2018 this was replaced with a plunge box with a rolled lip that reduced the energy of the falling lamprey and allowed them to volitionally exit (right image).

The Washington shore exit plunge box was monitored for safe passage. While reviewing video in 2017, it was determined that some lamprey were contacting the bridge wall as they fell from the LPS exit. As an in-season fix, a piece of submersible traveling screen was fashioned into a cone directing lamprey to the center of the fishway (**Figure 8** left). That cone was replaced with a plunge box, installed in the winter of 2017-18 (**Figure 8** right). Using an Arm Bullet Color Camera mounted to a hand rail and GANZ DVR, we recorded and confirmed this modification was successful at protecting lamprey from grazing the bridge or fishway wall. We also monitored it for delay to be sure fish were not holding there.

We collected one night of video to determine if lamprey would pass safely using the Washington shore plunge box without delaying passage. The plunge box replaced a 2017 in-season fix (a collar built of fish screen material) to help fish drop into the center of the fishway. Video of fish behavior showed that most lamprey quickly passed out of the plunge box with a mean residence time of five minutes. However, later in the year during a nighttime tour on 11 June, several lamprey were seen attaching to the outside of the plunge box, and two were able to actually climb back into the box. The qualitative observations of back climbing took place over about 15 minutes indicating the behavior may be frequent.

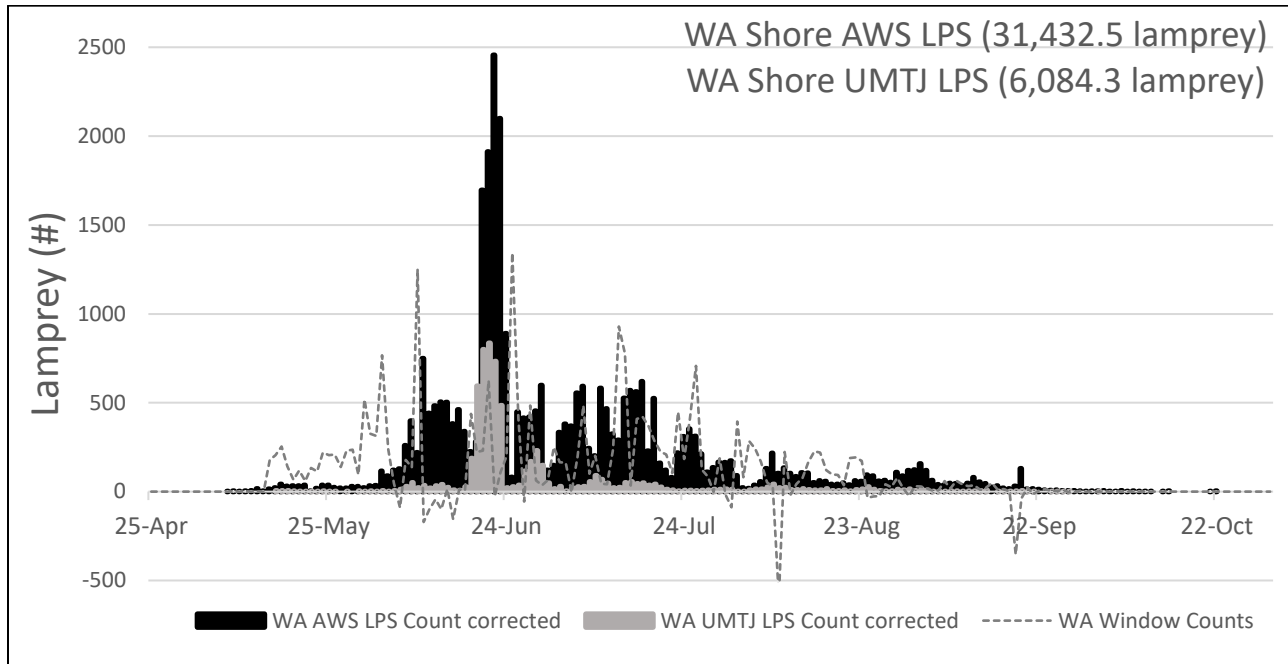
**Figure 9.** Washington Shore UMT Junction LPS (grey bars) which feeds into the Washington shore auxiliary water supply (WA-AWS, black bars) daily lamprey passage estimate (corrected). The WA-UMTJ lamprey do not add to the passage total. The dashed line represents cumulative 24 hour window counts at the Washington shore fish count window nearby.

Corrected daily lamprey passage fluctuated greatly at each of the LPSs with most fish passing in June and July (**Figure 9, Figure 10, and Figure 11**). The WA-AWS, CI-ENT, and BI-AWS LPSs accounted for 52.0%, 1.5%, and 46.5% of total passage, respectively. At most LPSs, the highest daily passage occurred during the end of June and early July and often exceeded the 24 hour count of the associated fish count window.

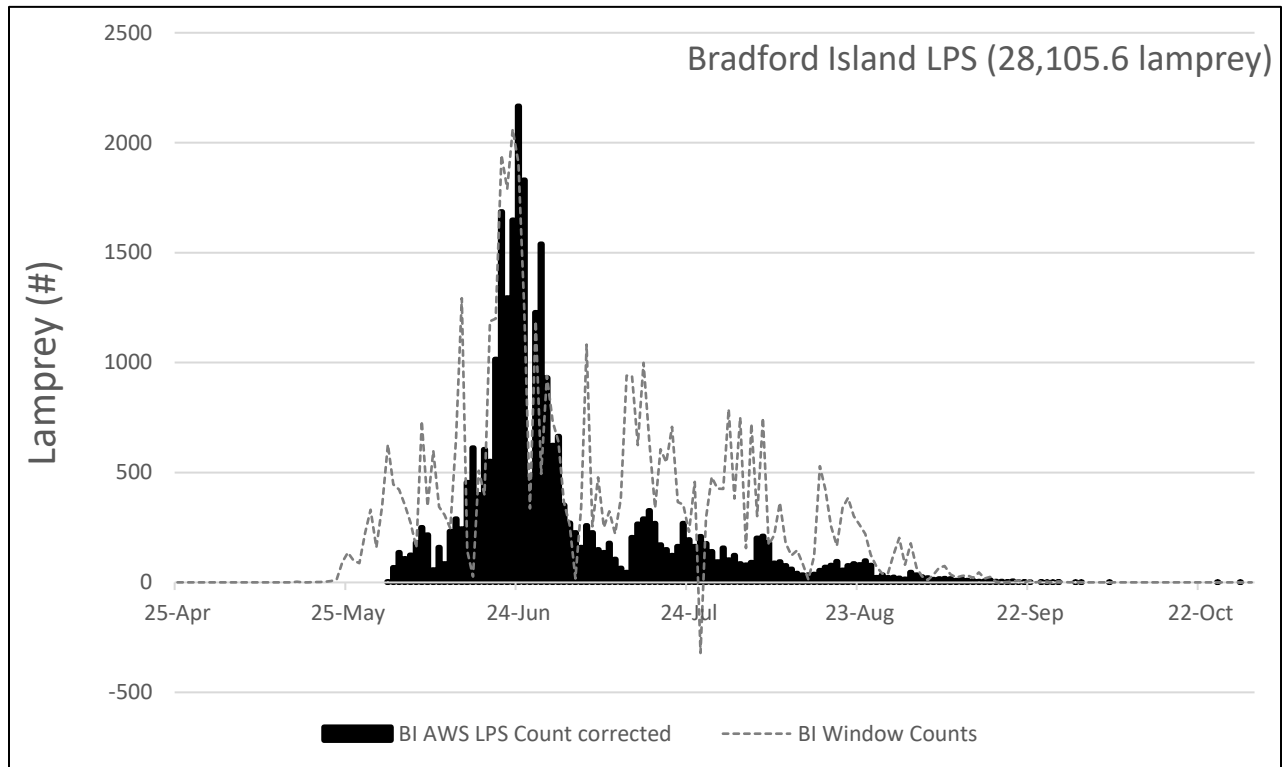
**Figure 11.** Bradford Island auxiliary water supply (BI-AWS LPS) daily lamprey passage estimates (corrected). The dashed grey line represents cumulative 24 hour window counts from the Bradford Island window.

Bradford Island AWS LPS passage started about one week after Pacific Lamprey were seen in the nearby counting window. In late June, passage was similar in magnitude to the window counts, however LPS passage then decreased.

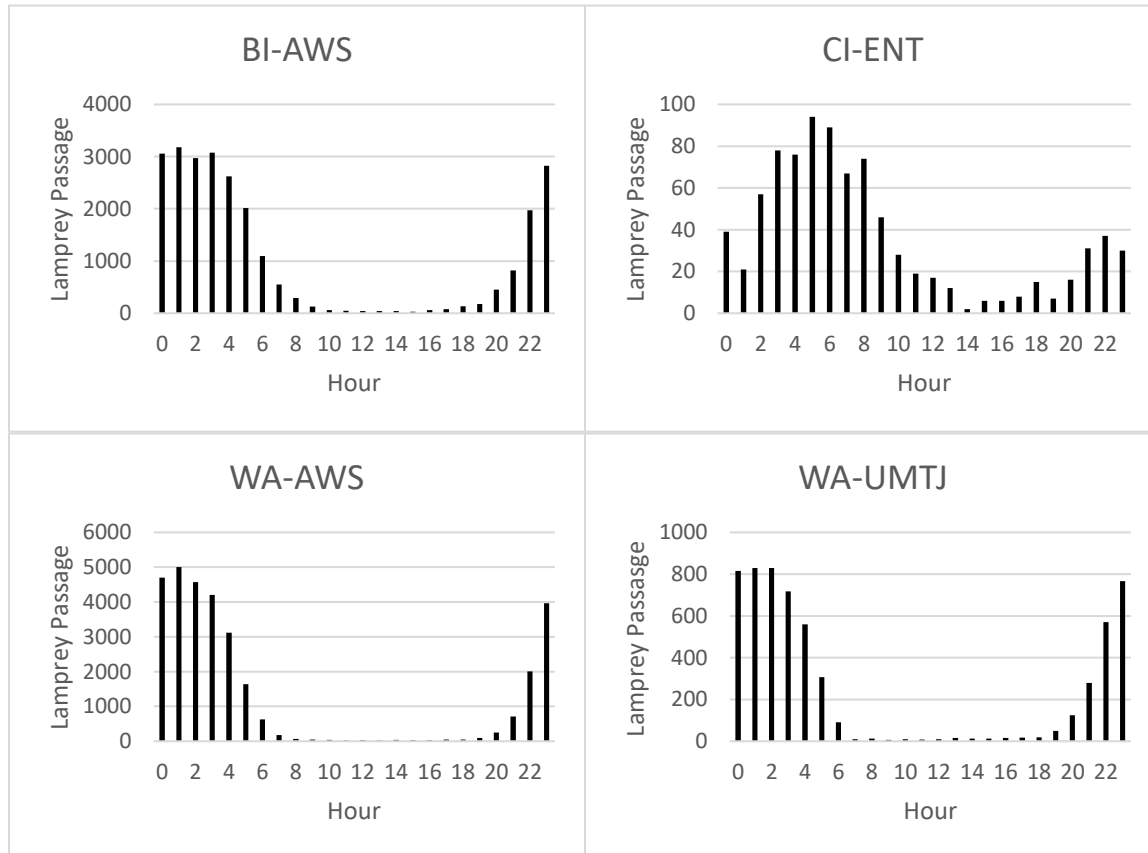
**Figure 13.** Diurnal distribution of lamprey passage by hour through LPSs at Bonneville Dam 2018. The LFS and JDA N-ENT traps do not have a mechanical counter, or time stamp, so are not presented here. Note changing y-axis.

Diurnal passage through the LPSs is very similar for WA-UMTJ, WA-AWS, and BI-AWS with most passage occurring in the dark of night and decreasing at dawn (**Figure 13**). However, as in previous years, passage at CI-ENT was more protracted, showing a more gradual increase at sunset and gradual decrease after dawn.

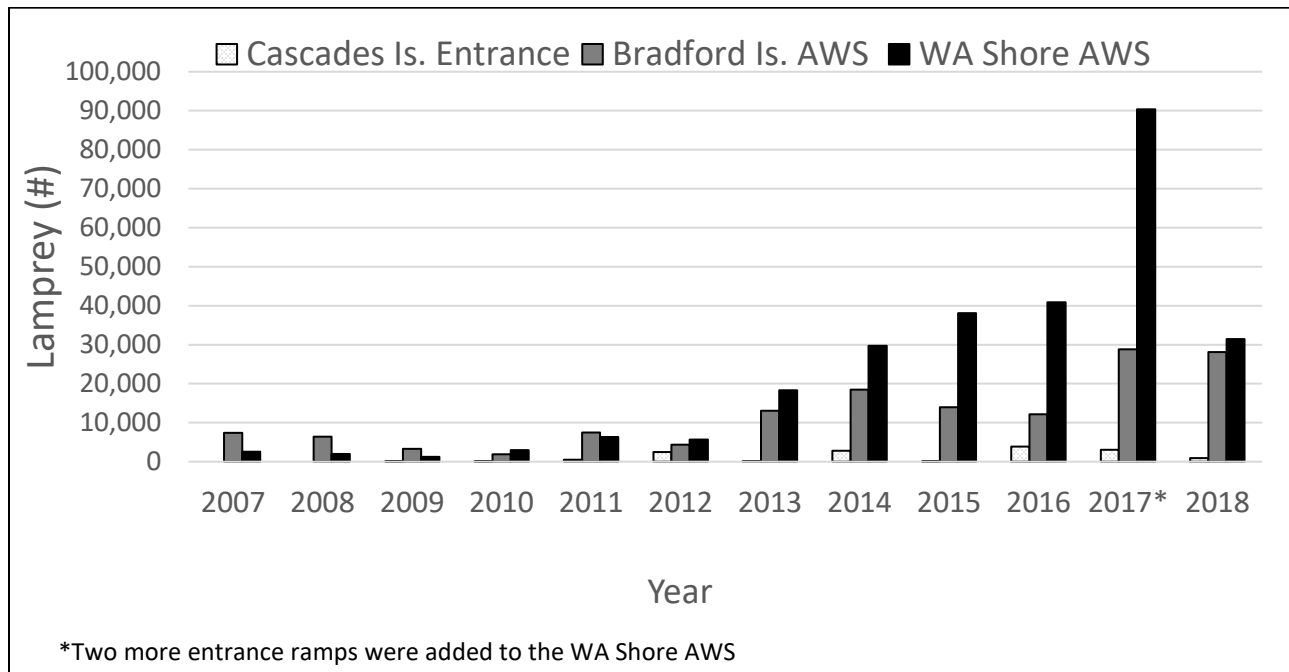
**Figure 15.** Annual lamprey passage estimates for Washington shore AWS (black), Bradford Island AWS (grey), and Cascades Island entrance (white) LPSs during 2007-2018.

Use of Bonneville LPSs has generally increased at both BI-AWS and WA-AWS since 2010, however WA-AWS showed a decrease this year (**Figure 15**). The proportional use of LPS routes was more evenly distributed between BI-AWS and WA-AWS this year, similar to 2013 and 2014. Total LPS passage was 60,420 with WA-AWS LPS accounting for 31,432 lamprey (52%) and BI-AWS passing 28,105 lamprey (46.5%), while CI-ENT passed 882 lamprey (1.5%) in 2018. The WA-UMTJ LPS collected 6,084 lamprey, or 19% used this entrance in its second season. Lamprey passage at BI-AWS decreased slightly between 2017 and 2018 from 28,843 to 28,105 (-2.6%), respectively. Passage also decreased at CI-ENT by 29% from 3,027 in 2017 to 882 in 2018.

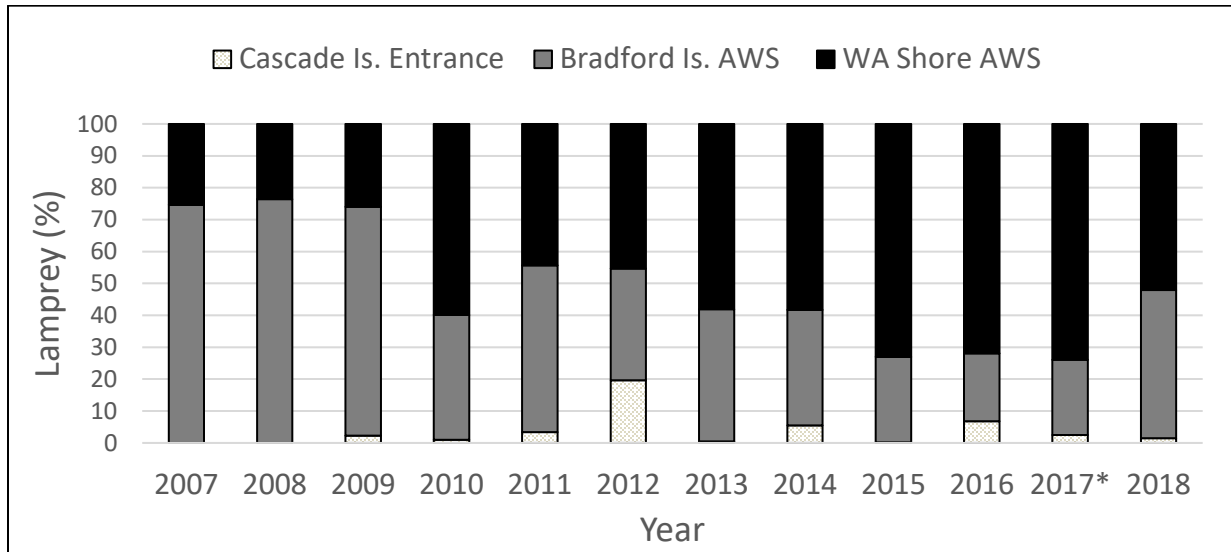
**Figure 16.** Proportional routes for LPS passed fish 2007-18. CI-ENT was first installed in 2009 as was the lamprey friendly keyhole entrance slot (variable width weir) and bollards that were part of the same entrance modification. \*Two new entrance ramps to the WA-UMTJ LPS installed in winter of 2016/17.

As various modifications to improve LPS passage have taken place, year to year changes in lamprey abundance confounds performance evaluations. To control for run size we looked at proportional routes of passage, percent of lamprey using each LPS, to see if they are changing over time or if they are affected by improvements such as additional entrance ramps. As Figure 16 shows, since 2013 there has been an increasing proportion of lamprey choosing the WA-AWS LPS. However, in 2018 lamprey chose the WA-AWS and BI-AWS LPSs nearly equally. The proportion using the CI-ENT LPS is small with some variation between years.

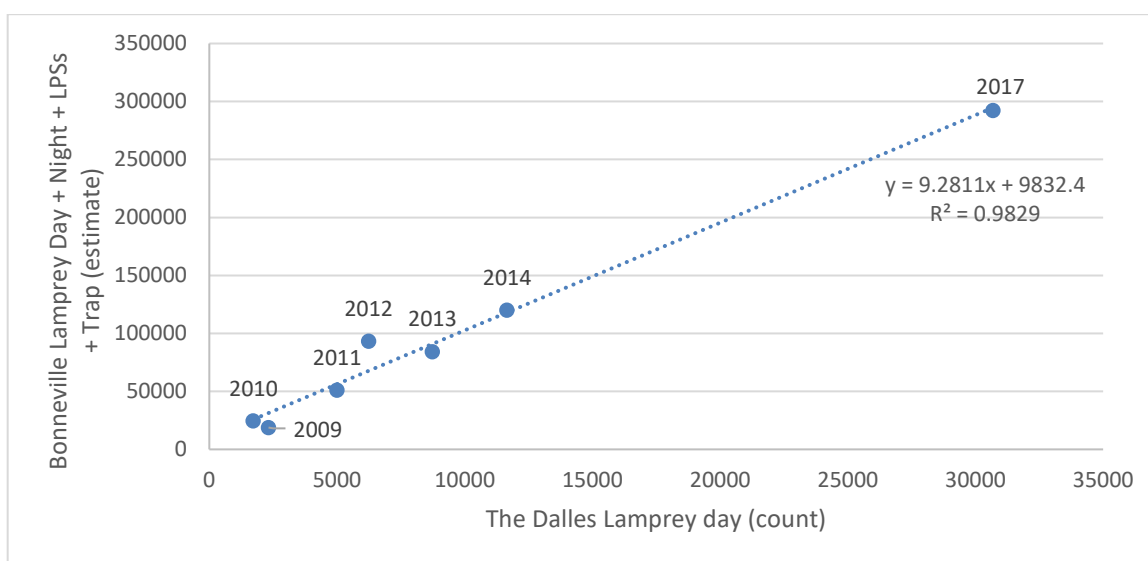
**Figure 17.** Regression model and passage data with fitted line. The x-axis is The Dalles daytime window index. The y-axis includes the Bonneville daytime window index + night time video counts + LPS counts + fish trapped and released above the dam for research or tribal translocations.

The line fitted to these data had an  $r^2 = 0.98$  with a p-value = 0.0004. To estimate 2018, total lamprey passage we used these formula;
