Adult Pacific Lamprey Passage Structures: Use and Development at Bonneville Dam and John Day Dam South Fishway, 2014

Report of research by

Northwest Fisheries Science Center, National Marine Fisheries Service
National Oceanic and Atmospheric Administration
2725 Montlake Boulevard East, Seattle, WA 98112

Portland District, U.S. Army Corps of Engineers
P.O. Box 2946, Portland OR 97020
Contract E96950021

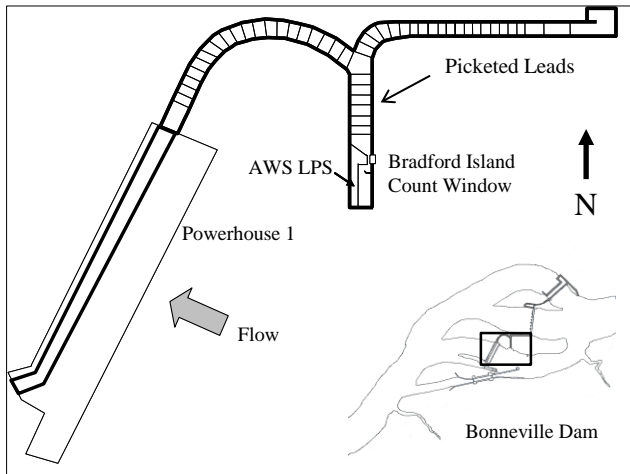
Figure 2. Schematic drawing of the Bradford Island fishway system at Bonneville Dam with locations of the auxiliary water supply LPS (AWS LPS) and count window.

The first LPS was installed in 2004 at the AWS channel near the top of the Bradford Island fishway (Figure 2). Lamprey entered the structure via one of two collector ramps and then passed through a series of wetted aluminum ramps, rest boxes, and horizontal flumes that led upward and to an exit slide at elevation 7.9 m. The overall

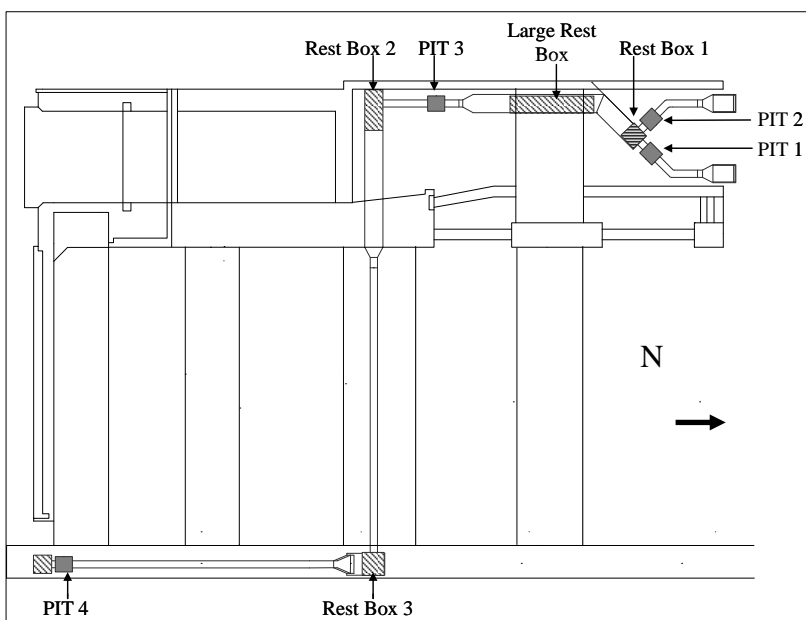
Figure 3. Top view of the Bradford Island LPS with locations of half-duplex PIT-tag detection antennas (PIT 1-4) and rest boxes indicated.

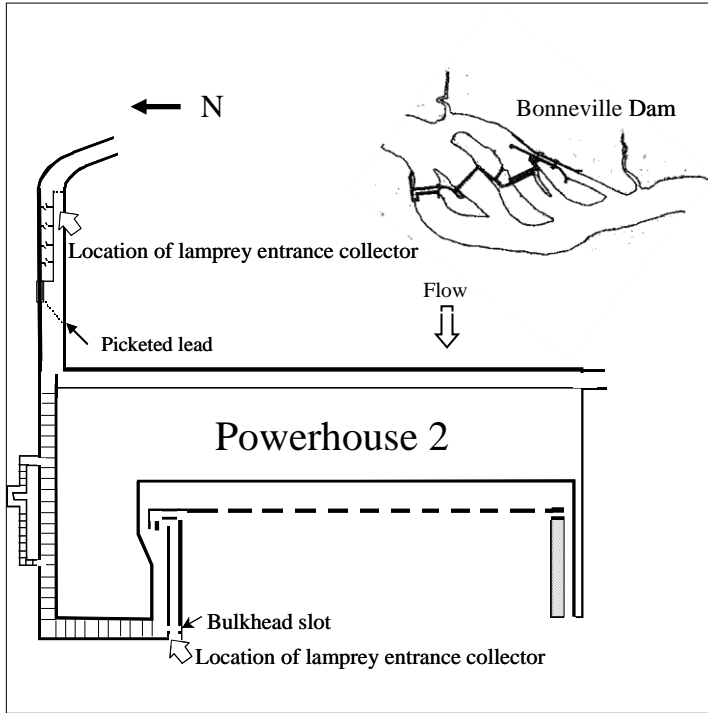
Figure 4. Plan view of Bonneville Powerhouse 2 showing location of lamprey structures at the Washington Shore fishway.

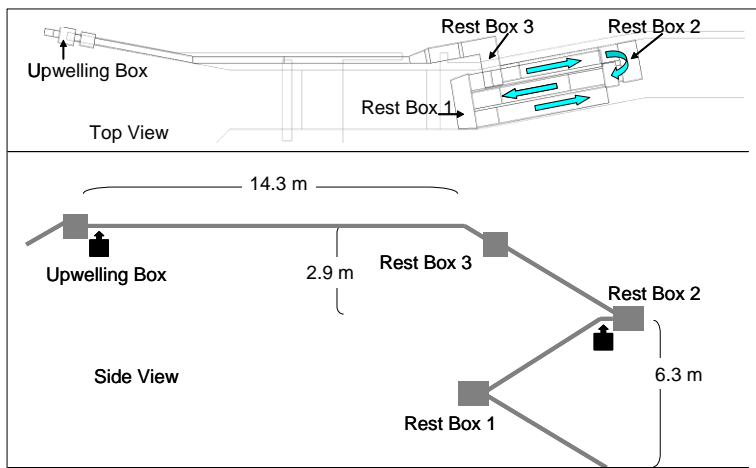
Figure 5. Upper panel shows plan view of the Washington Shore AWS LPS. Shaded arrows indicate the direction of water flow on the switchback ramps. Lower panel show side view of the same structure. Black boxes indicate the position of half-duplex PIT antennas.

The overall length of the Washington Shore AWS LPS was approximately 19 m, with an elevation gain of 9.1 m (Figure 5).

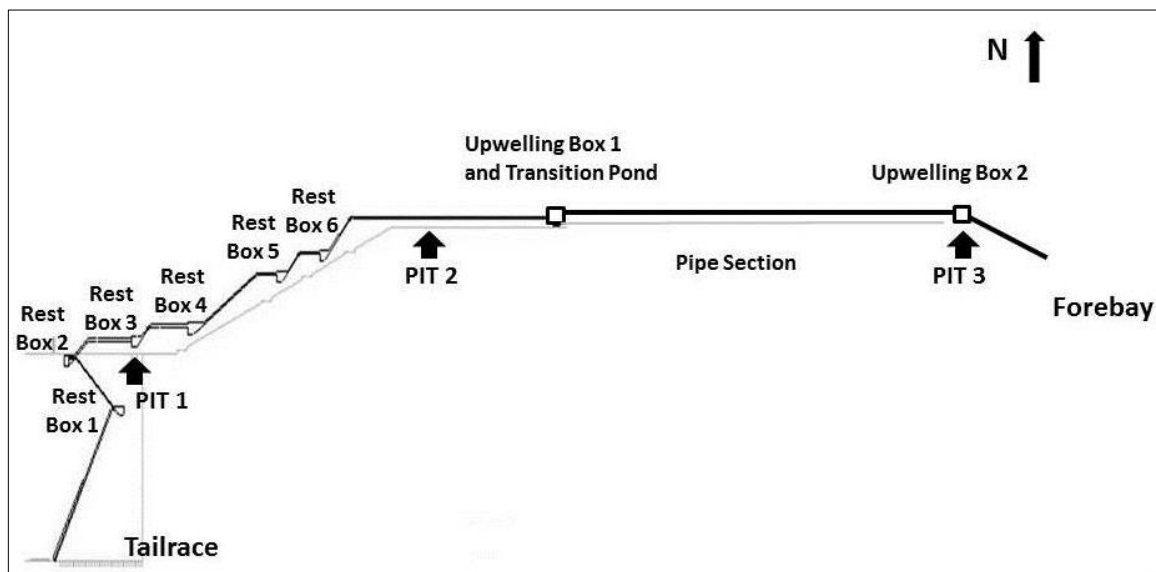
Figure 6. The Cascades Island entrance LPS collector in 2014 (side view), showing locations of rest boxes, the upwelling box and transition pond, and PIT monitoring antennas.

A third LPS was installed in 2009 at the Cascades Island fishway entrance (Figure 6). This ambitious structure allowed lamprey to ascend from the tailrace level to an elevation of 27 m (the full height of the dam). It incorporated many of the design features from the AWS structures, but was much longer (92.4 m; Figure 6).

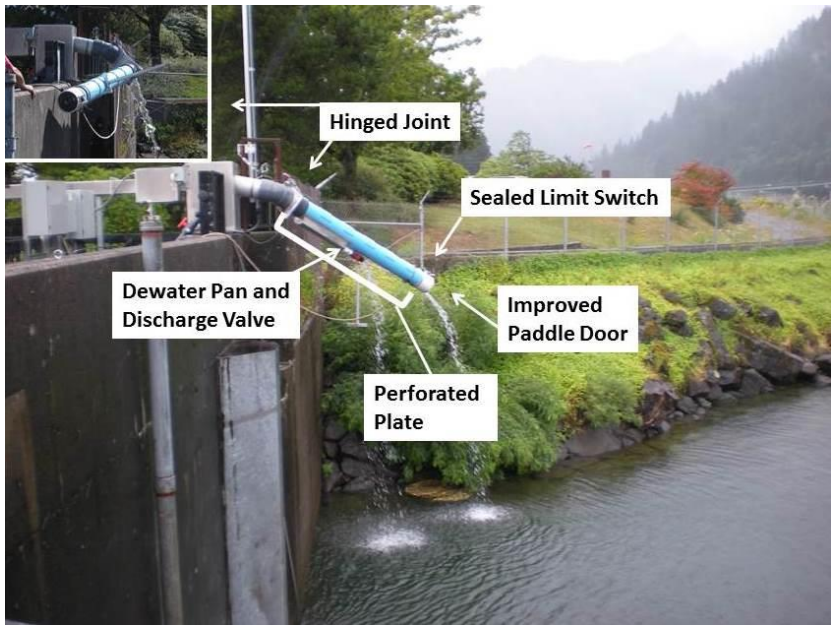
Figure 7. Photograph of redesigned exit slide at Bradford Island AWS LPS with features labeled.

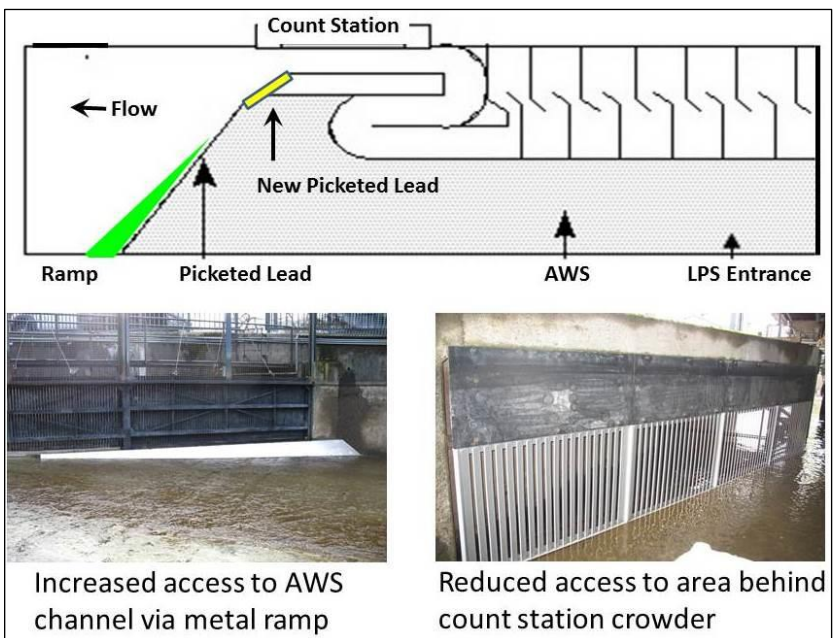
Figure 8. Upper panel diagram shows location of newly installed ramp and picketed lead at Bradford Island fishway. Lower panel photos (L-R) show ramp and picketed lead.

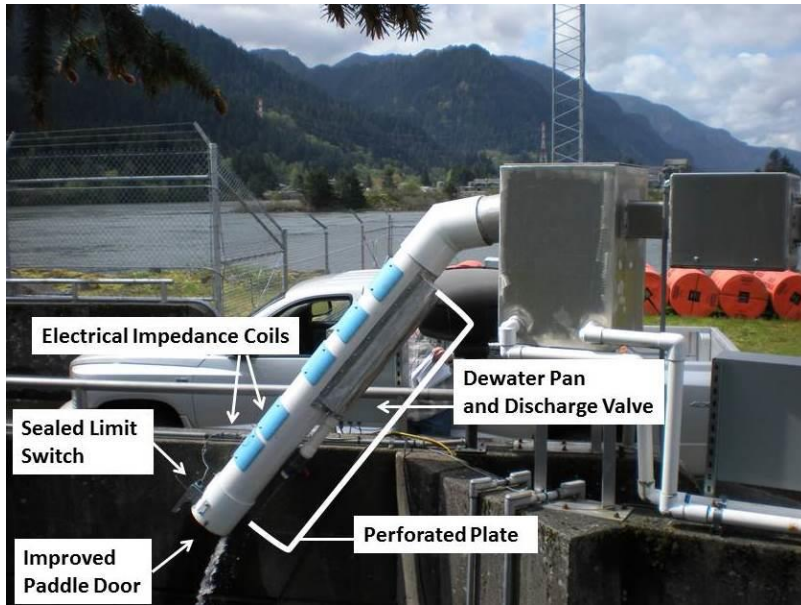
Figure 9. Photograph of redesigned exit slide at Washington Shore AWS LPS with features labeled.

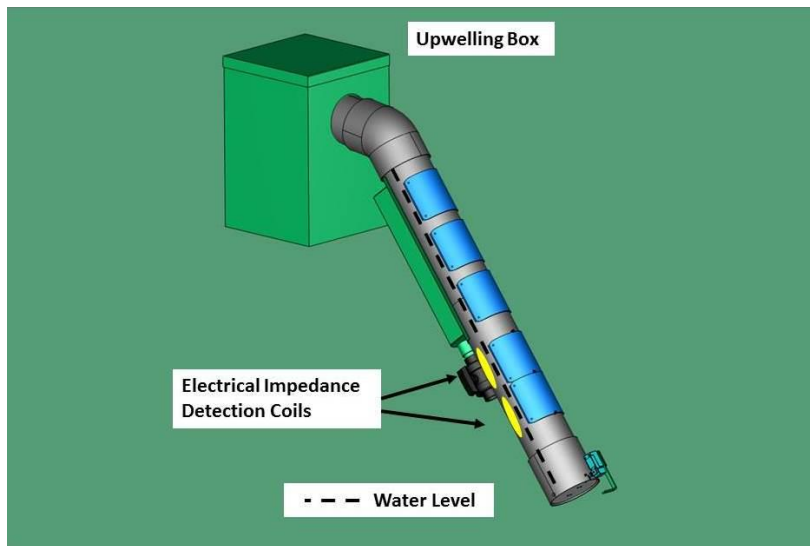
Figure 10. Diagram of exit slide at Washington Shore AWS LPS showing the upwelling box where lamprey were introduced, electrical impedance detection coils, and water level in the exit slide.

Of the experimental lamprey introduced to the upwelling box leading to the Washington Shore AWS LPS exit slide, 70% were not recorded passing by the impedance counter as they exited. We observed that non-detected lamprey failed to contact the electrodes due to swimming behavior and the steep slope of the exit slide.

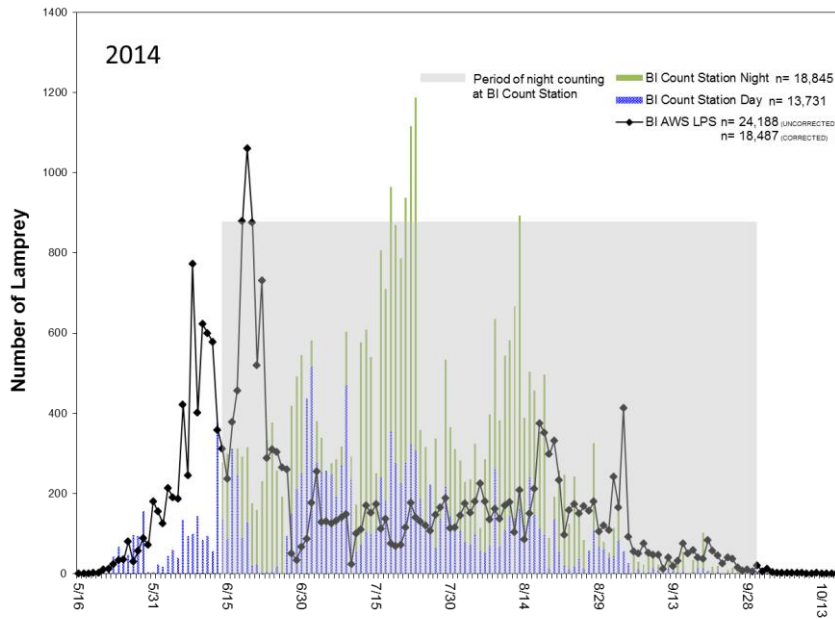
Figure 11. Number of lamprey counted at the Bradford Island count station during the day (blue) and night (green) and at the AWS LPS exit slide (closed diamonds) during the periods of LPS operation in 2014. Total values reported for the count station and LPS.

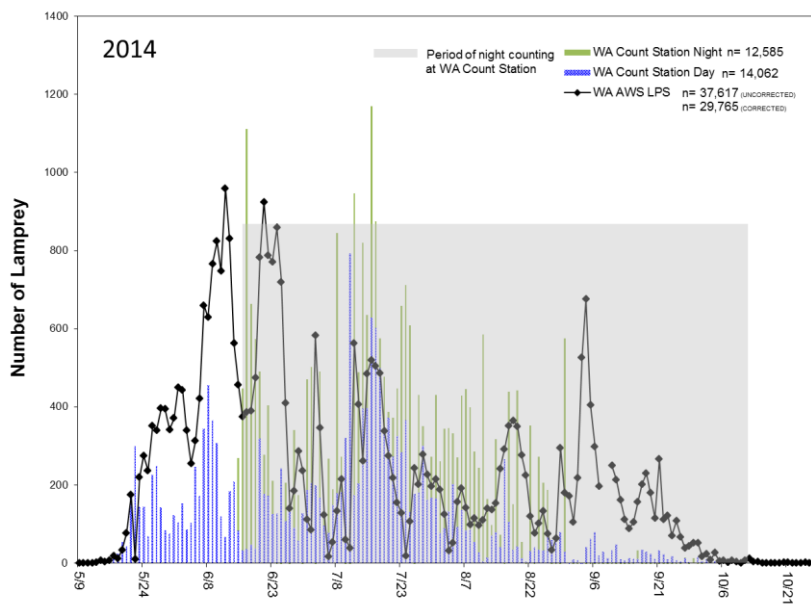
Figure 12. Number of lamprey counted at the Washington Shore count station during the day (blue) and night (green) and at the AWS LPS exit (closed diamonds) during periods of LPS operation in 2014. Total values reported for the count station and LPS.

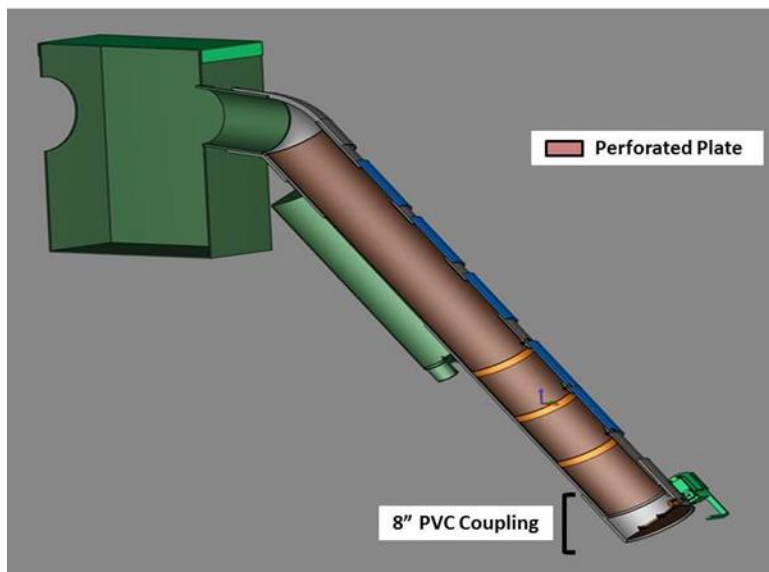
Figure 13. Cross section drawing of Bradford Island AWS LPS and Washington Shore AWS exit slides showing area that is lined with perforated plate and location of PVC coupling.

Unfortunately, due to the design of LPS exit slides, these gaps were located in close upstream proximity to the count paddle. Some lamprey were able to attach upstream from the count paddle while 50-70% of its body passed under the paddle. In subsequent attempts to back-climb, the count paddle was lifted and the limit switch engaged multiple times. This behavior created multiple counts for a single lamprey passage event. The PVC coupling at the terminus of the exit slide allows mounting of the count paddle system. This area was not lined with perforated plate in 2014, and it provided an ~8-inch smooth surface where lamprey could attach (Figure 13). These areas should be lined with perforated plate to improve LPS passage estimation accuracy.

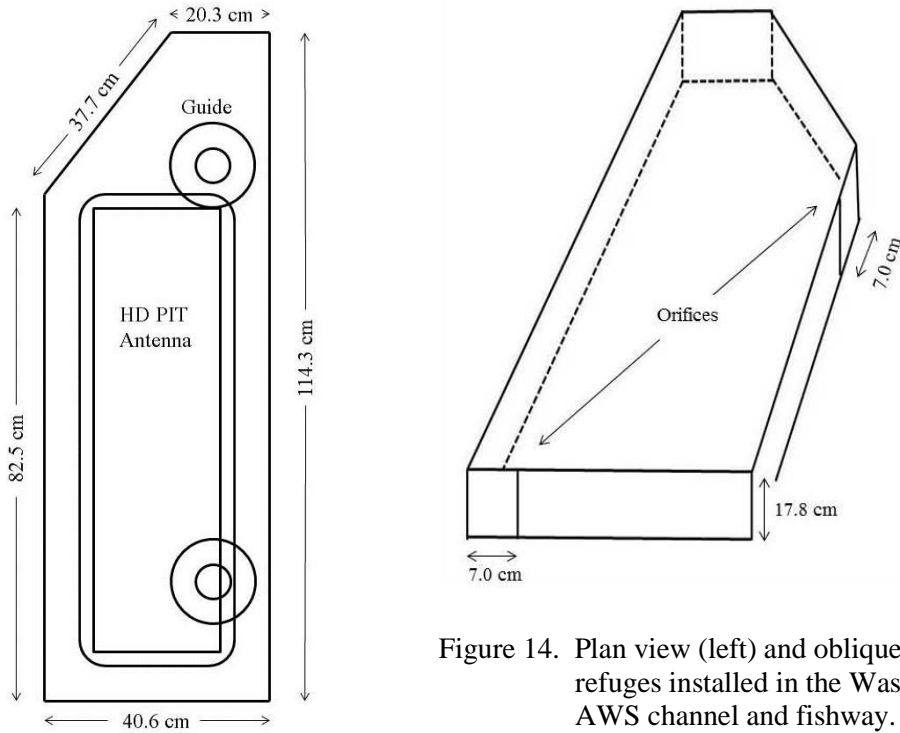
Figure 14. Plan view (left) and oblique view (above) of refuges installed in the Washington Shore AWS channel and fishway.

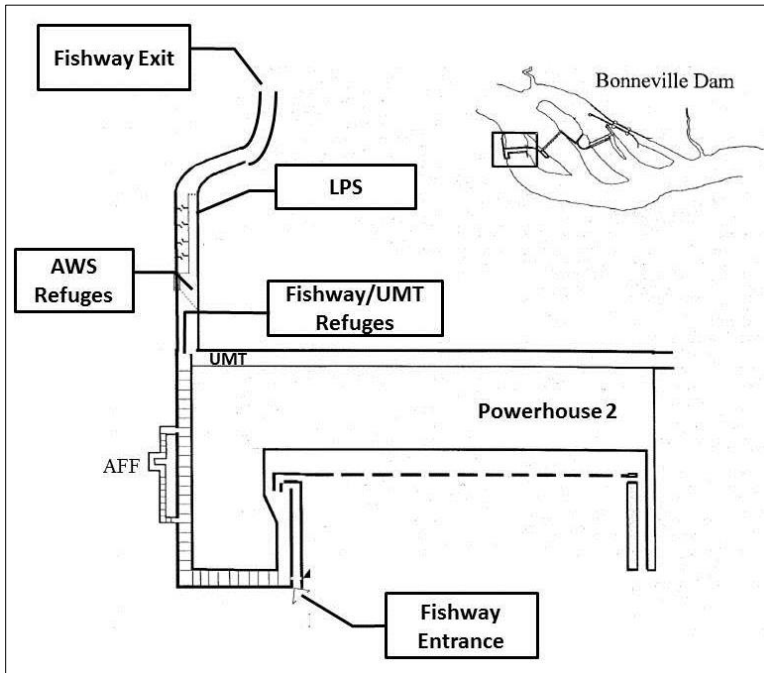
Figure 15. Location of refuges in the Washington Shore AWS channel and fishway at Bonneville Dam.

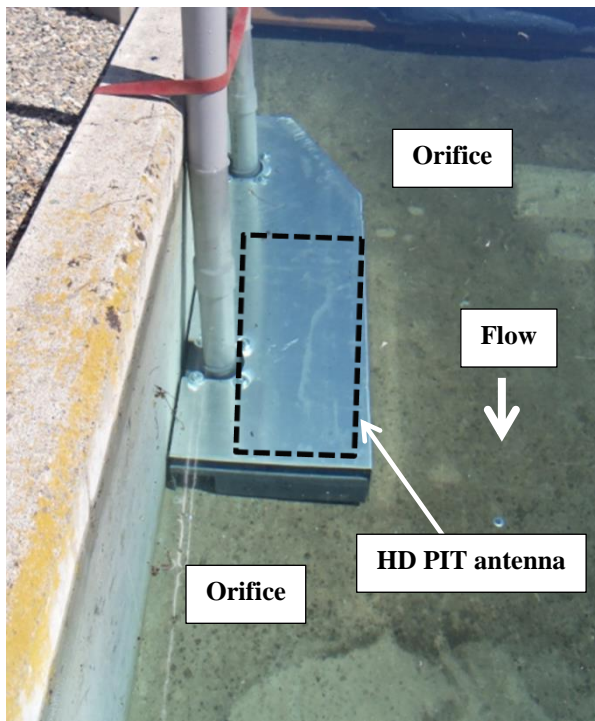
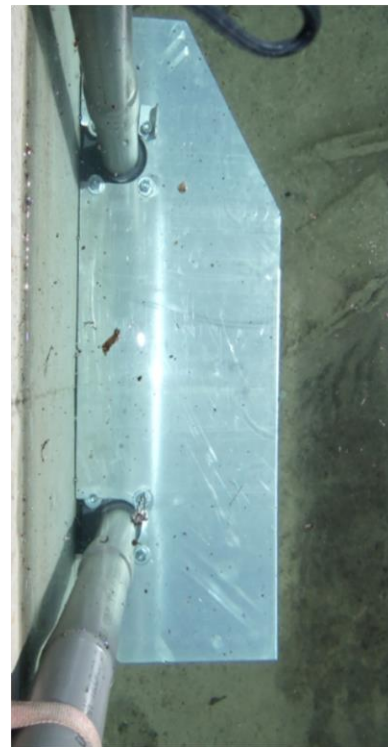
Figure 17. Photographs of refuge design and placement.

Prior to the 2013 migration period, two additional refuges were installed in the Washington Shore fishway downstream from the AWS channel. These refuges were positioned along the north and south walls of the fishway below its junction with the upstream migrant tunnel (Figure 16; Corbett et al. 2014). A PIT antenna was integrated into each refuge to allow detection of tagged lamprey (Figure 17).

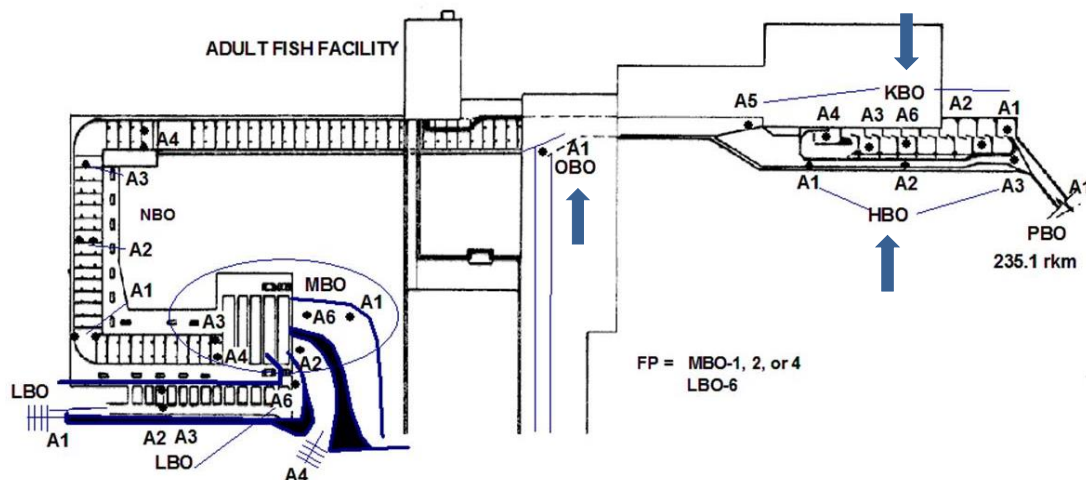
Figure 18. Radio antenna array at the Washington-shore fishway at Bonneville Dam in 2014 (from Johnson et al. in review). Blue arrows point to receivers near the refuge study area (antenna complexes HBO, KBO and OBO).

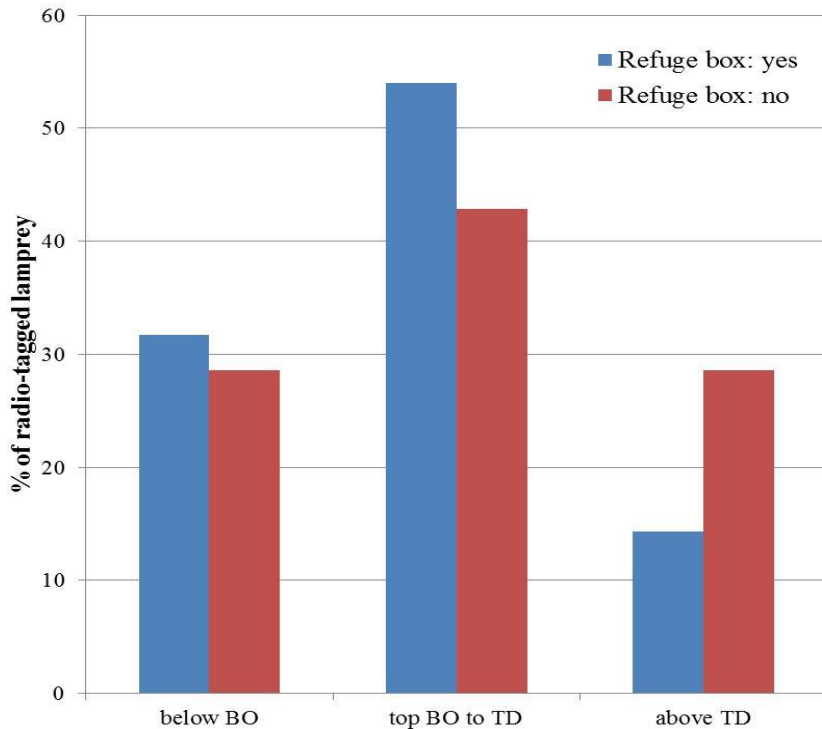
Figure 19. Percentages of radio-tagged lamprey last detected at or downstream from Bonneville Dam (below BO), in the Bonneville pool (top BO to TD), or upstream from The Dalles Dam (above TD). Blue bars indicate lamprey that used an AWS refuge and red bars indicate those that did not.

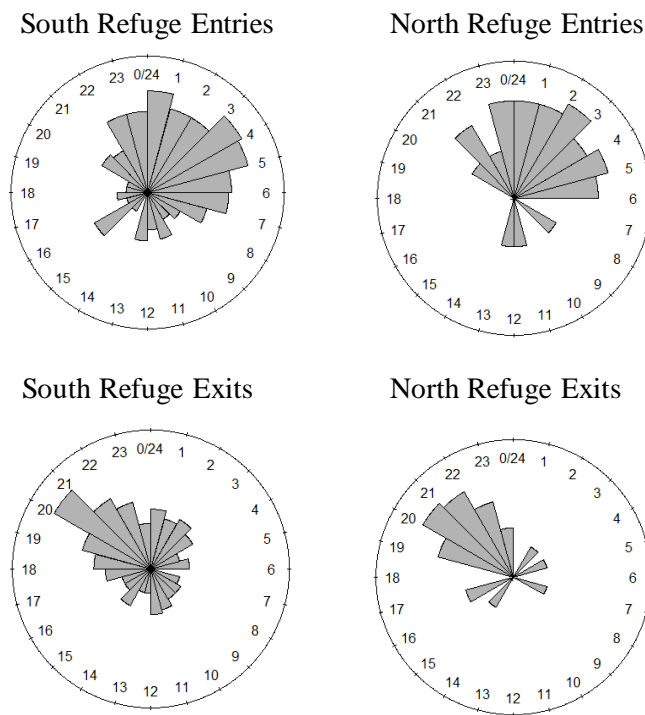
Figure 20. Rose plots of Washington-shore AWS refuge entries and exits by PIT-tagged lamprey for a 24-hour clock.

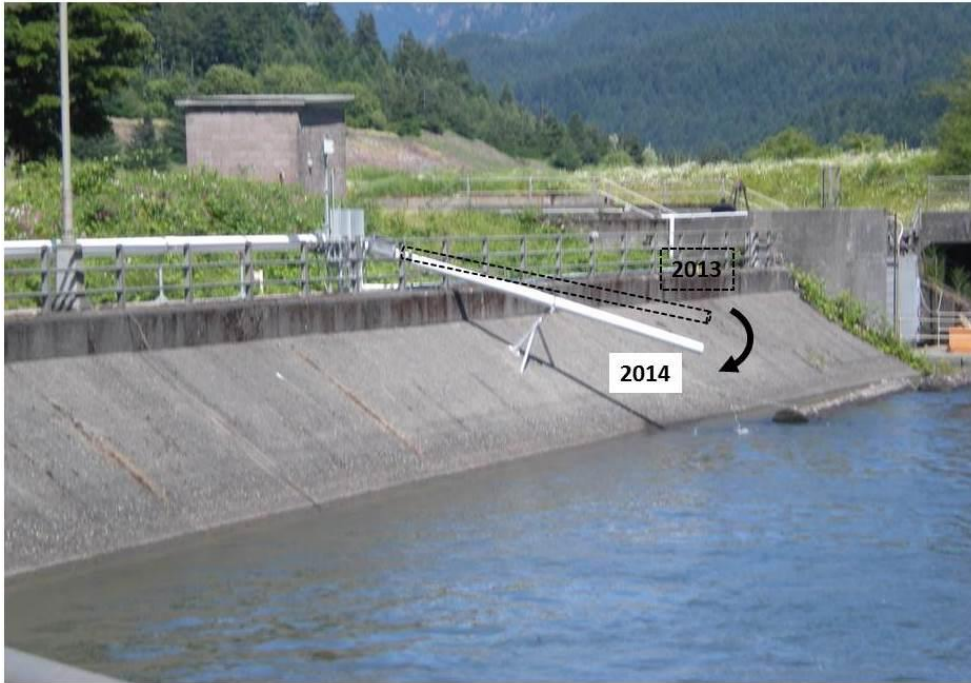
Figure 21. Photo and illustration of 2013 position and 2014 modification that increased the slope of the Cascades Island exit slide.

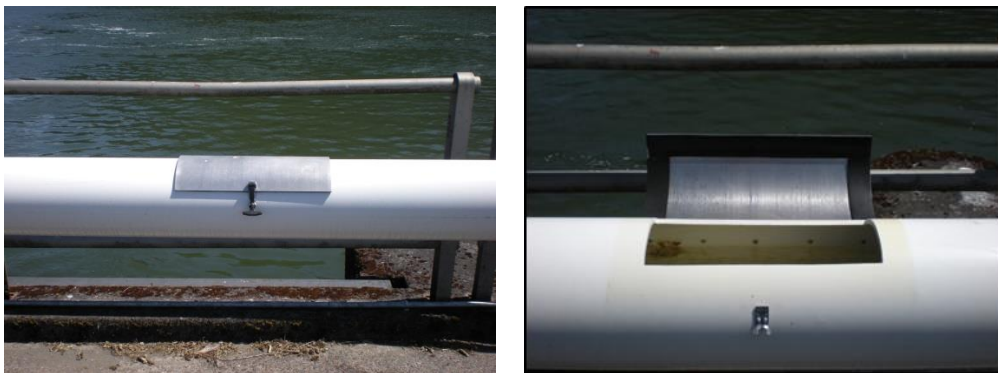
Figure 22. Photos of one of four ports and hatch covers added to the Cascades Island entrance LPS exit extension in 2014 to facilitate inspection and cleaning.

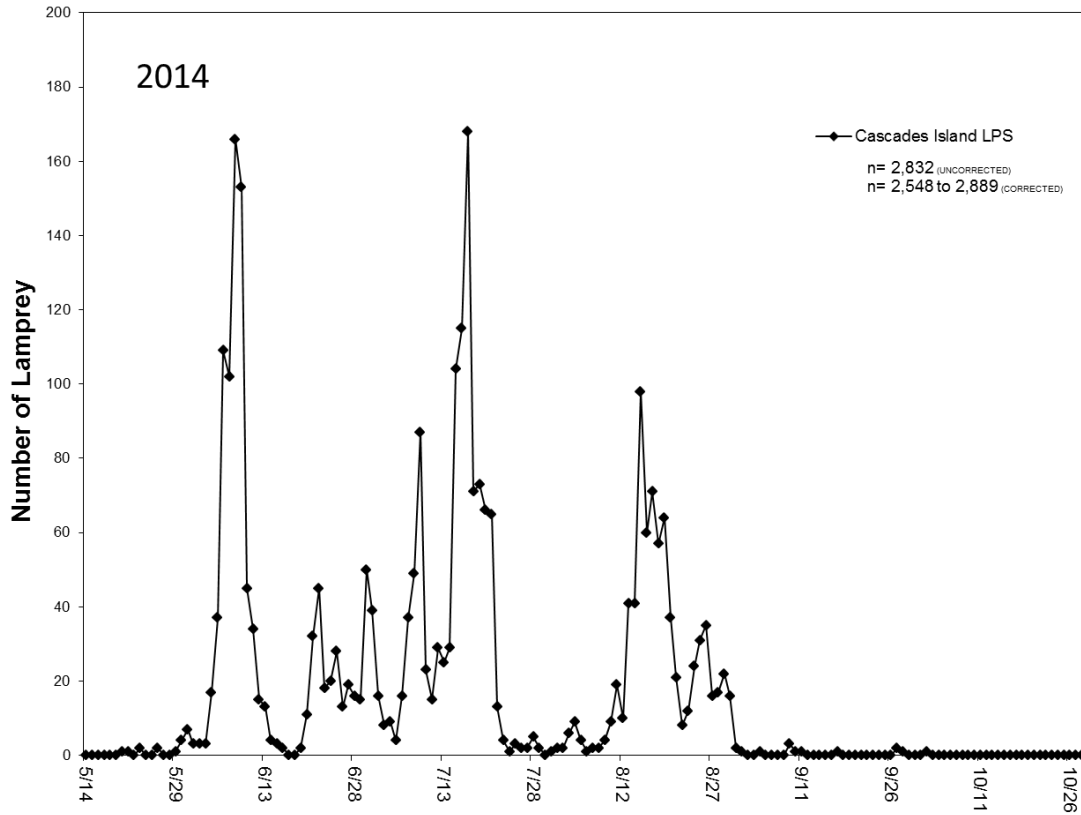
Figure 23. Number of lamprey counted at the Cascades Island LPS exit slide (closed diamonds) during the periods of LPS operation in 2014. Total uncorrected and corrected values are reported for the LPS.

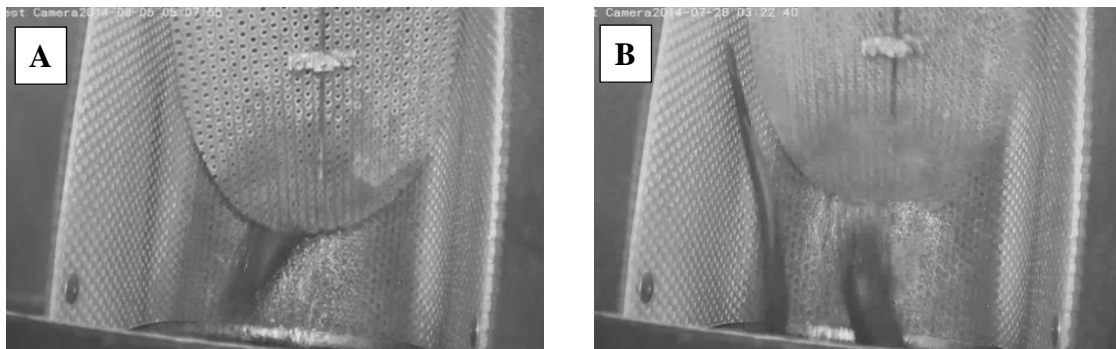
Figure 24. Photos of lamprey passing under the count paddle at the Cascades Island LPS exit: A) head-first orientation, and B) tail-first orientation.

During validations, lamprey were observed passing under the count paddle either in a head-first or tail-first orientation (Figure 24). Instances where lamprey passed in the head-first orientation always resulted in a single event being recorded by the pulse-counter. In each of the 4 instances where the pulse counter recorded multiple counts for a single lamprey passage event, lamprey were observed passing in a tail-first orientation. During these events, the limit switch was activated multiple times by lamprey attempts to back-climb. This resulted in multiple events being recorded by the pulse-counter for a single lamprey passage event.

There were also several instances where lamprey passed in the tail-first orientation, and a single count was recorded by the data logger. Such outcomes were due to lamprey not attempting to back-climb, or to the attempted back-climb not being vigorous enough to re-activate the limit switch. In one instance, a lamprey was observed passing under the count paddle slowly and with very little body movement such that the limit switch was not activated and no corresponding pulse was measured by the pulse counter.

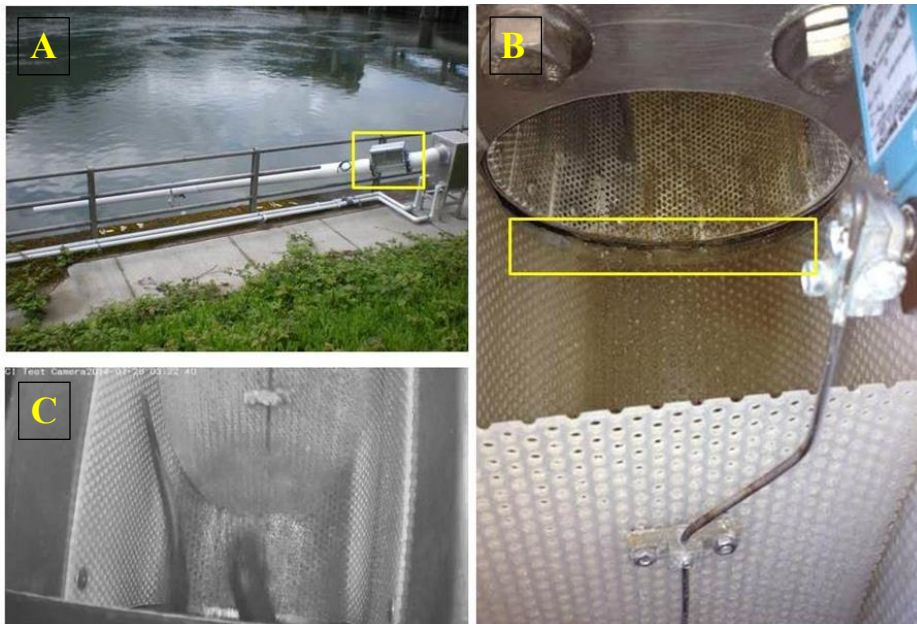
Figure 25. Photos of the Cascades Island LPS exit (A, yellow outline), the gap in perforated plate (B, yellow outline), and lamprey passing under the counter paddle (C).

For lamprey that attempt, but fail to attach at this location, passage can be slowed by the attempt, and these fish can pass under the count paddle in a tail-first, horseshoe orientation. Video validation showed that most lamprey passed under the count paddle in this orientation, indicating that these fish frequently attempt to attach but are not always able. For lamprey that passed under the count paddle in a head-first orientation, the result was an accurate passage event record reported by the pulse counter.

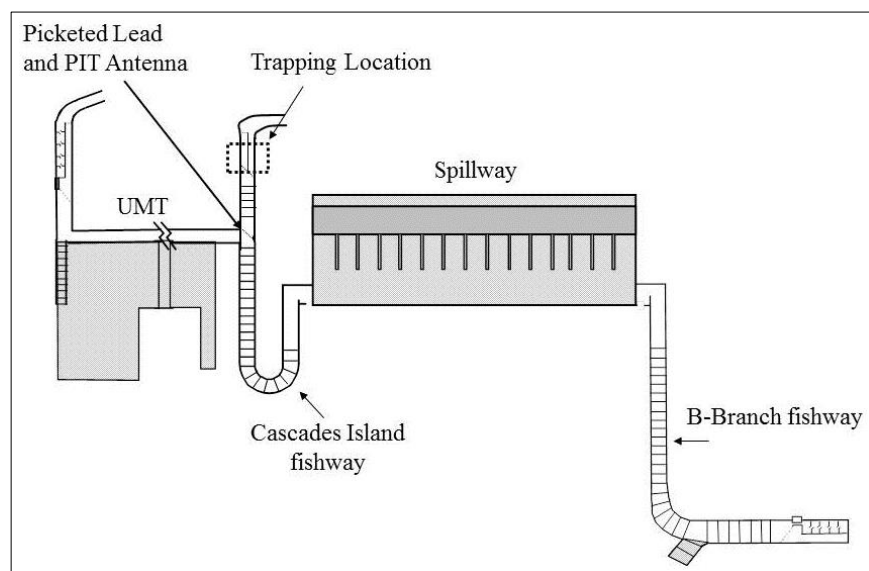
Figure 26. Locations of the HD-PIT antenna at picketed lead and trap deployments at the Cascades Island MUWS channel.

In 2014, portable traps similar to those at the adult fish facility were deployed at the Cascades Island makeup water supply channel upstream from the picketed lead near the fishway exit (Figure 26). Lamprey have been observed accumulating in this area, and

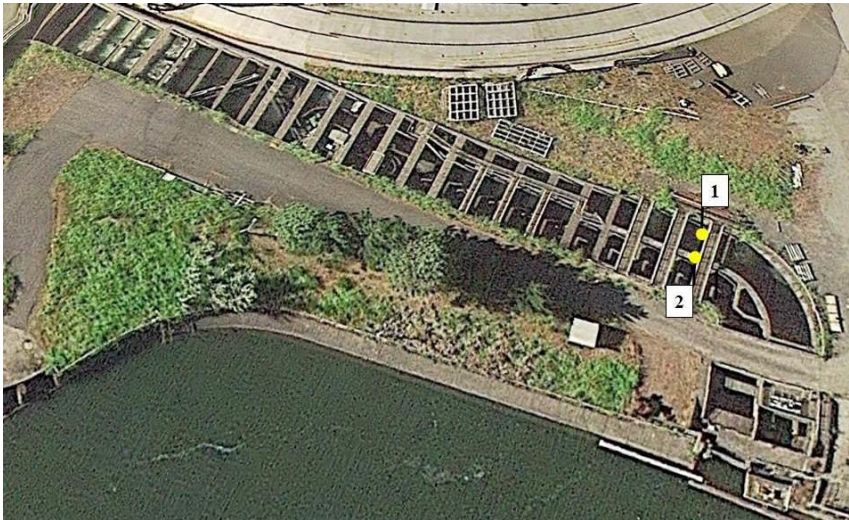
Figure 27. Locations of the two traps (yellow dots) deployed in the Cascades Island makeup water supply channel in 2014.

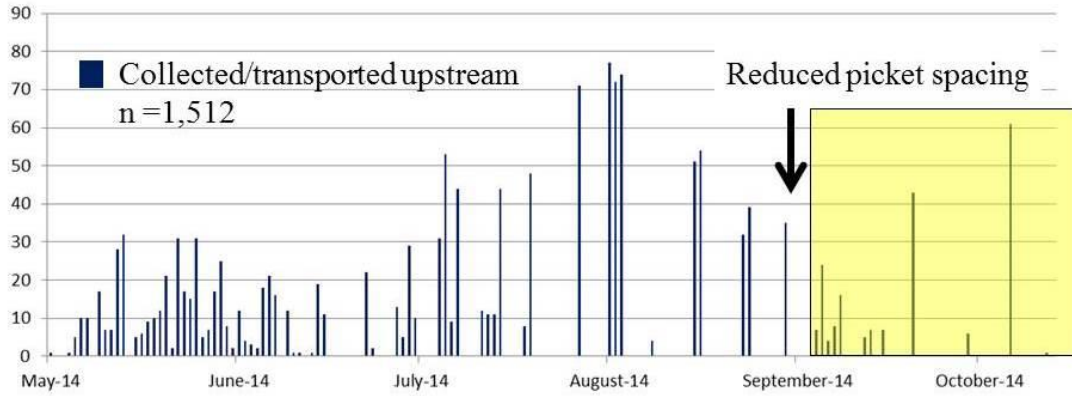
Figure 28. Lamprey captures by date at traps in the Cascades Island makeup water supply channel. Shaded area indicates the period when picket spacing was reduced to discourage lamprey entry into the channel. Those captured during this time may have entered the channel prior to the change or may have passed through the narrower spacing.

Initial attempts to reduce lamprey access to the makeup water supply were not completely successful: lamprey continued to enter the channel and become trapped long after the picketed lead spacing was reduced to prevent access (Figure 28). These entries of lamprey may have been caused by discontinuities between the fishway floor and bottom of the new picket or by an insufficient reduction in spacing of the picketed lead. Further modifications to eliminate lamprey access to this area were completed during the in water work period in 2015, after these assessments were completed.

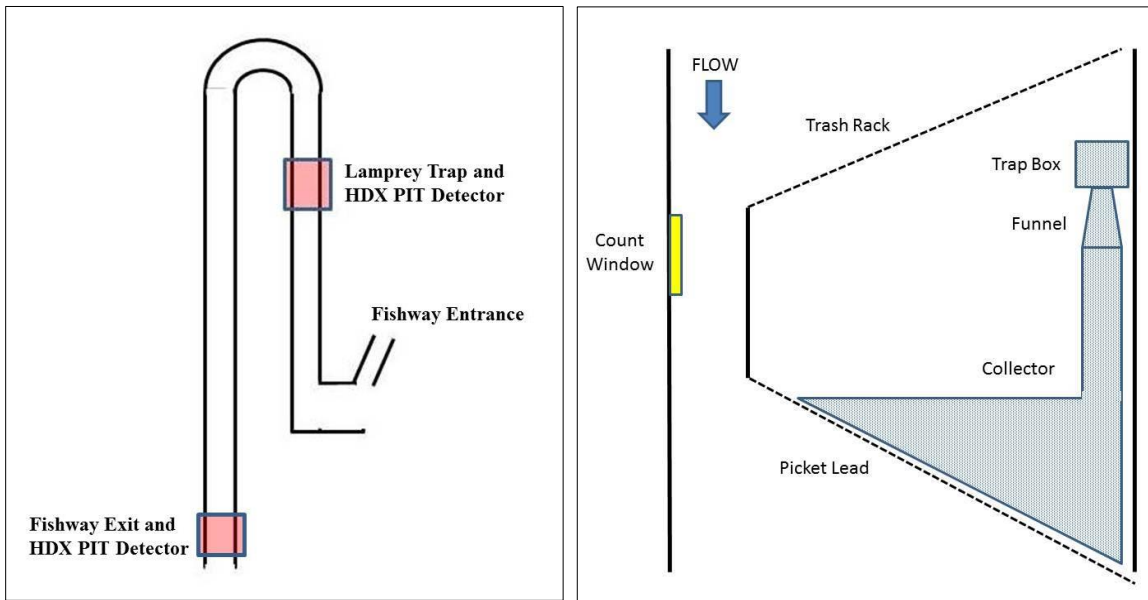
Figure 29. Plan views showing location of the lamprey trap and PIT-tag detectors in the John Day south fishway. Right panel shows location of the trap in relation to other structures within the fishway.

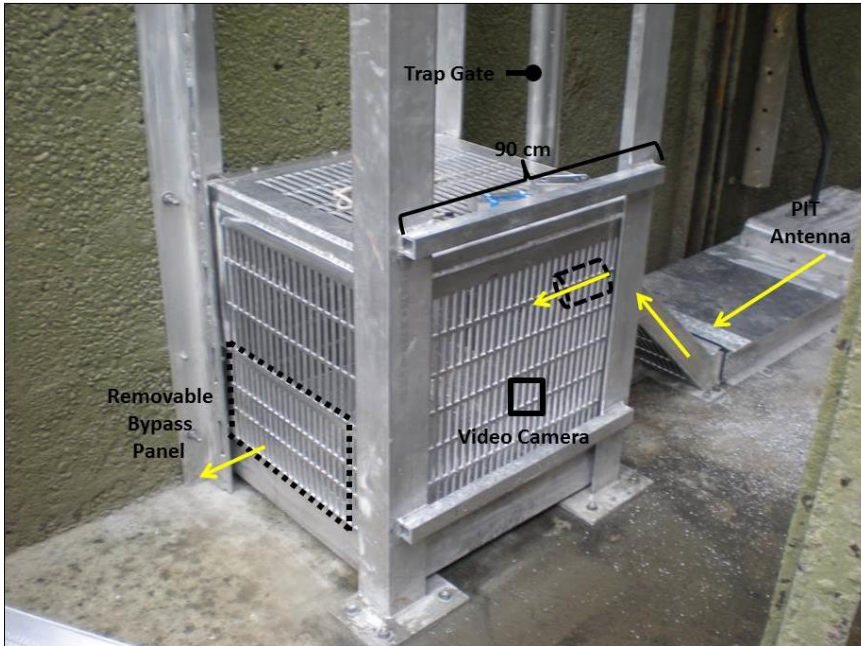
Figure 30. Photo of trap and associated features (labeled) in the south fishway at John Day Dam.

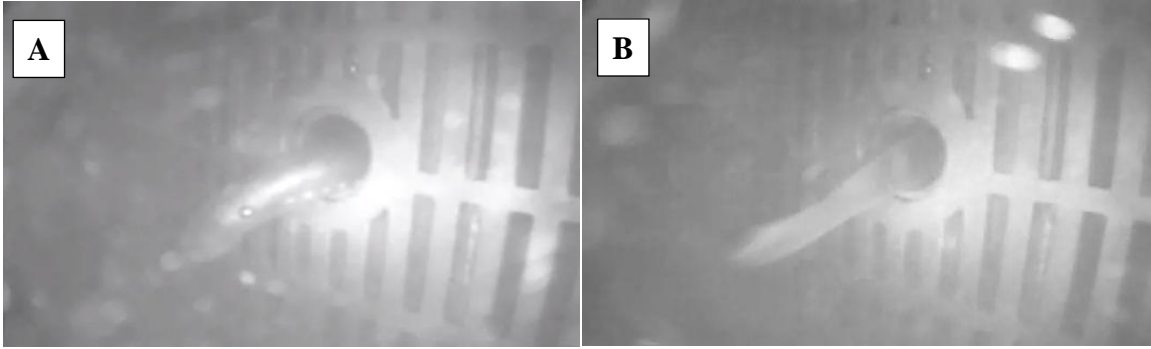
Figure 31. Still imagery extracted from recorded video displaying examples of: A) lamprey only partially entering the trap box via the entrance port, and B) lamprey exiting the trap box via the entrance port.

Some interesting lamprey interactions with the trap have been observed during video reviews. Many individuals showed hesitation upon entering the trap box from the entrance port. Frequently a lamprey would extend one third to one half of its body length into the trap box (Figure 31A) and appear to search for a surface to attach to before retracting from the entrance port. Additionally, one lamprey that had previously fully entered the trap box was observed exiting the trap box head-first through the entrance port (Figure 31B).

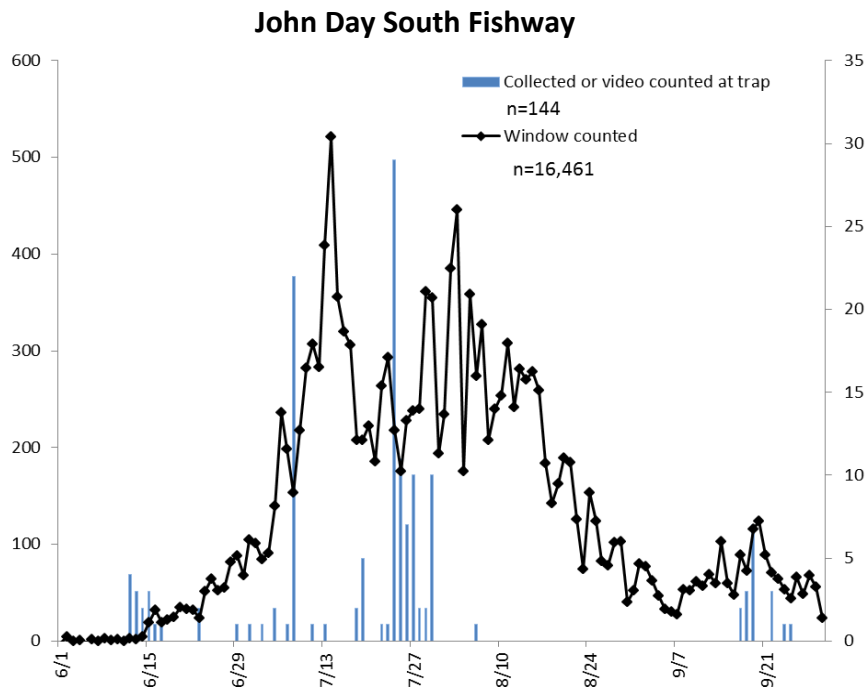
Figure 32. Number of lamprey counted at the John Day south count station (closed diamonds, primary axis) and either collected from the trap or video counted entering the trap (bars, secondary axis) during dates it was operated in pass-through mode in 2014. Total values reported for the count station and trap.

From the 288 h of video footage recorded during 16-30 July, when the trap was operated in pass-through mode, we observed an additional 66 lamprey swimming through the structure. An additional 432 h of digital video was recorded when the trap was operated in pass-through mode (18 trapping periods from 31 July to 19 August). This imagery will be reviewed and the results reported. By comparison, a total of 16,461 lamprey were counted during day and night visual counts at the John Day south count window between 1 June and 30 September (Figure 32).

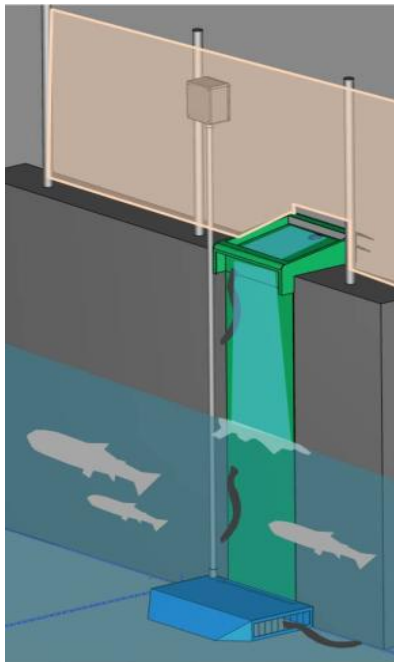
Figure 33. Schematic diagram of theoretical wetted wall. Conduit pipe is located adjacent to the climbing surface on the upstream side of the wall, and a refuge box is placed on the fishway floor below the climbing surface. These features encourage exploration of the passage option provided.

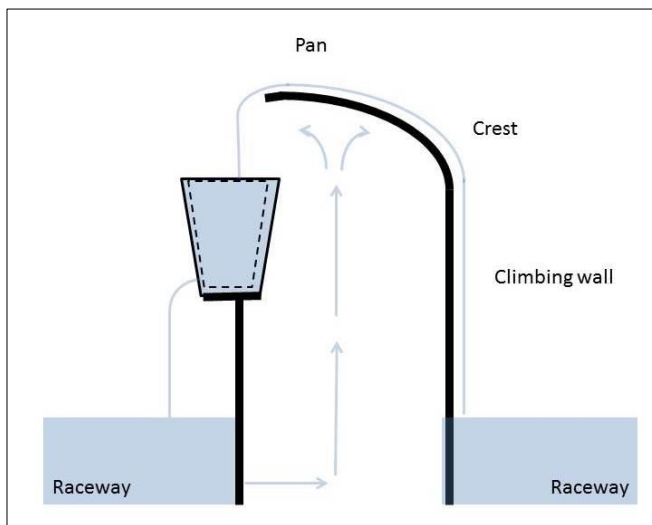
Figure 34. Schematic diagram (side view) of experimental wetted wall collector with features labeled.

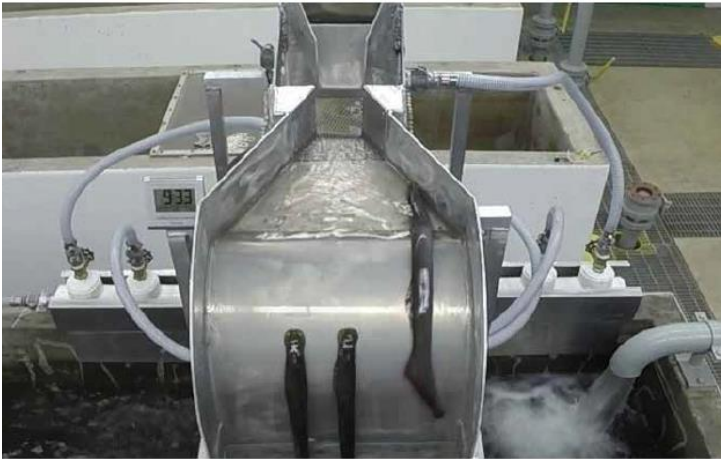
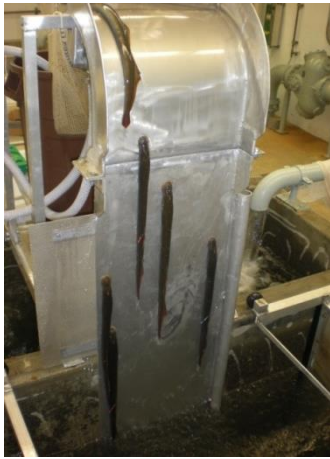
Figure 35. Photos of experimental wetted wall collector show lamprey ascending during a trial.

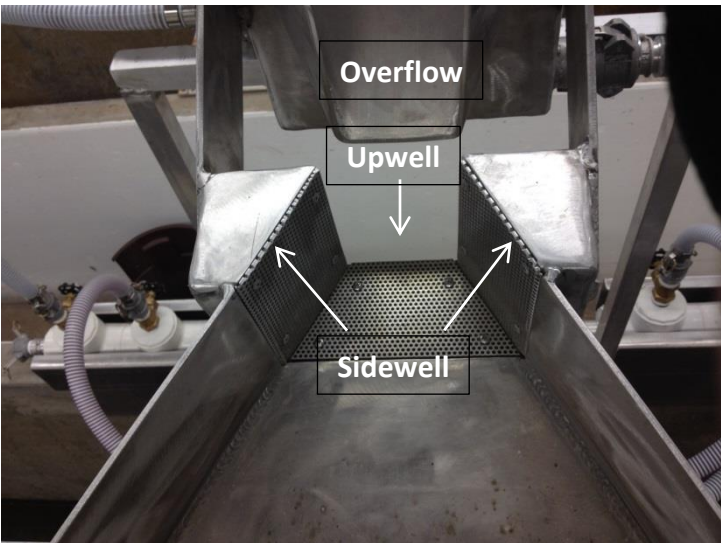
Figure 36. Photo of wetted wall collector pan exit with three water delivery system inputs labeled.

Test fish were introduced to the raceway containing the wetted wall at previously set experimental conditions (Figure 36), and observed throughout the length of the trial. Data were recorded for lamprey that interacted with the wetted wall within 2.5 h. Some lamprey that did not ascend within the trial period were left unobserved in the raceway overnight to evaluate climbing success outside of the experimental timeframe.

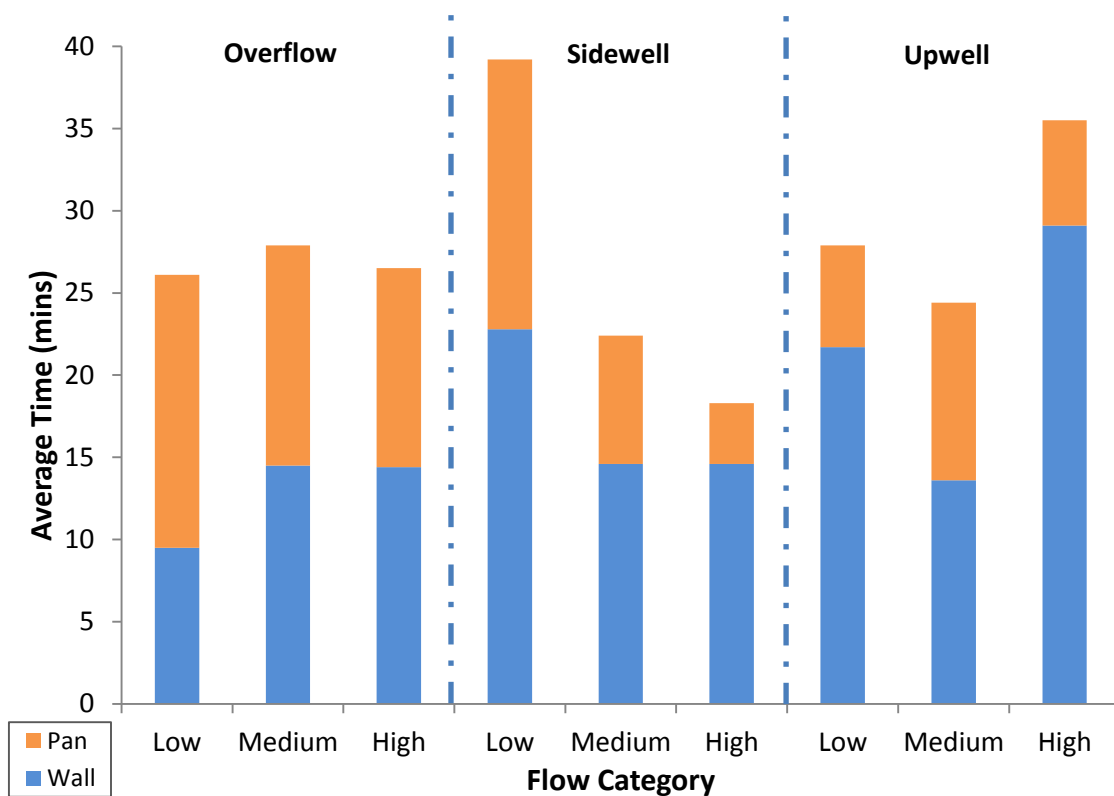
Figure 37. Average time lamprey spent on the vertical wall portion (blue) and upper pan section (orange) of the experimental wetted wall for each water supply type.
