Adult Pacific Lamprey Passage Structures: Use and Development at Bonneville Dam and John Day Dam South Fishway, 2014

Report of research by

Northwest Fisheries Science Center, National Marine Fisheries Service
National Oceanic and Atmospheric Administration
2725 Montlake Boulevard East, Seattle, WA 98112

Portland District, U.S. Army Corps of Engineers
P.O. Box 2946, Portland OR 97020
Contract E96950021

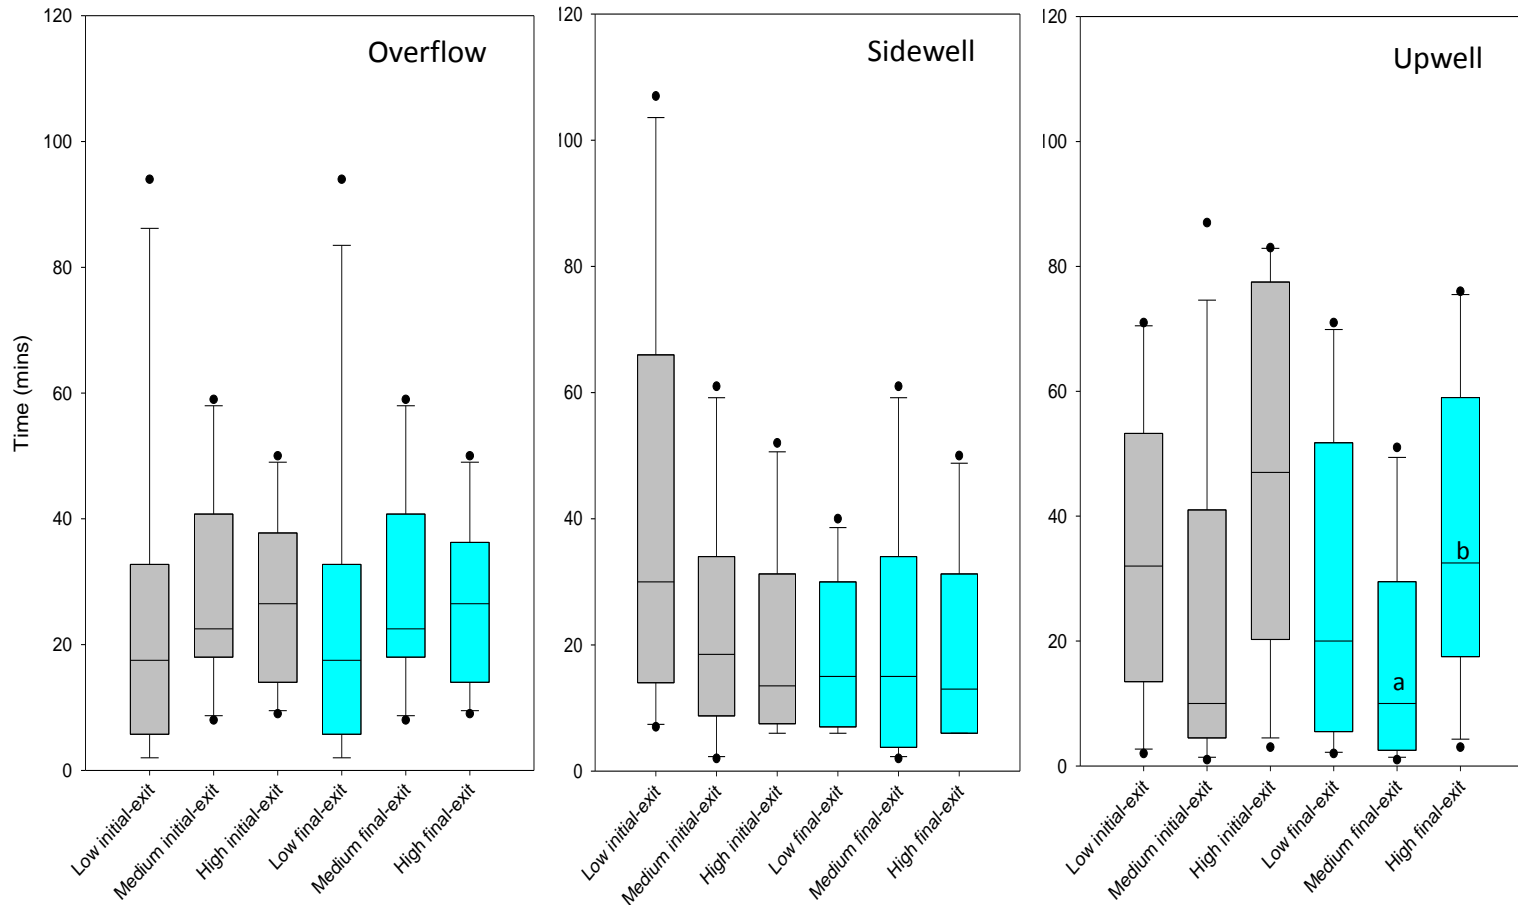
Figure 38. Passage time (min) as a function of water supply type. Reported times are from initial attachment on the climbing structure to final exit (initial-exit) or from final attachment to final exit (final-exit) for low, medium, and high flow treatments. Boxes indicate quartiles, lines indicate median, whiskers indicate 10th and 90th percentiles, and dots (●) indicate 5th and 95th percentiles. Single instance of a significant difference between flow treatments for final attachment to exit within a water supply category is indicated (upwelling).

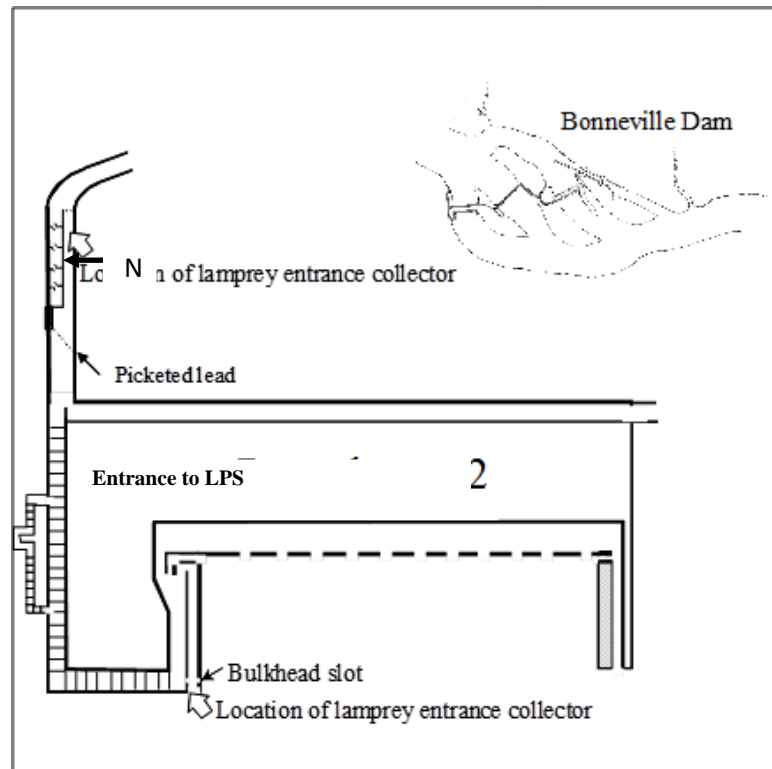
Figure 1. Schematic drawing of Washington Shore fishway at Bonneville Dam. Location of the Washington Shore AWS LPS is indicated by the white arrow.

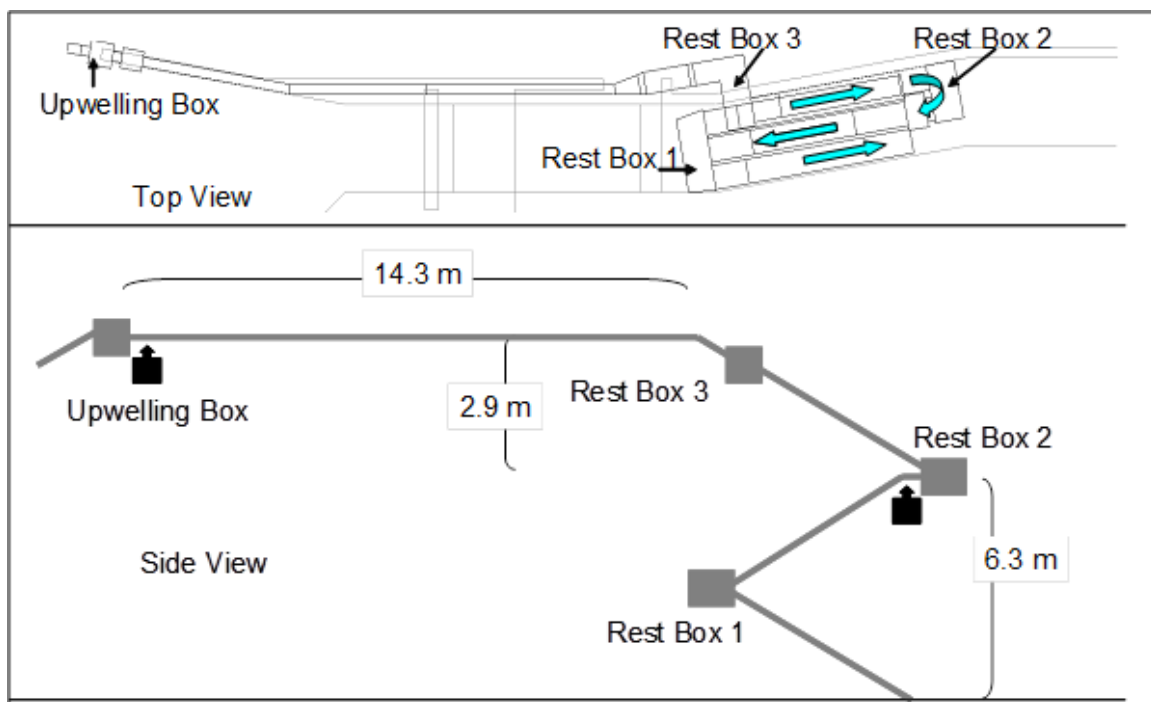
Figure 2. Upper panel shows top view and lower panel side view of lamprey passage structure in the Washington Shore AWS. Shaded arrows indicate direction of flow on switchback ramps. Black boxes indicate positions of half-duplex PIT antennas.

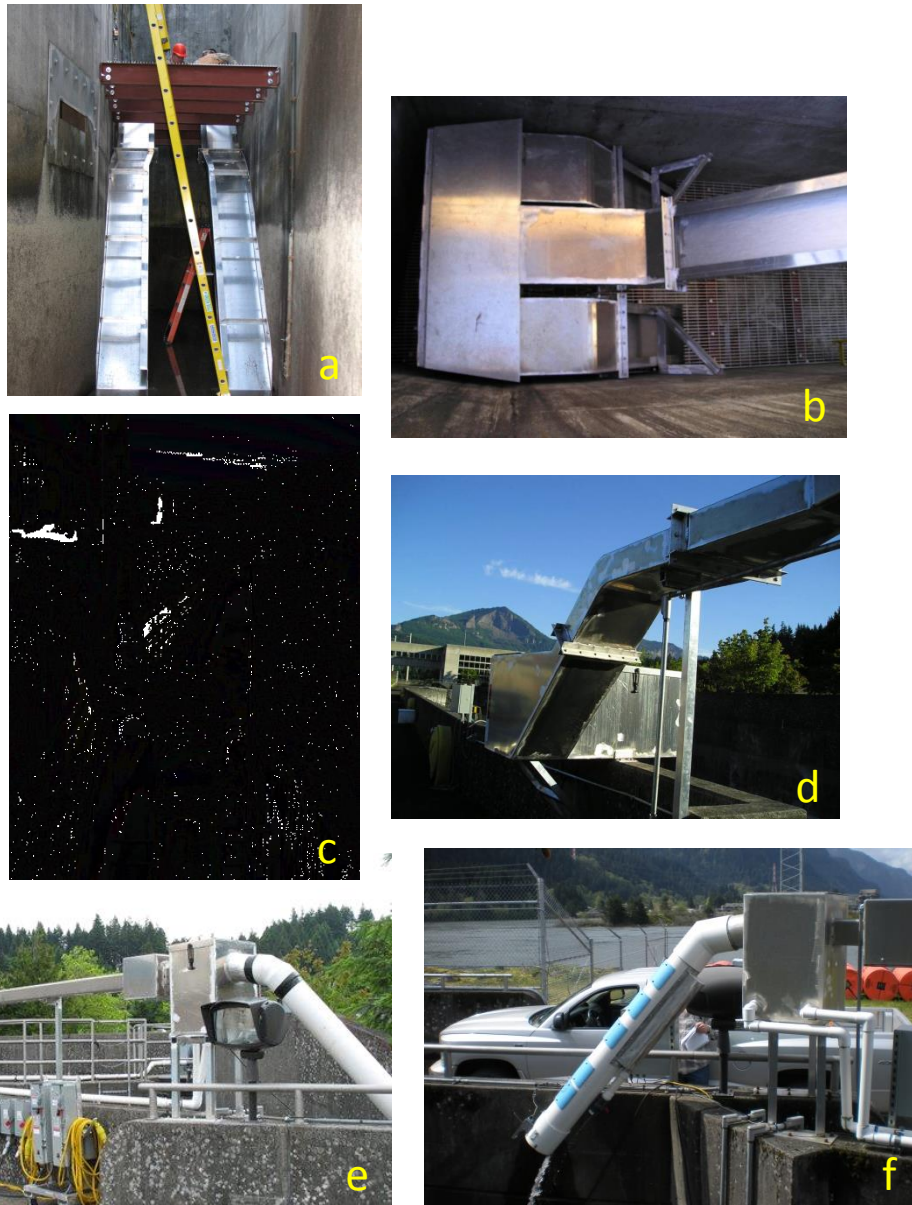
Figure A3. Photos of Washington Shore lamprey passage structure showing ramps converging at Rest Box 1 (a), Rest Box 1 (b), switchback at Rest Box 2 (c), Rest Box 3 (d), upwelling box (e), and exit slide (f).

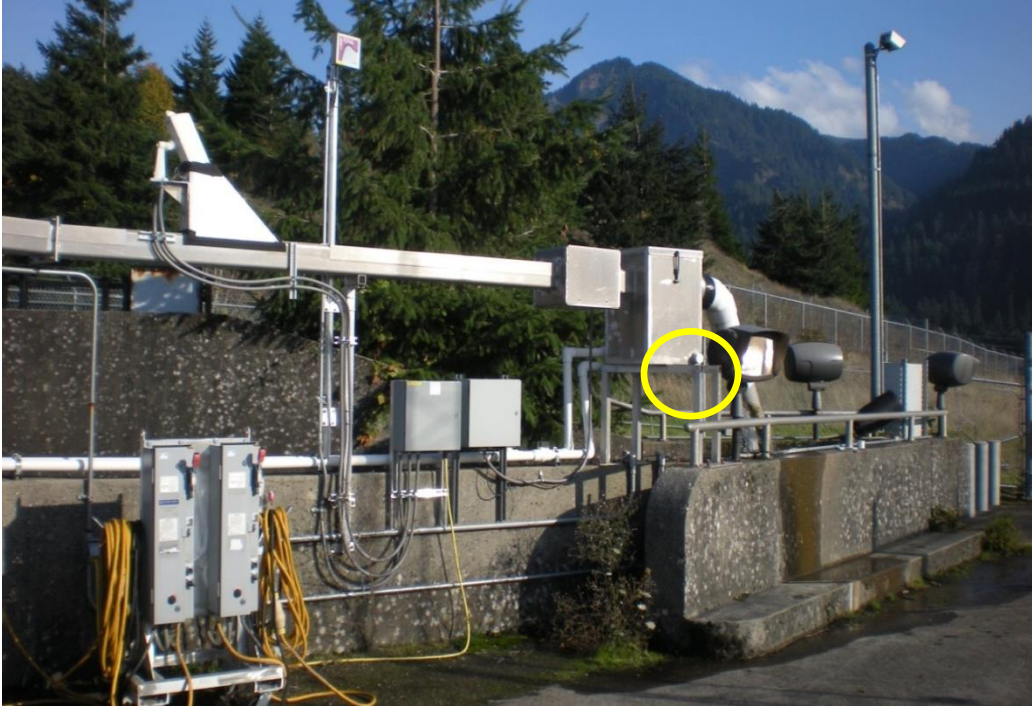
Figure A4. Discharge valve at Washington Shore AWS LPS upwelling box.

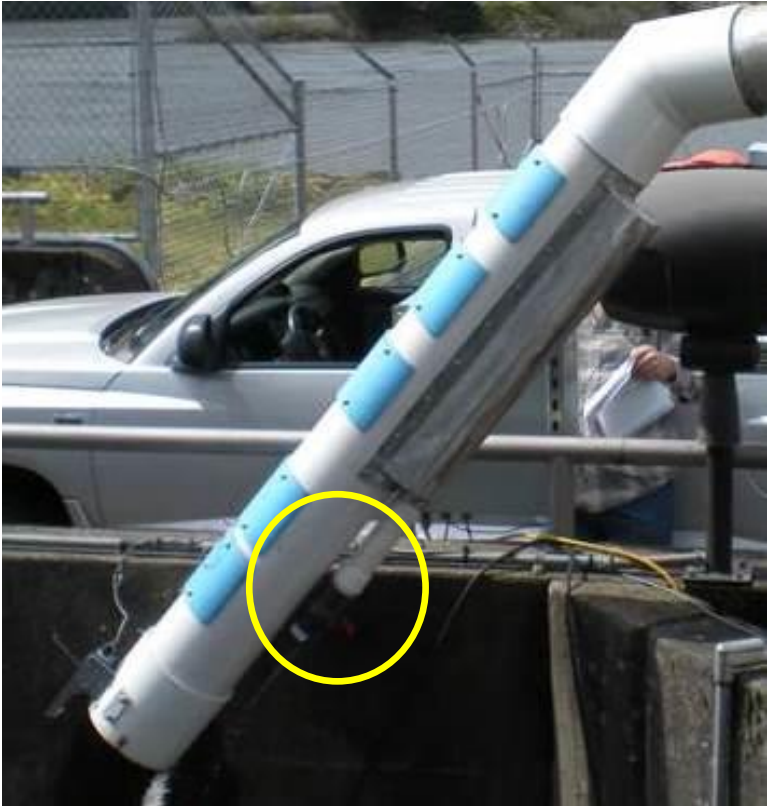
Figure A5. Discharge valve at exit slide of Washington Shore AWS LPS.

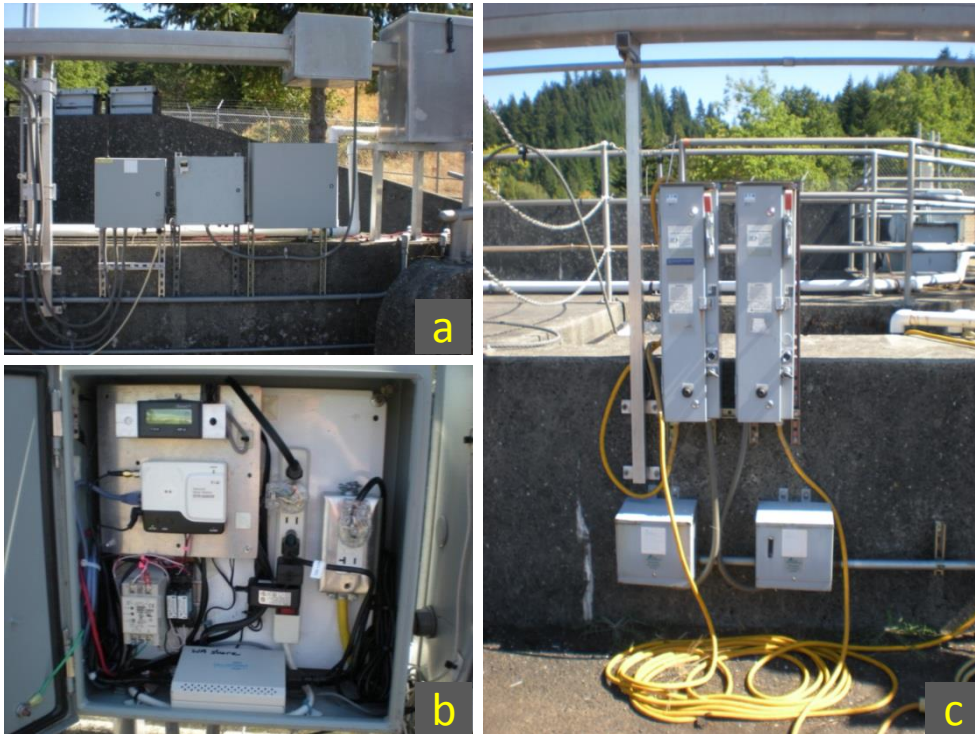
Figure A6. System controls at electrical box (a-b) and pump panels (c) for Washington Shore AWS LPS.

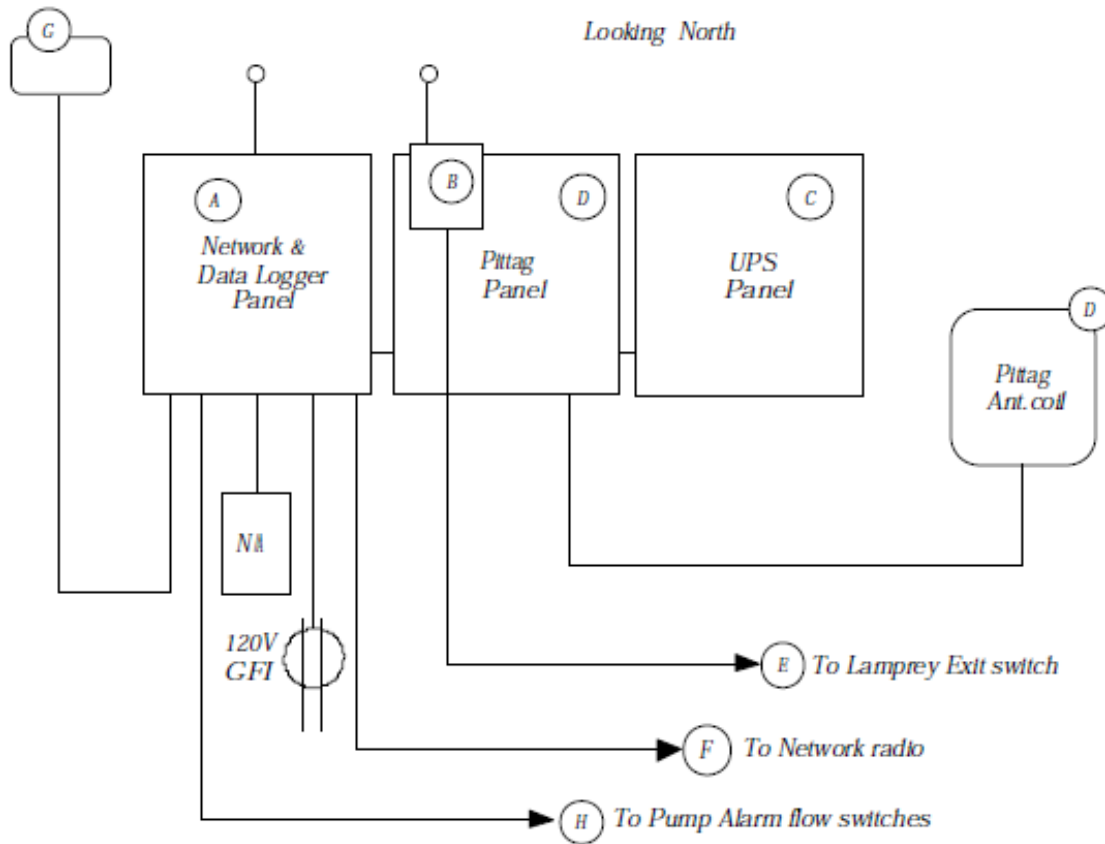
Figure A7. Wiring diagram showing electrical panels for lamprey passage structure (LPS) at the Washington Shore auxiliary water supply channel (AWS) at Bonneville Dam. See Figure 6a for photo of electrical box.

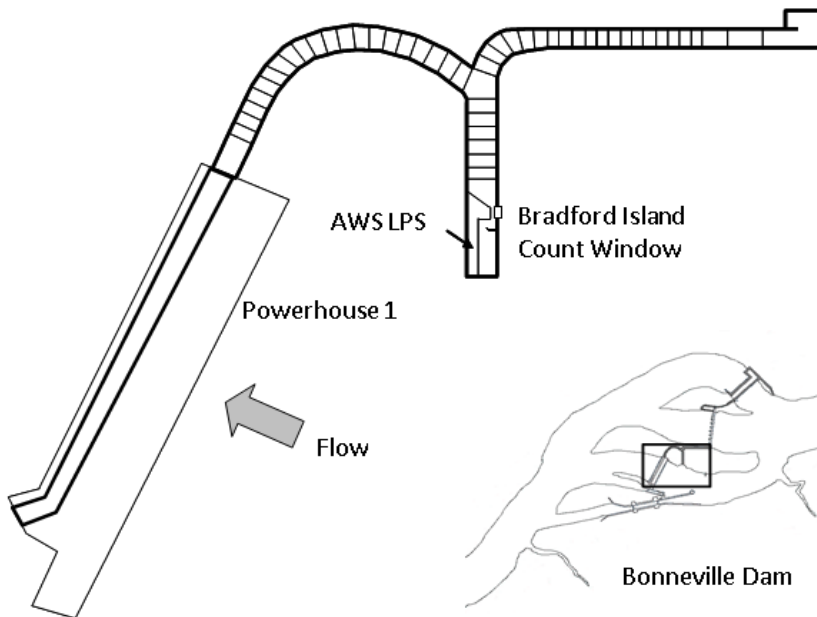
Figure B1. Schematic drawing of Bradford Island fishway system at Bonneville Dam. The location of the Bradford Island AWS is indicated by the black arrow.

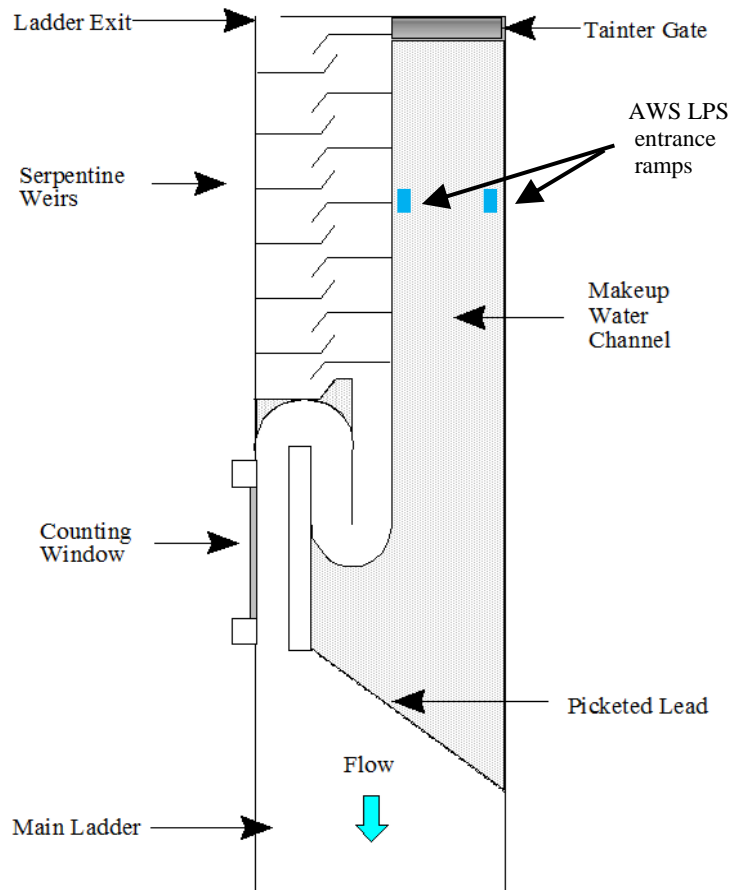
Figure B2. Overhead schematic drawing of the Bradford Island fishway and location of AWS LPS entrances.

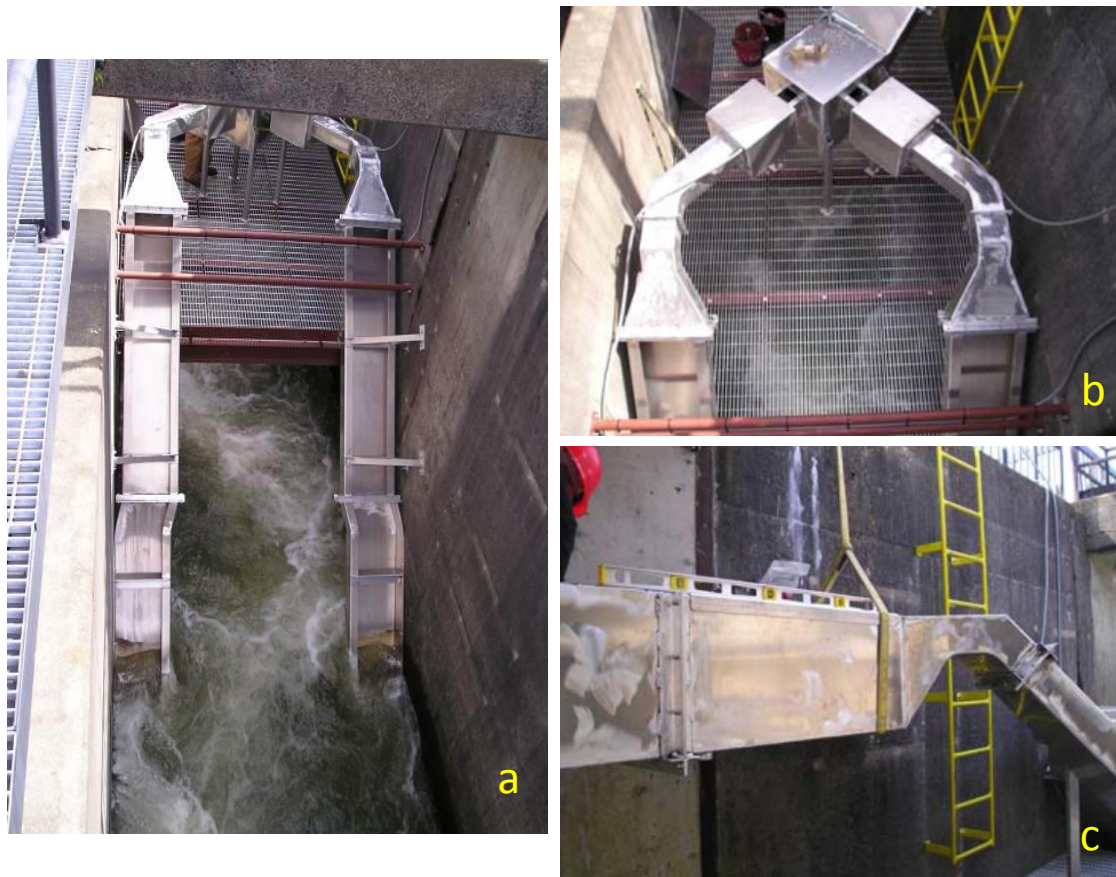
Figure B3. Photos of LPS installation in the Bradford Island AWS channel: a) dual collection ramps, b) access platform, and c) short ramp leading to large second rest box.

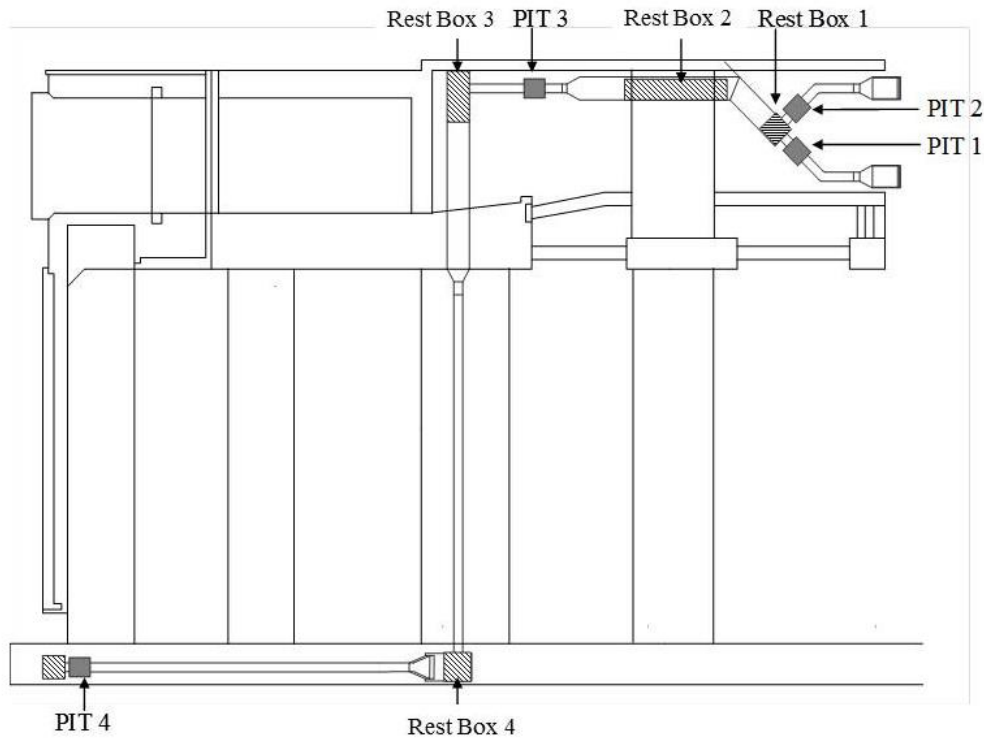
Figure B4. Schematic overhead view of Bradford Island AWS LPS with rest boxes and PIT detector locations indicated.

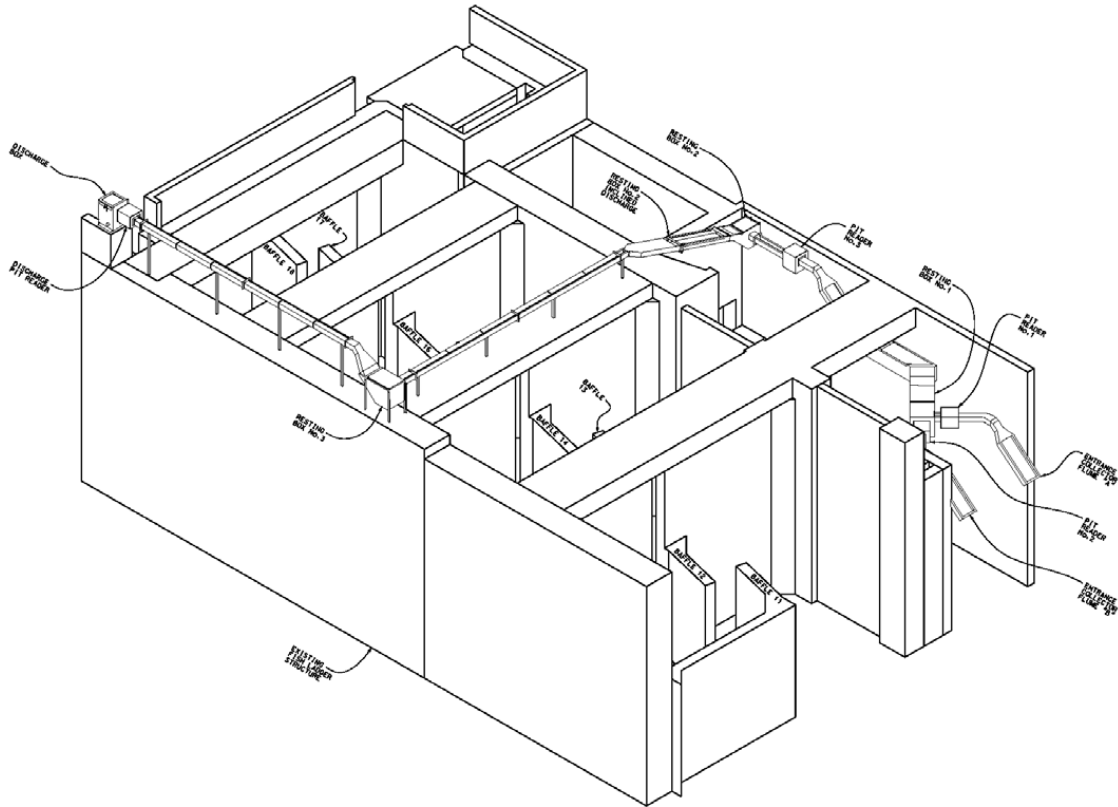
Figure B5. Schematic drawing of the Bradford Island AWS LPS (three dimensional view created by Michael Crump, U.S. Army Corps of Engineers).

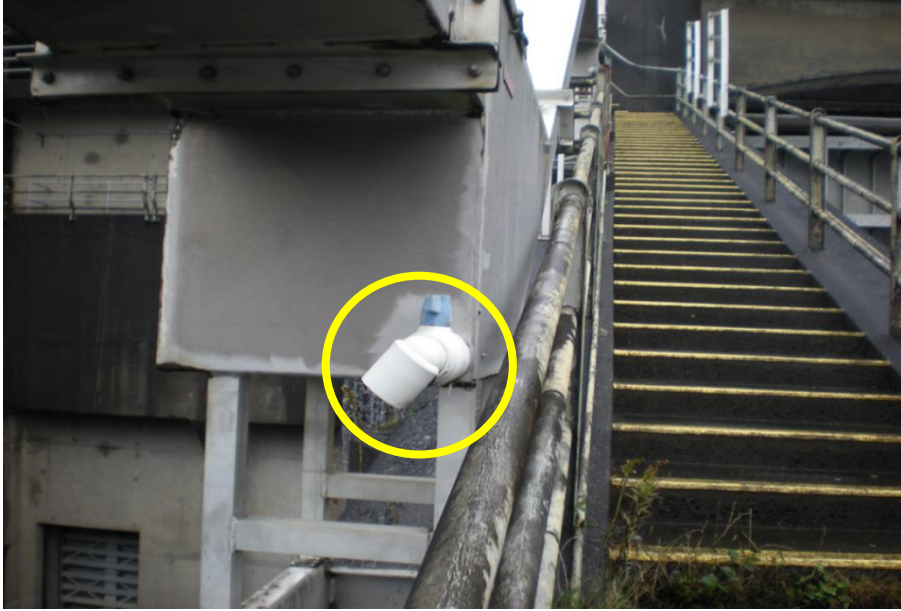
Figure B6. Example of a discharge valve at a rest box.

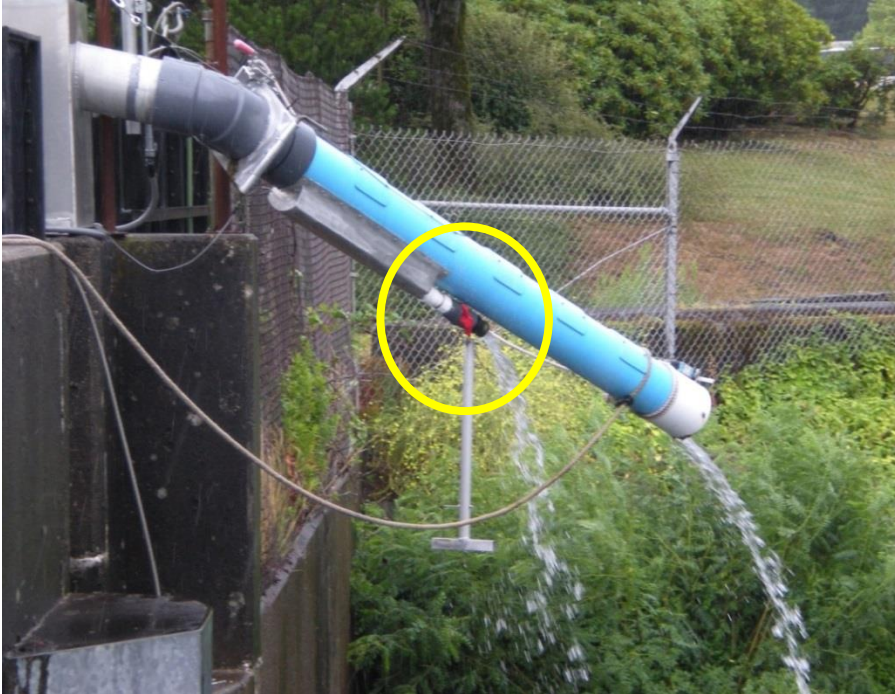
Figure B7. Discharge valve at Bradford Island LPS exit slide.

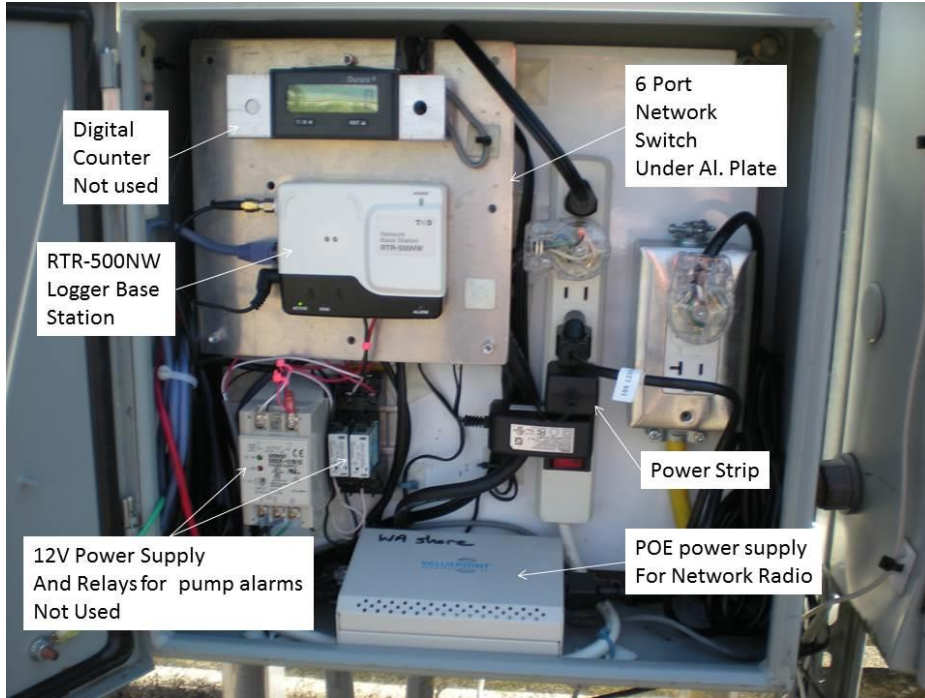
Figure B8. Electrical box with components labeled.

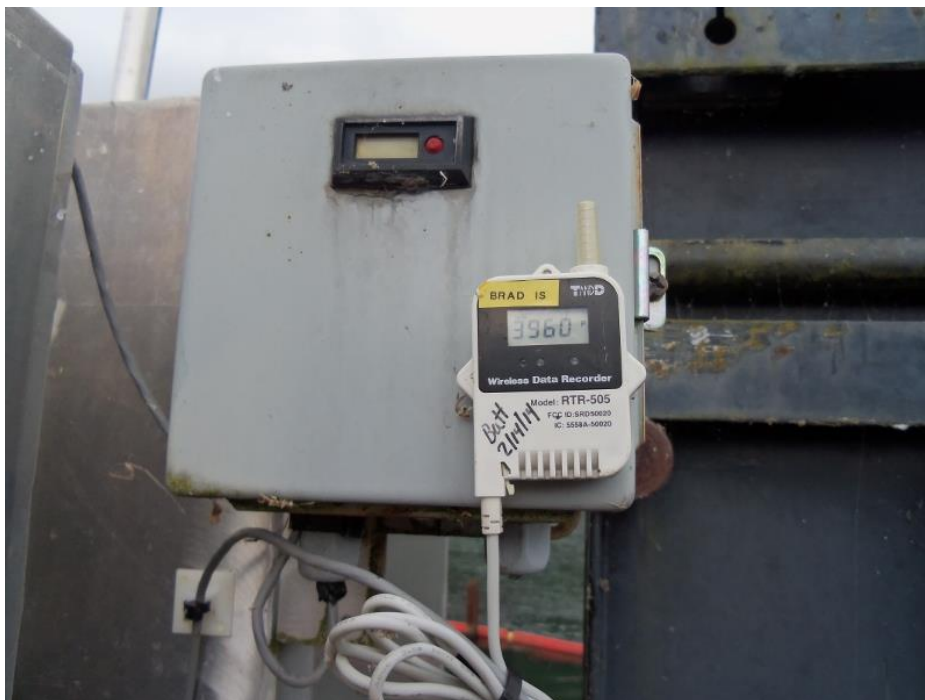
Figure B9. Wireless data recorder, RTR-500.

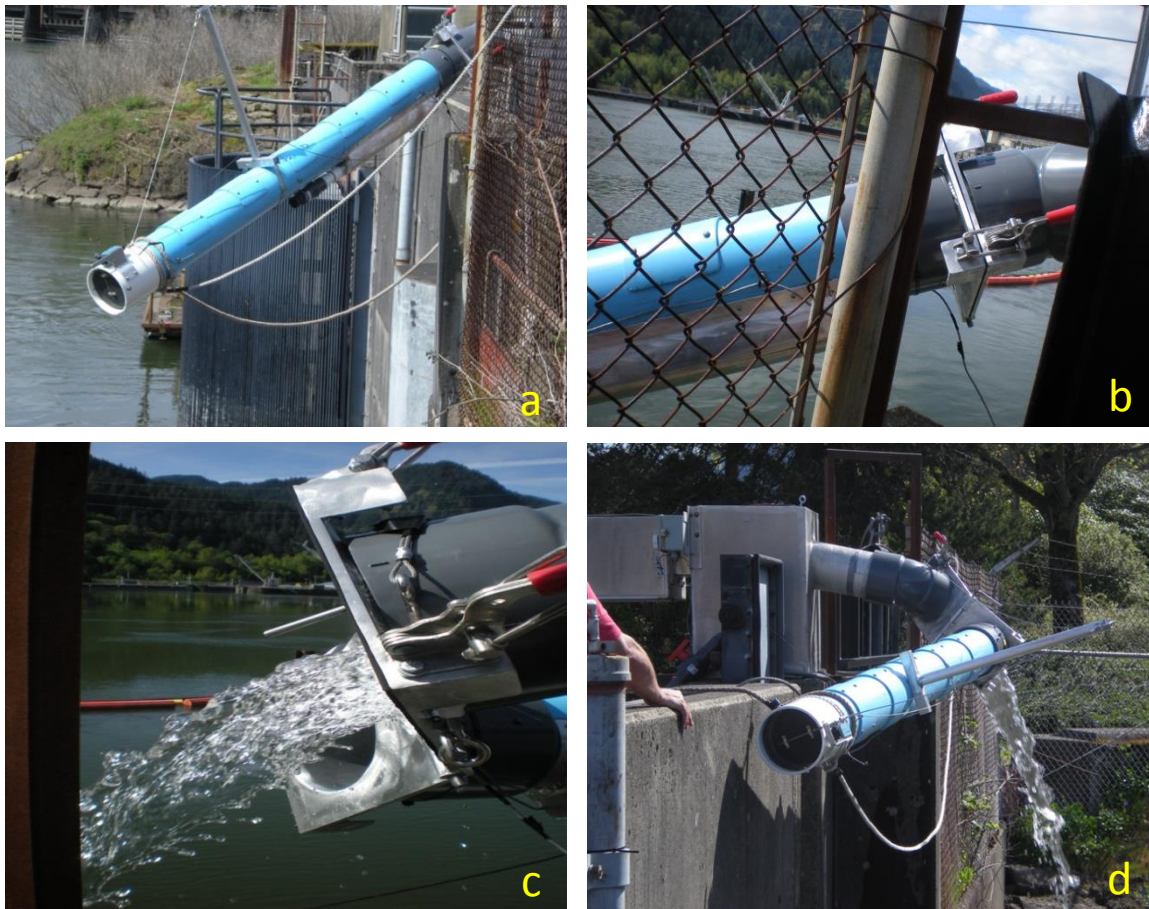
Figure B10. Retractable exit slide of Bradford Island LPS showing slide deployed (a), hinge closed (b), hinge open (c), and slide retracted (d).

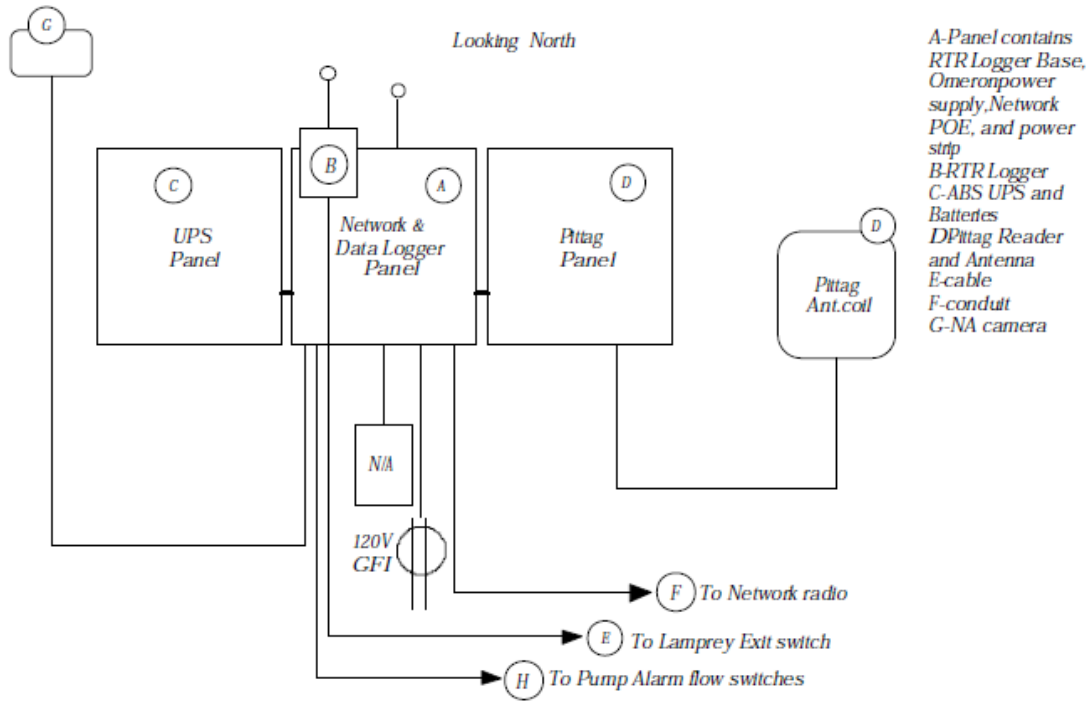
Figure B11. Bradford Island AWS LPS electrical panel.

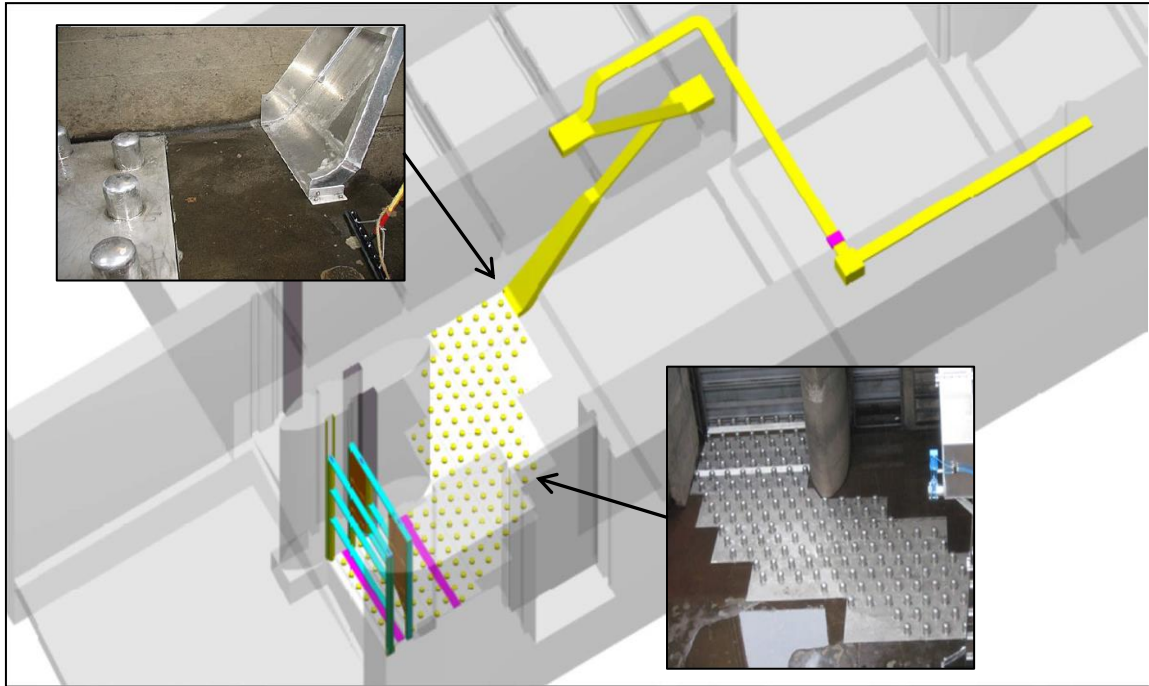
Figure C2. Schematic of Cascades Islands fishway entrance showing velocity-reducing bollard field (inset at lower right) and LPS entrance (inset at upper left). This LPS entrance is located on the north wall of the Cascades Island fishway just upstream of the fishway entrance. Note the collector/entrance ramp is flared at its base width of 1.22 m (4 ft), narrows quickly to a width of 0.61 m (2 ft), and narrows one final time to a width of 0.51 m above the water line. Schematic courtesy of USACE.

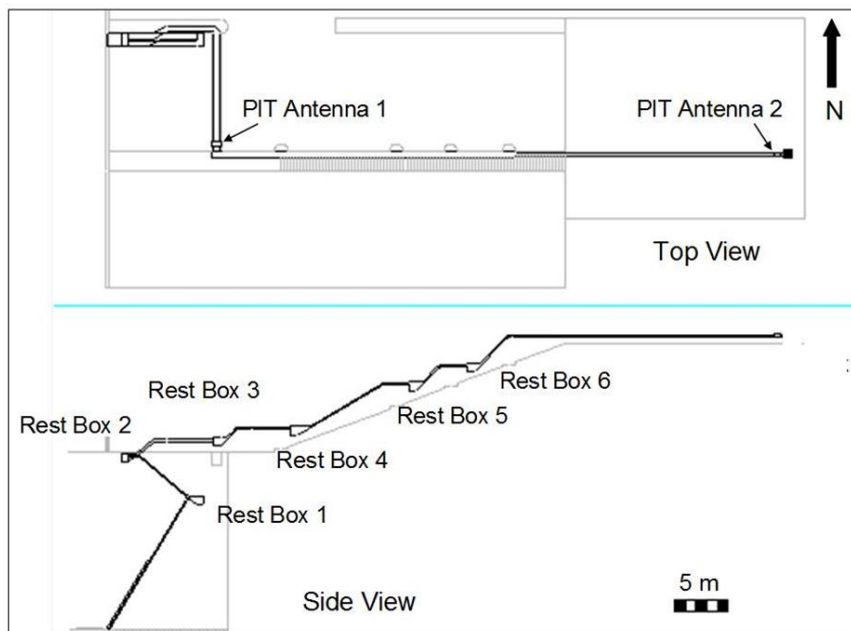
Figure C3. Top (upper panel) and side views of the lower portion of the Cascades Island LPS collector. Locations of PIT monitors are shown in the top view and rest boxes are shown in the plan view.

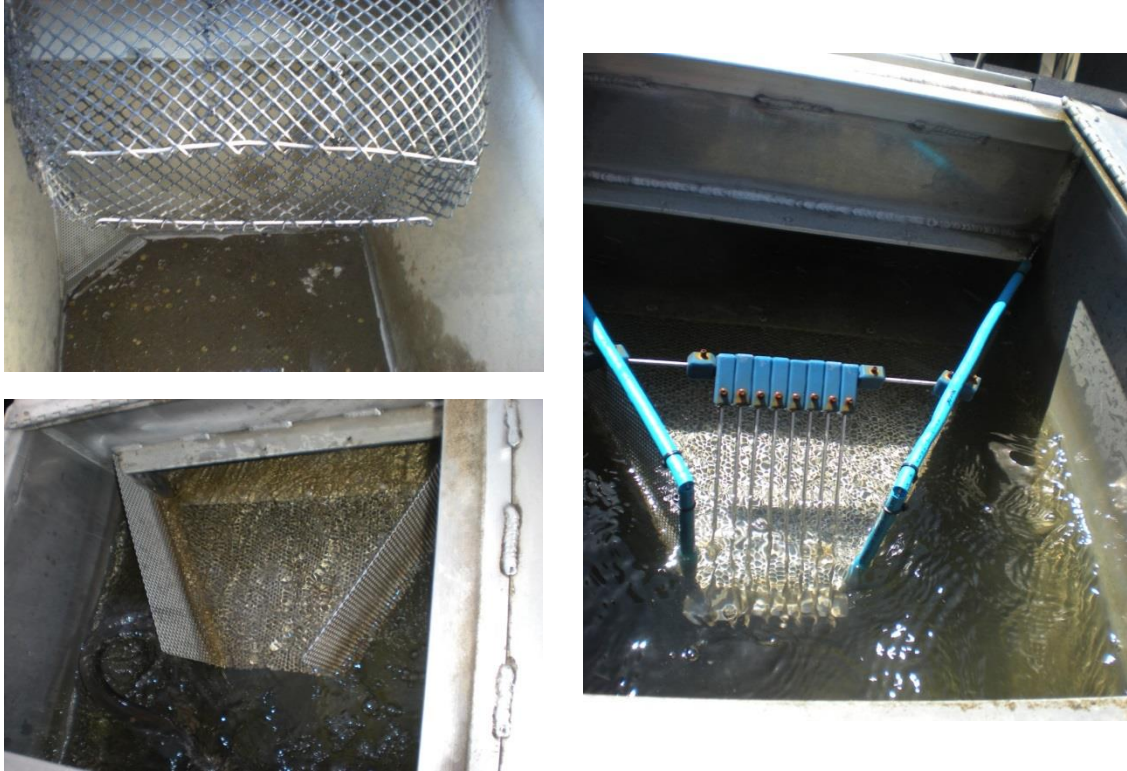
Figure C4. Examples of different fyke entry designs for rest boxes in the Cascades Island LPS.

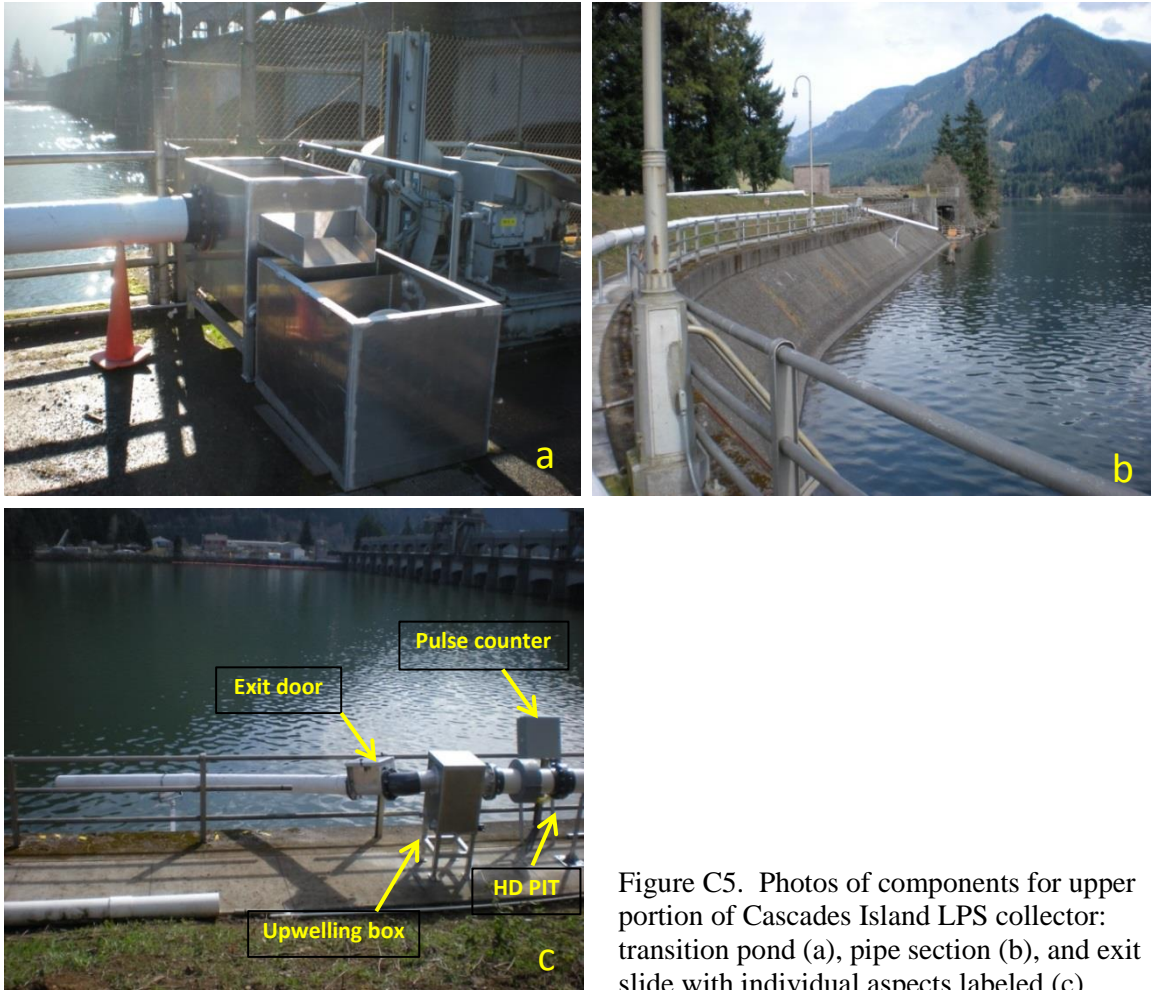
Figure C5. Photos of components for upper portion of Cascades Island LPS collector: transition pond (a), pipe section (b), and exit slide with individual aspects labeled (c).

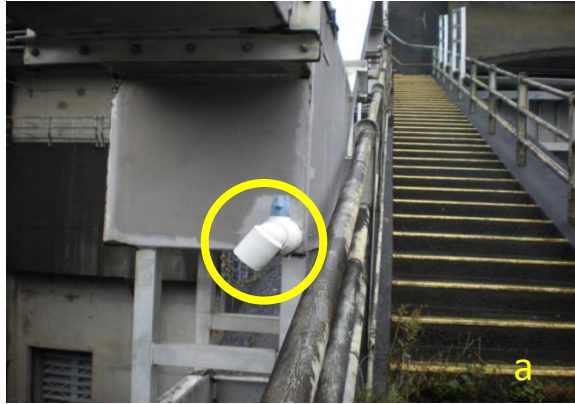
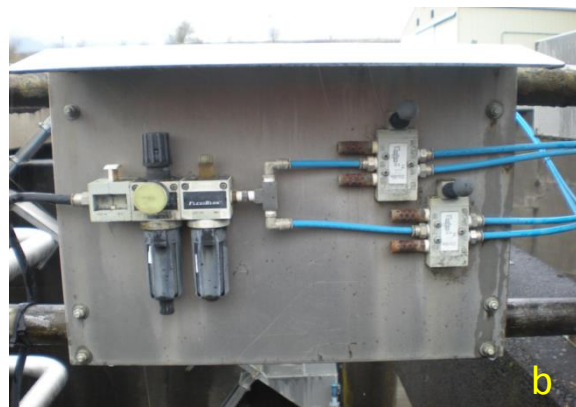
Figure C6. Discharge valves at rest boxes are mostly PVC ball valves at accessible boxes (a). Remote hydraulic purge valves for Rest Boxes 1 and 2 have controls at the deck (b).

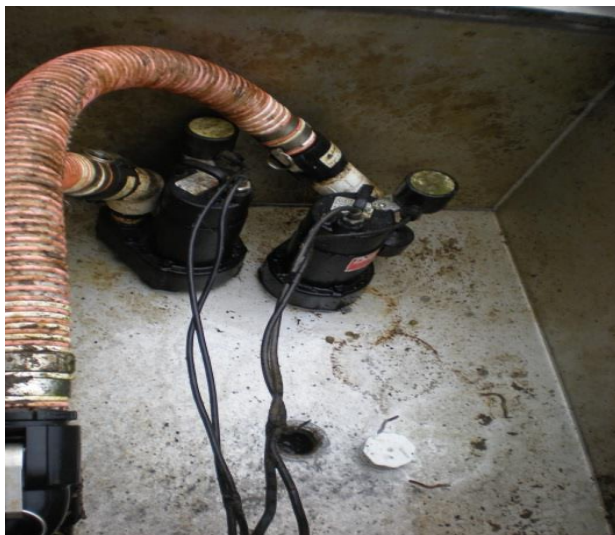
Figure C7. Upstream transition pond showing pumps and unplugged drain in reservoir at Cascades Island LPS.

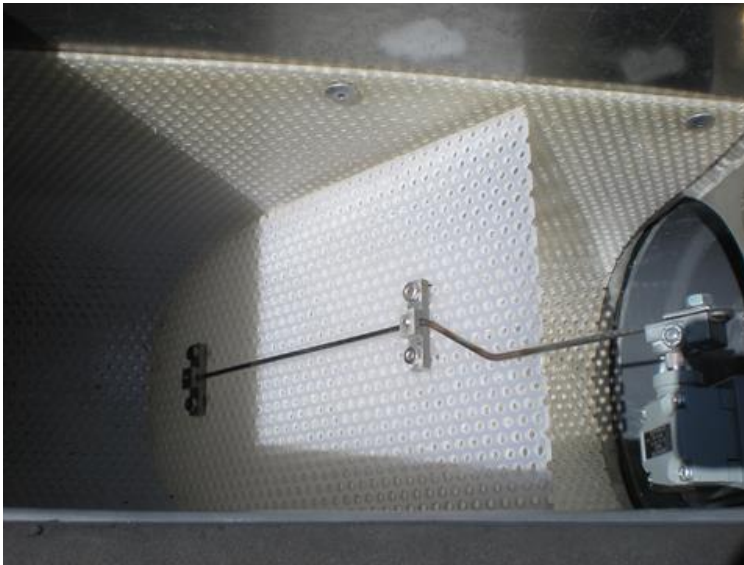
Figure C8. Cascades Island exit slide passage estimation paddle door, arm, and limit switch.

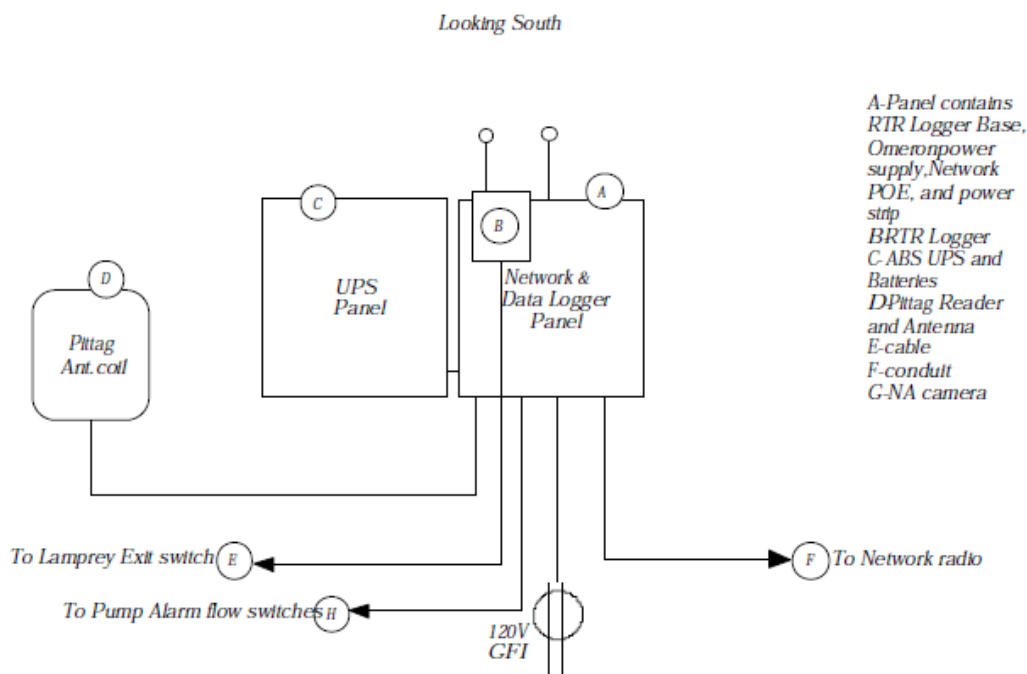
Figure C9. Electrical wiring diagram for Cascades Island LPS electrical panel.
