MCNARY SPILLWAY STATUS

FPOM
January 2023

MCNARY SPILLWAY

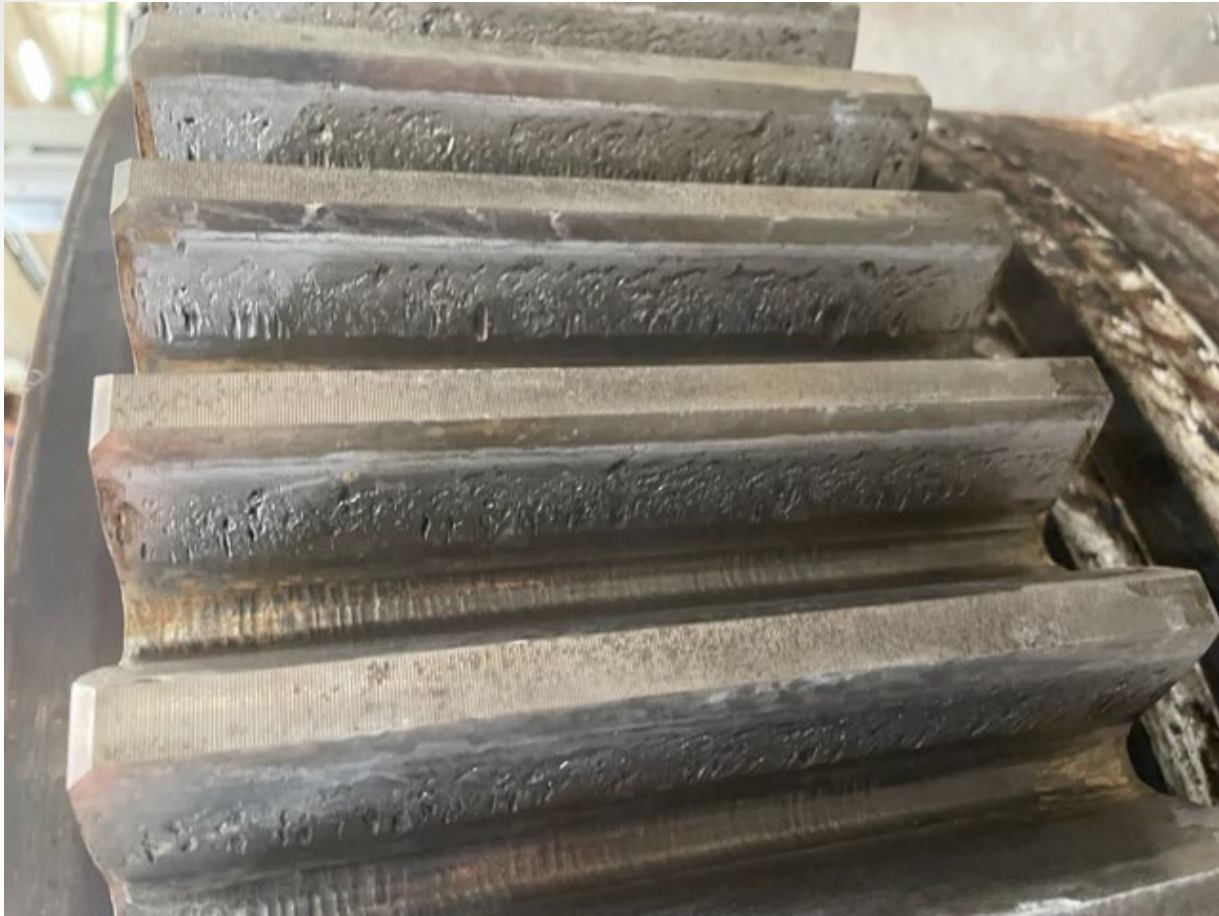
Pitted north drum gear

- 2022, Hoist #6 failed, gears showed severe pitting due to material fatigue from high contact stresses, replaced with hoist from bay #16. Bay #16 RTS after about three month outage.
Hoist #15 OOS for one week for repairs
Hoist #20 taken OOS for repairs
Hoist #21 gearbox coupler failed and brakes failed during closure causing gate to fall on sill

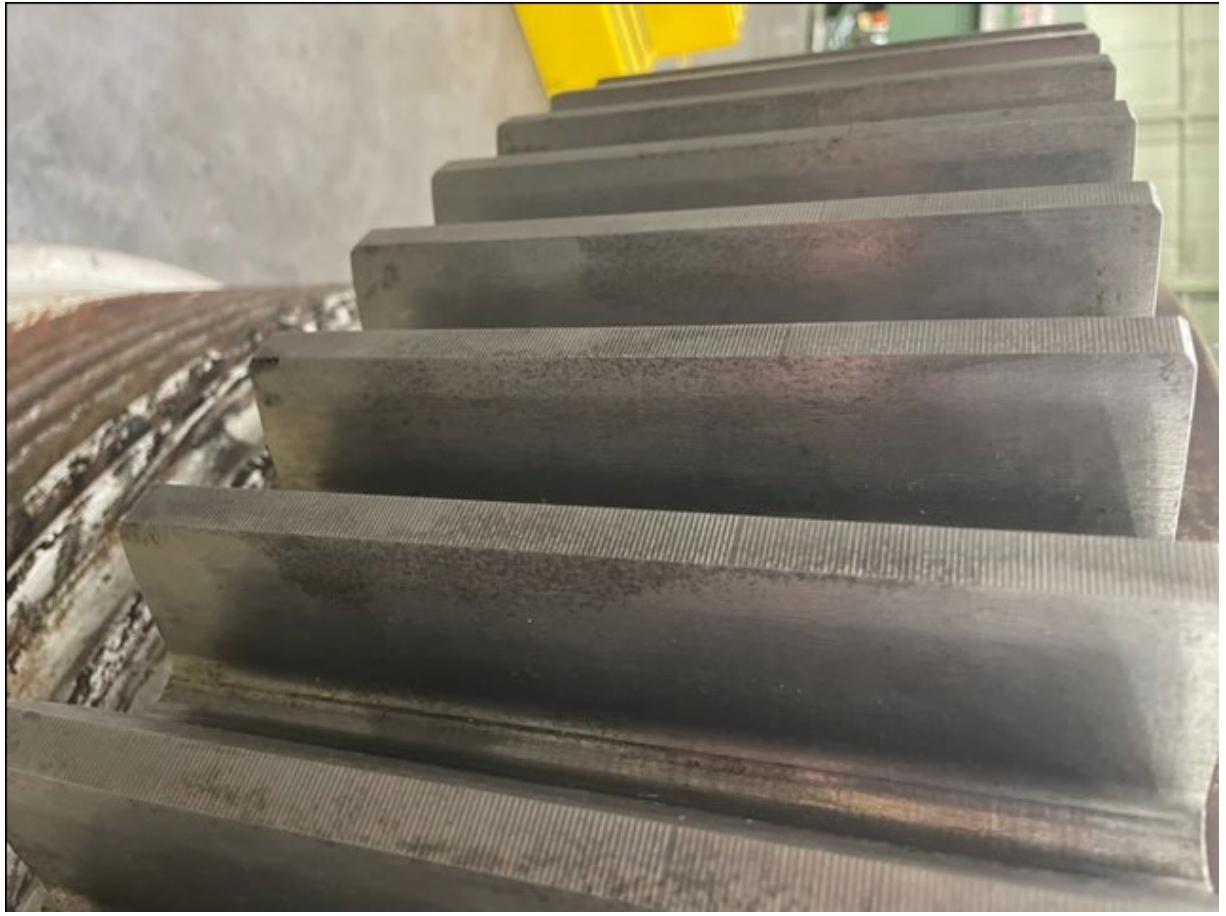
Unworn gear

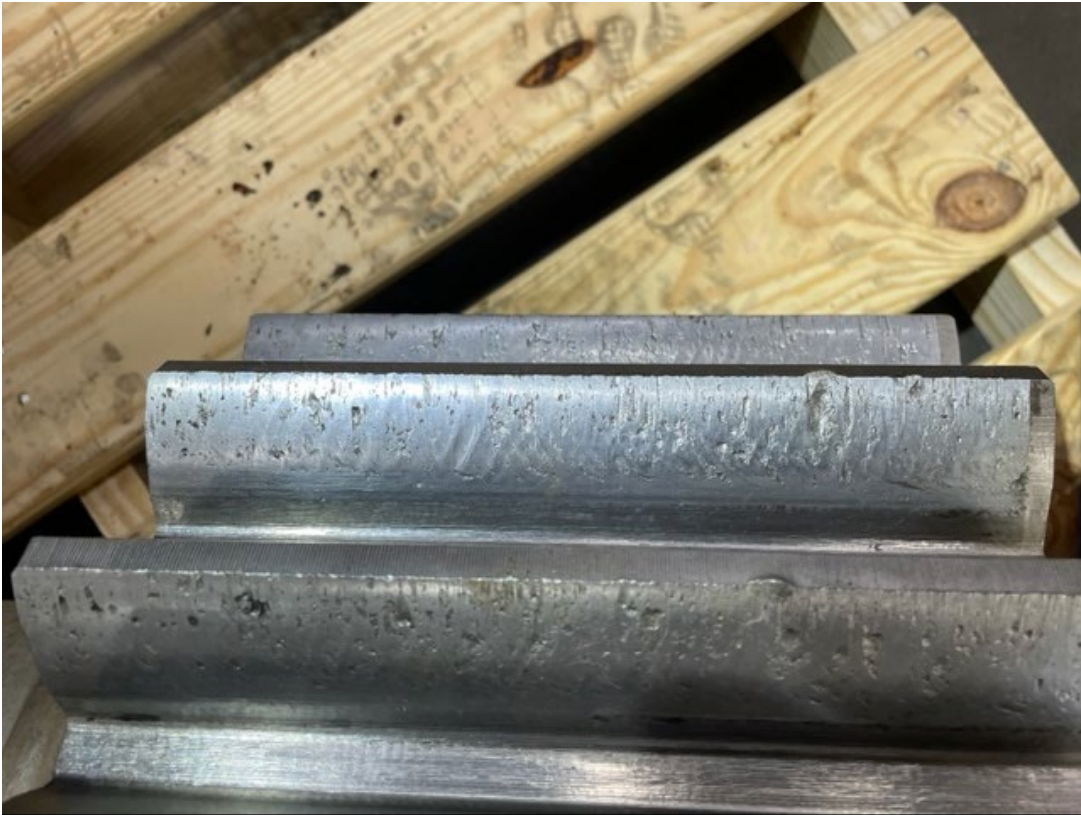
Pitting on south pinion gear
