MCNARY SPILLWAY STATUS

FPOM
12 December 2024

MCNARY SPILLWAY

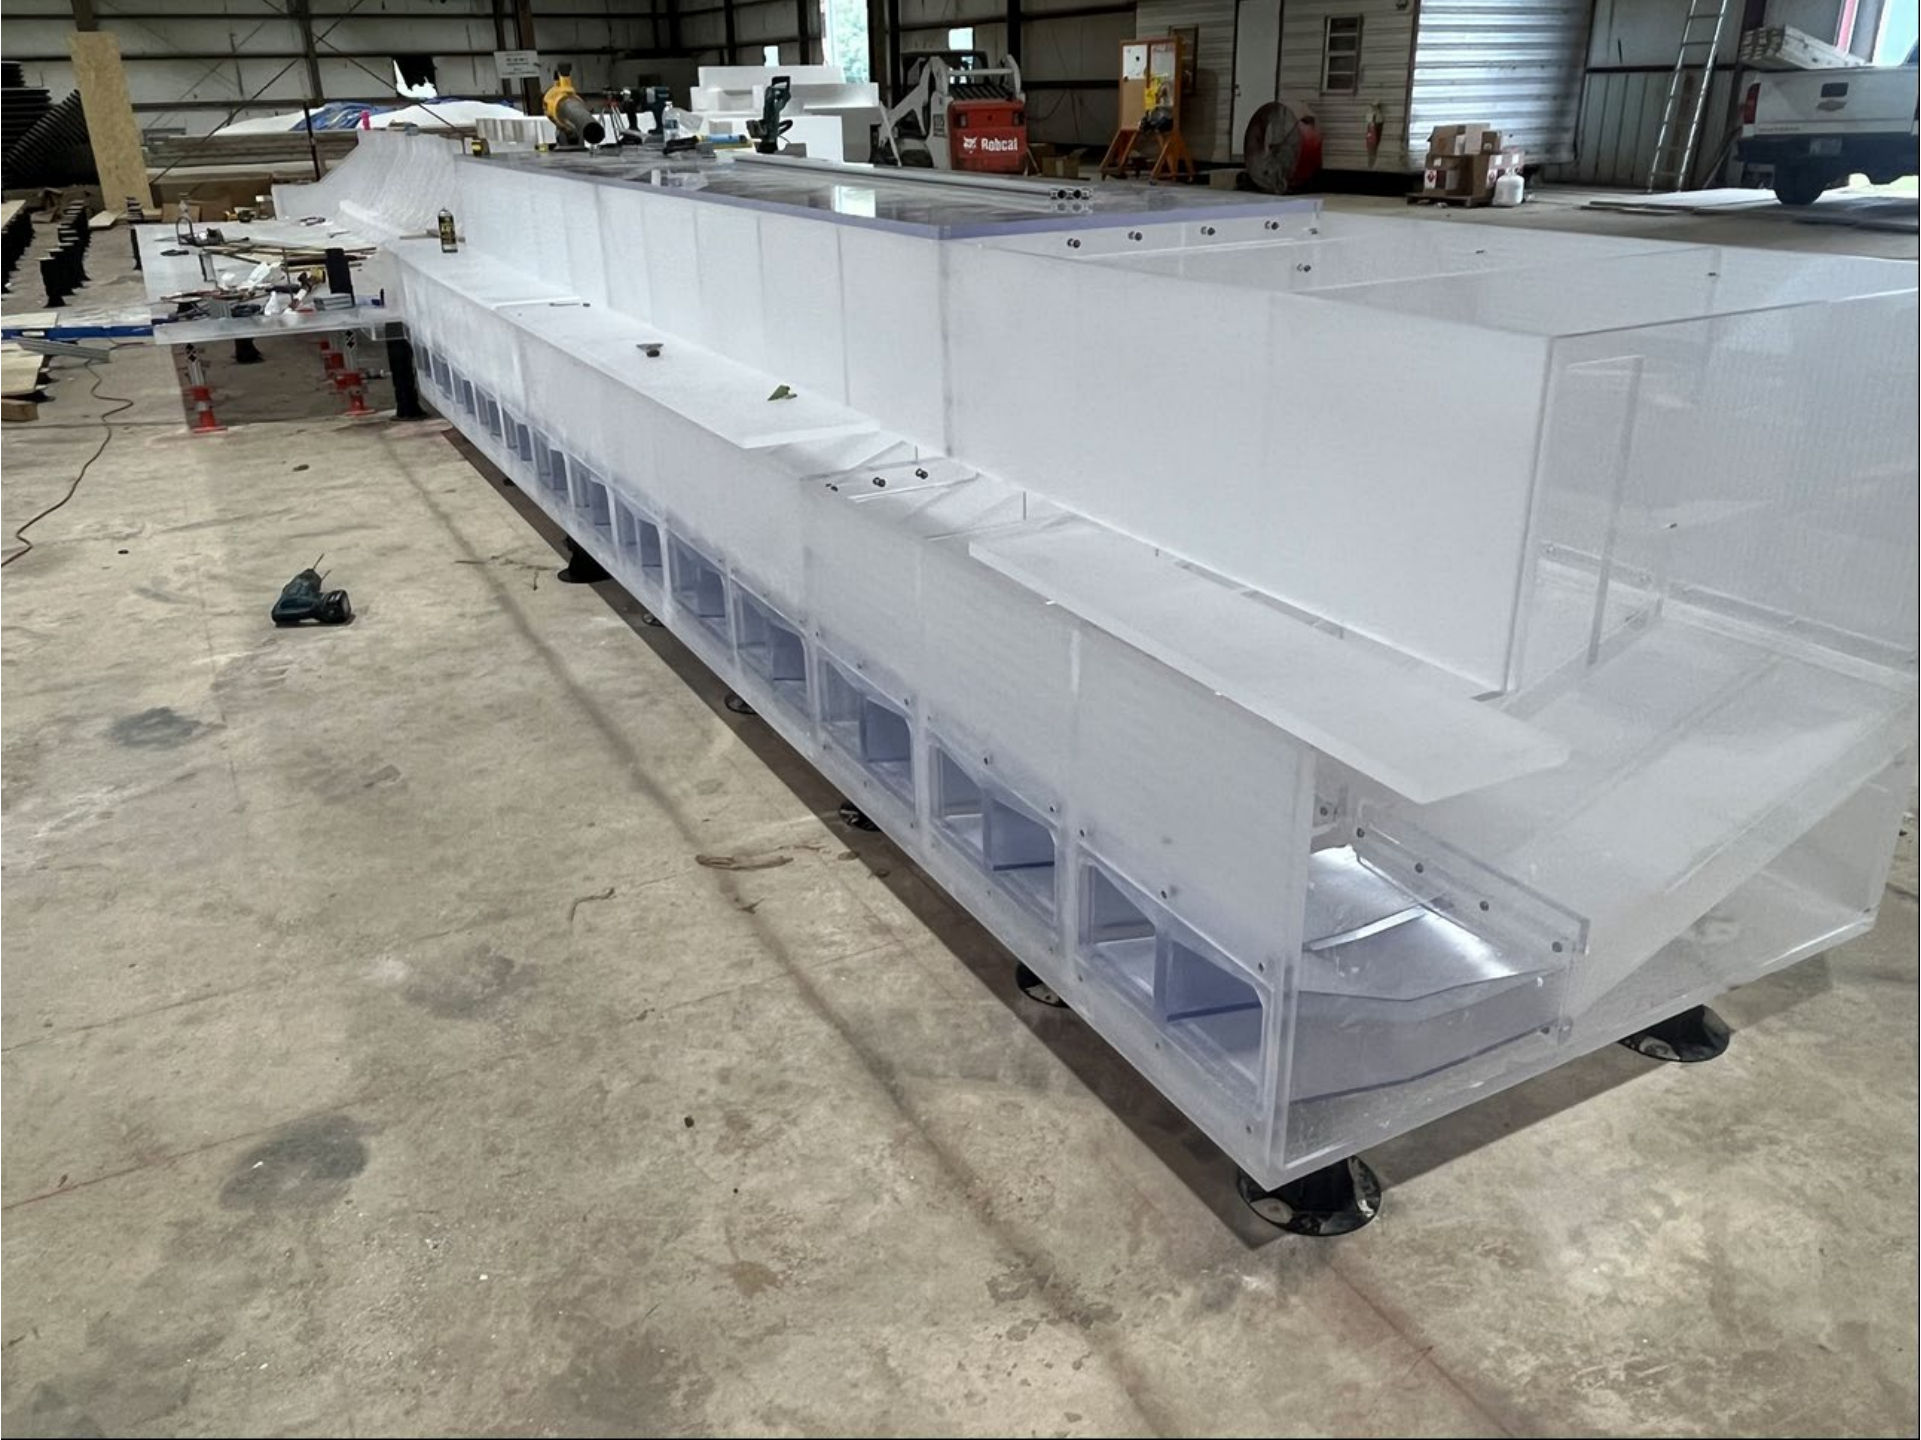
Figure 2. Mounted powerhouse mechanisms.

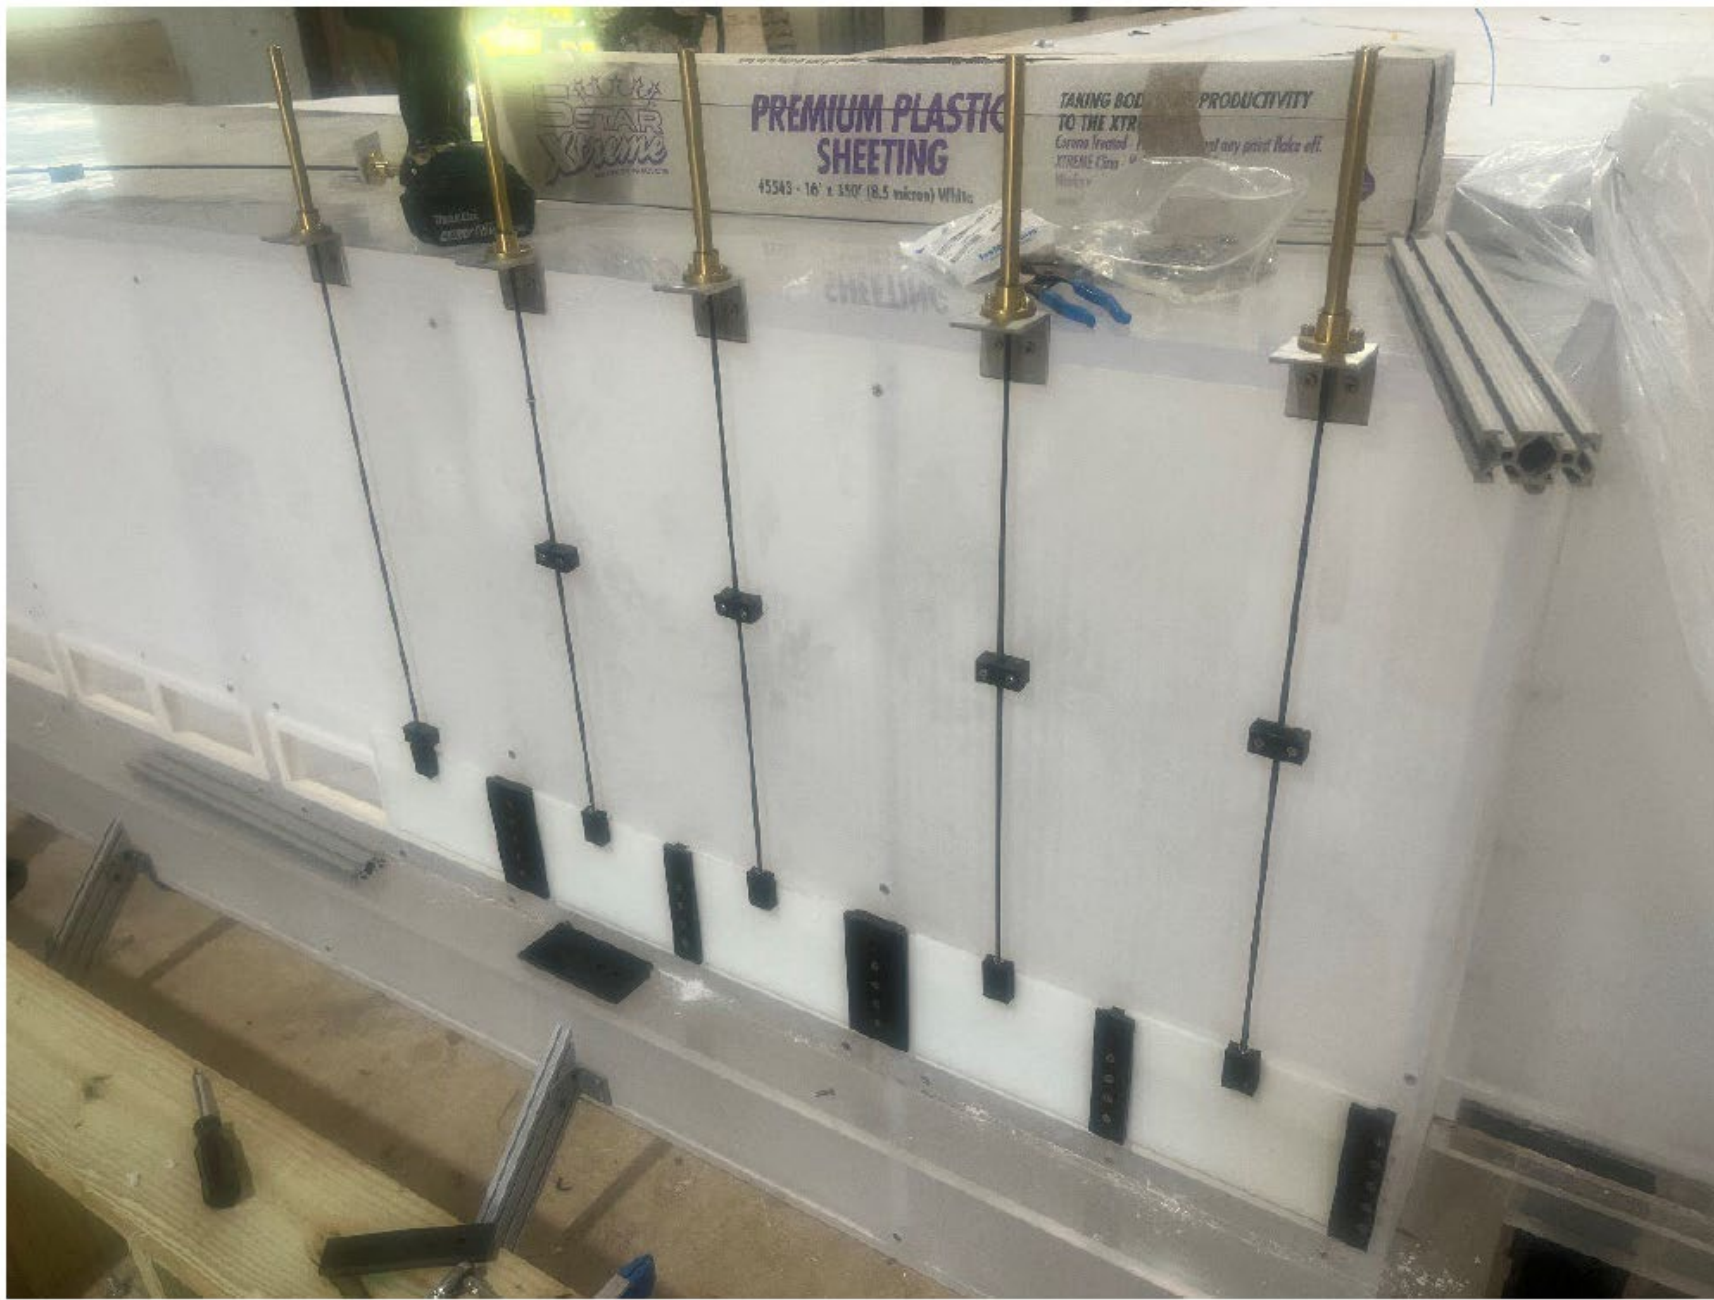
Figure 3. Repurposed gates from original McNary physical model.

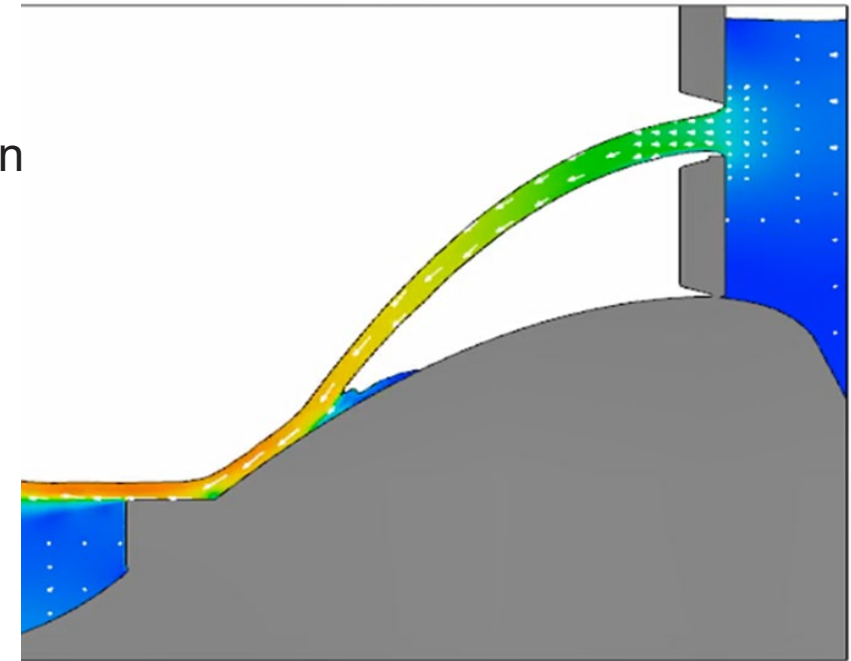
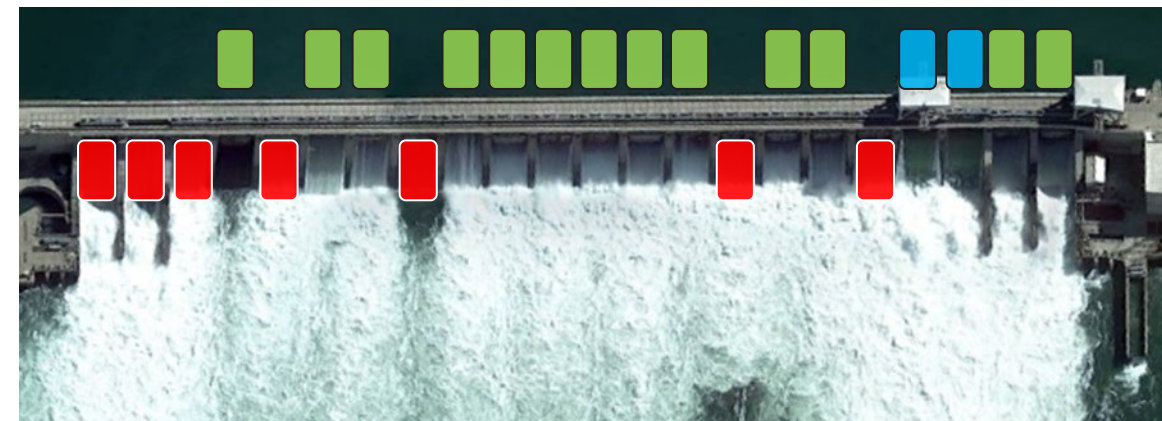
Move 13 gates and hoists to upstream slot and use in split leaf configuration

Retain 7 gates in downstream slot closed in full gate configuration

■ Split-leaf upstream slot
 ■ TSW
 ■ Full gate downstream slot

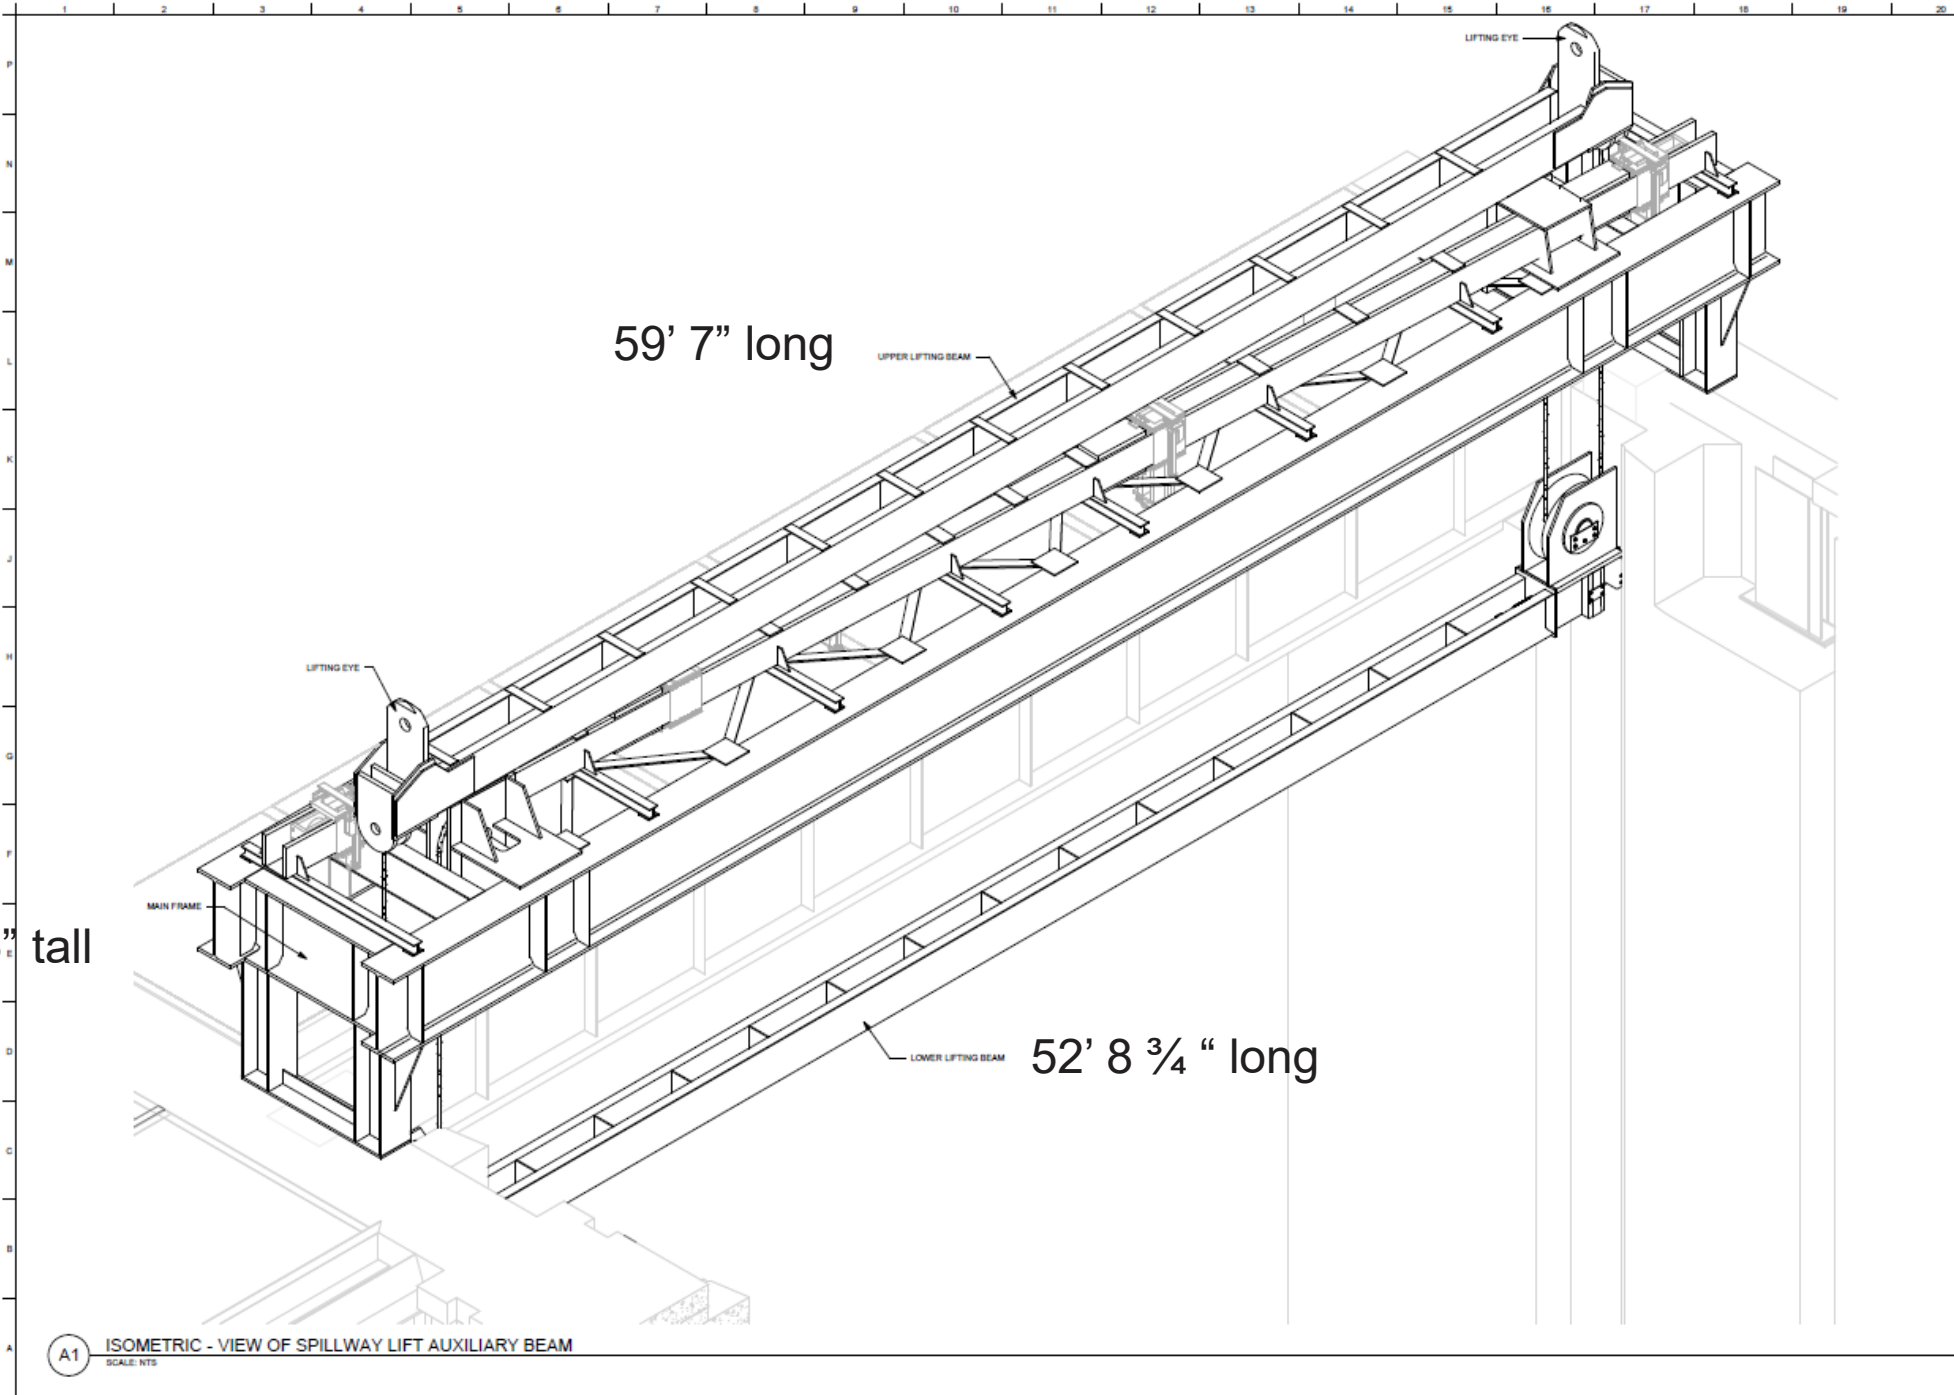
A1 ISOMETRIC - VIEW OF SPILLWAY LIFT AUXILIARY BEAM
SCALE: NTS

59' 7" long

UPPER LIFTING BEAM

LIFTING EYE

MAIN FRAME

LOWER LIFTING BEAM

52' 8 3/4 " long

7' 6 11/16" tall

- Purchase new SLABs to allow use of spillway cranes without overloading (**PRIORITY**)
- Reduces spillway gate load from the spillway cranes and allows spillway crane operation within acceptable load limits

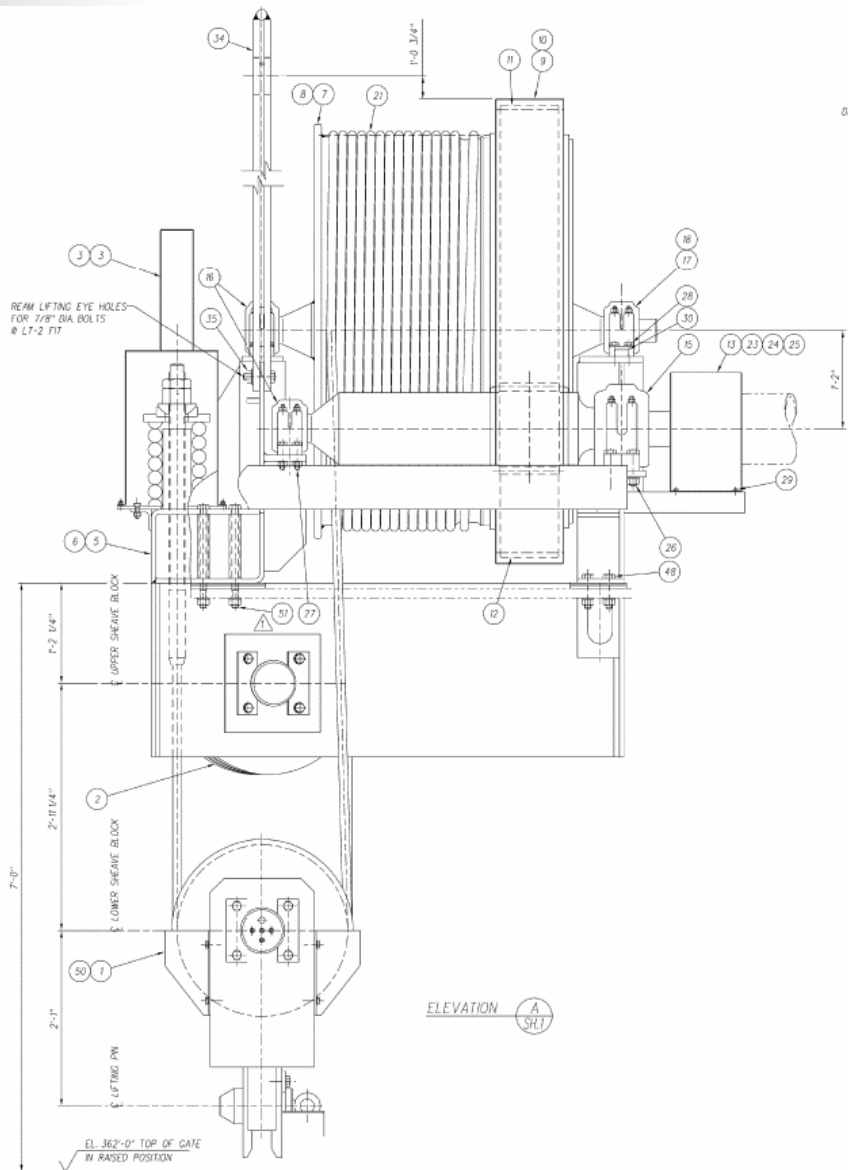
ELEVATION A

Old Hoist Design

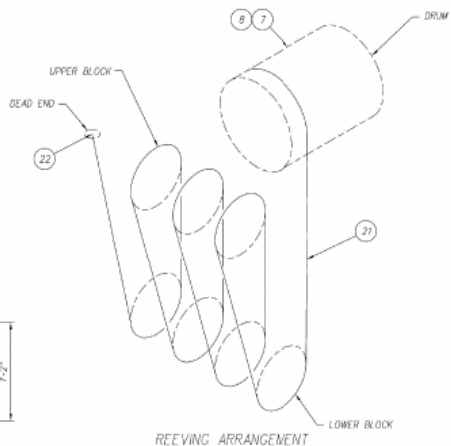
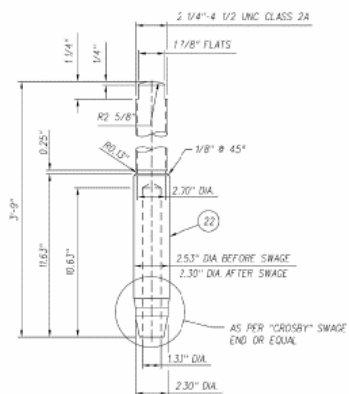
DEAD END SWAGED WIRE ROPE FITTING

CUSTOM MADE BY "CROSBY" OR EQUAL FORGED FROM SPECIAL BAR QUALITY CARBON STEEL, SUITABLE FOR COLD FORMING. HARDNESS CONTROLLED BY SPHEROIDIZE ANNEALING EFFICIENCY RATING TO BE 100% BASED ON THE CATALOG STRENGTH OF THE WIRE ROPE PROOF LOAD IN ACCORDANCE WITH AISI830.9

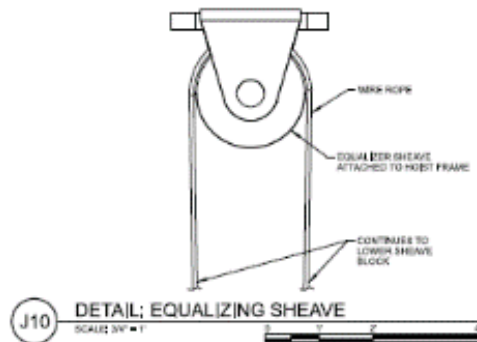
J10 DETAIL: EQUALIZING SHEAVE
SCALE: 3/4" = 1"

New Hoist Design

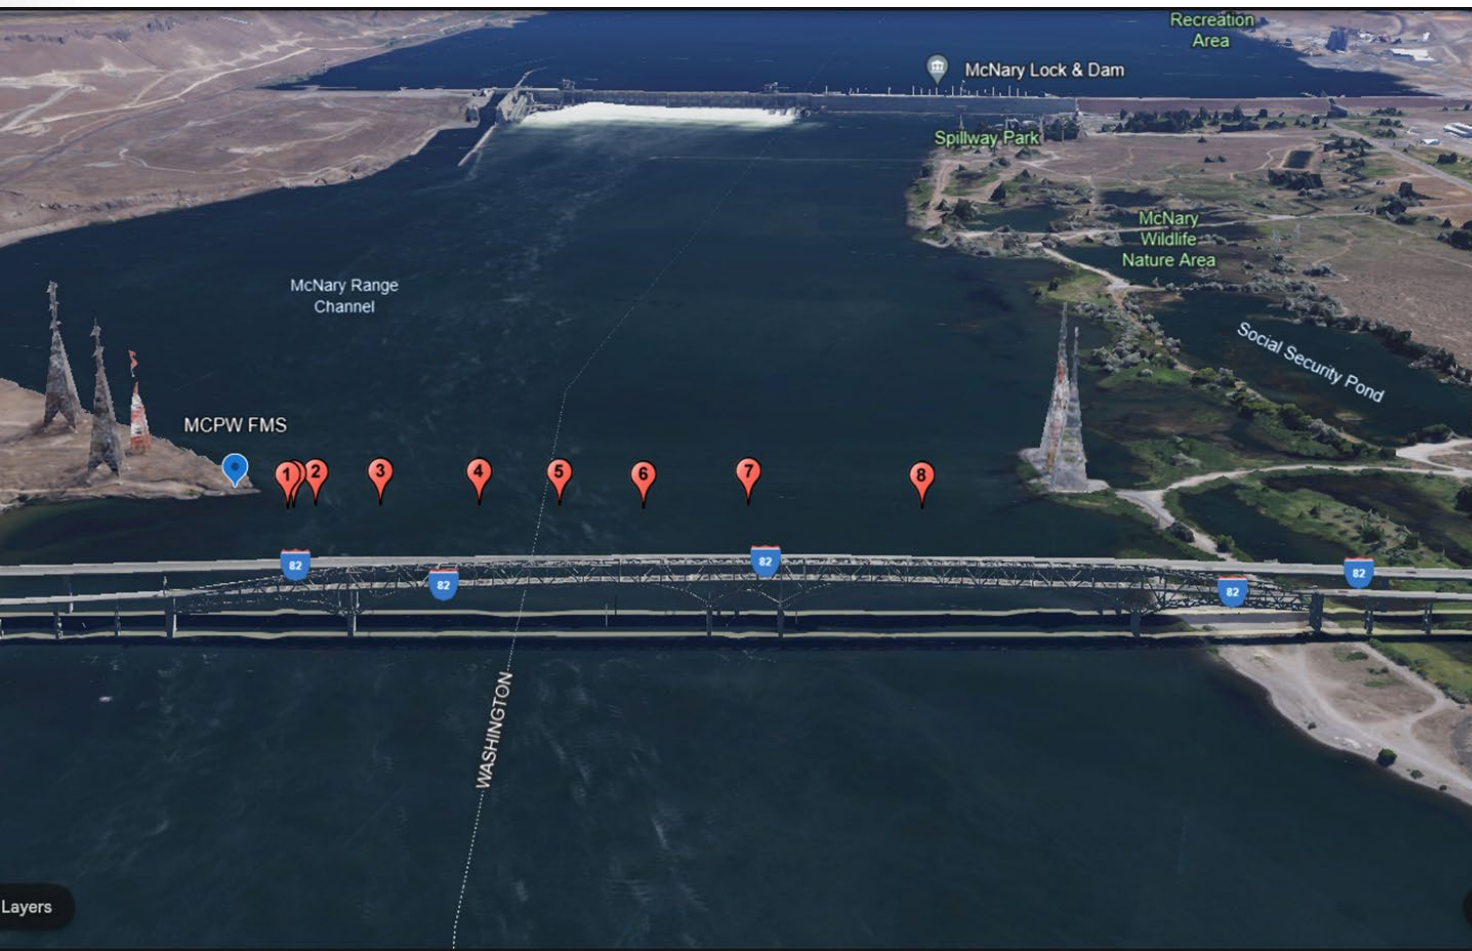
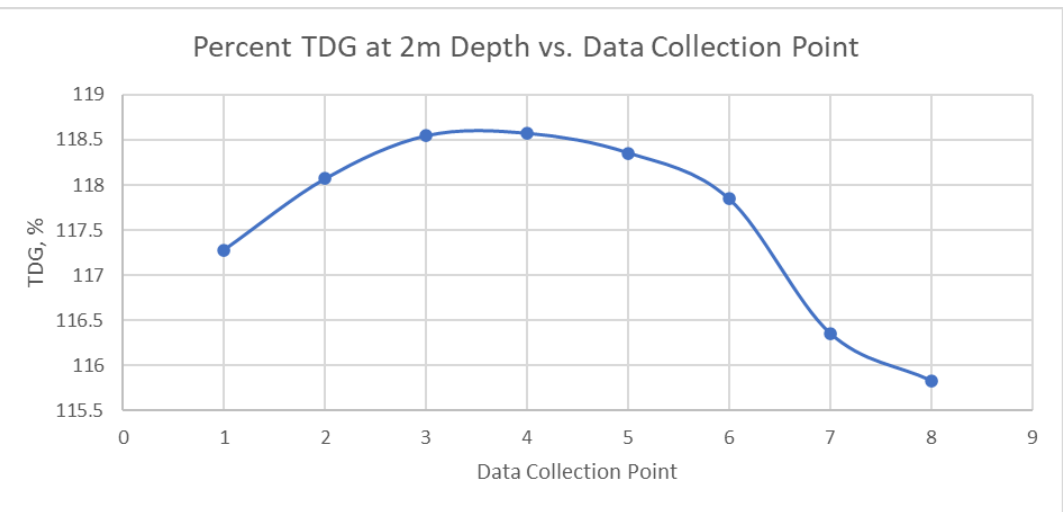
TDG Results Table							
Date	Time UTC	Air Pressure	TDG	Depth	TDG	Field Notes	
MM/dd/yyyy	hh:mm:ss	mmHg	mmHg	ft	%		
4/16/2024	18:00:00	761.0	894	21.3	117.5	MCPW FMS reading: TDG = 117.4%, Depth = 19.0 ft	
4/16/2024	18:08:00	761.0	893	5.6	117.3	Point 1	
4/16/2024	18:22:00	761.0	899	6.1	118.1	Point 2	
4/16/2024	18:38:00	760.9	902	7.6	118.5	Point 3	
4/16/2024	19:50:00	760.3	902	6.1	118.6	Point 4	
4/16/2024	20:20:00	760.0	900	6.1	118.4	Point 5	
4/16/2024	20:48:00	759.9	896	6.6	117.8	Point 6	
4/16/2024	21:25:00	760.6	885	6.8	116.4	Point 7	Flow 174 kcfs
4/16/2024	21:52:00	759.3	880	6.5	115.8	Point 8	Spill 115 kcfs

TDG was measured and observed for each of the red pinpoints spanning the Columbia River below McNary Dam and upstream of the I-82 bridge. Points 1 through 8 represent the TDG measurements taken at approximately 6-ft depths. The red star pin represents the correlation measurement with the Fixed Monitoring Station (FMS) MCPW, taken at approximately 20-ft depth.

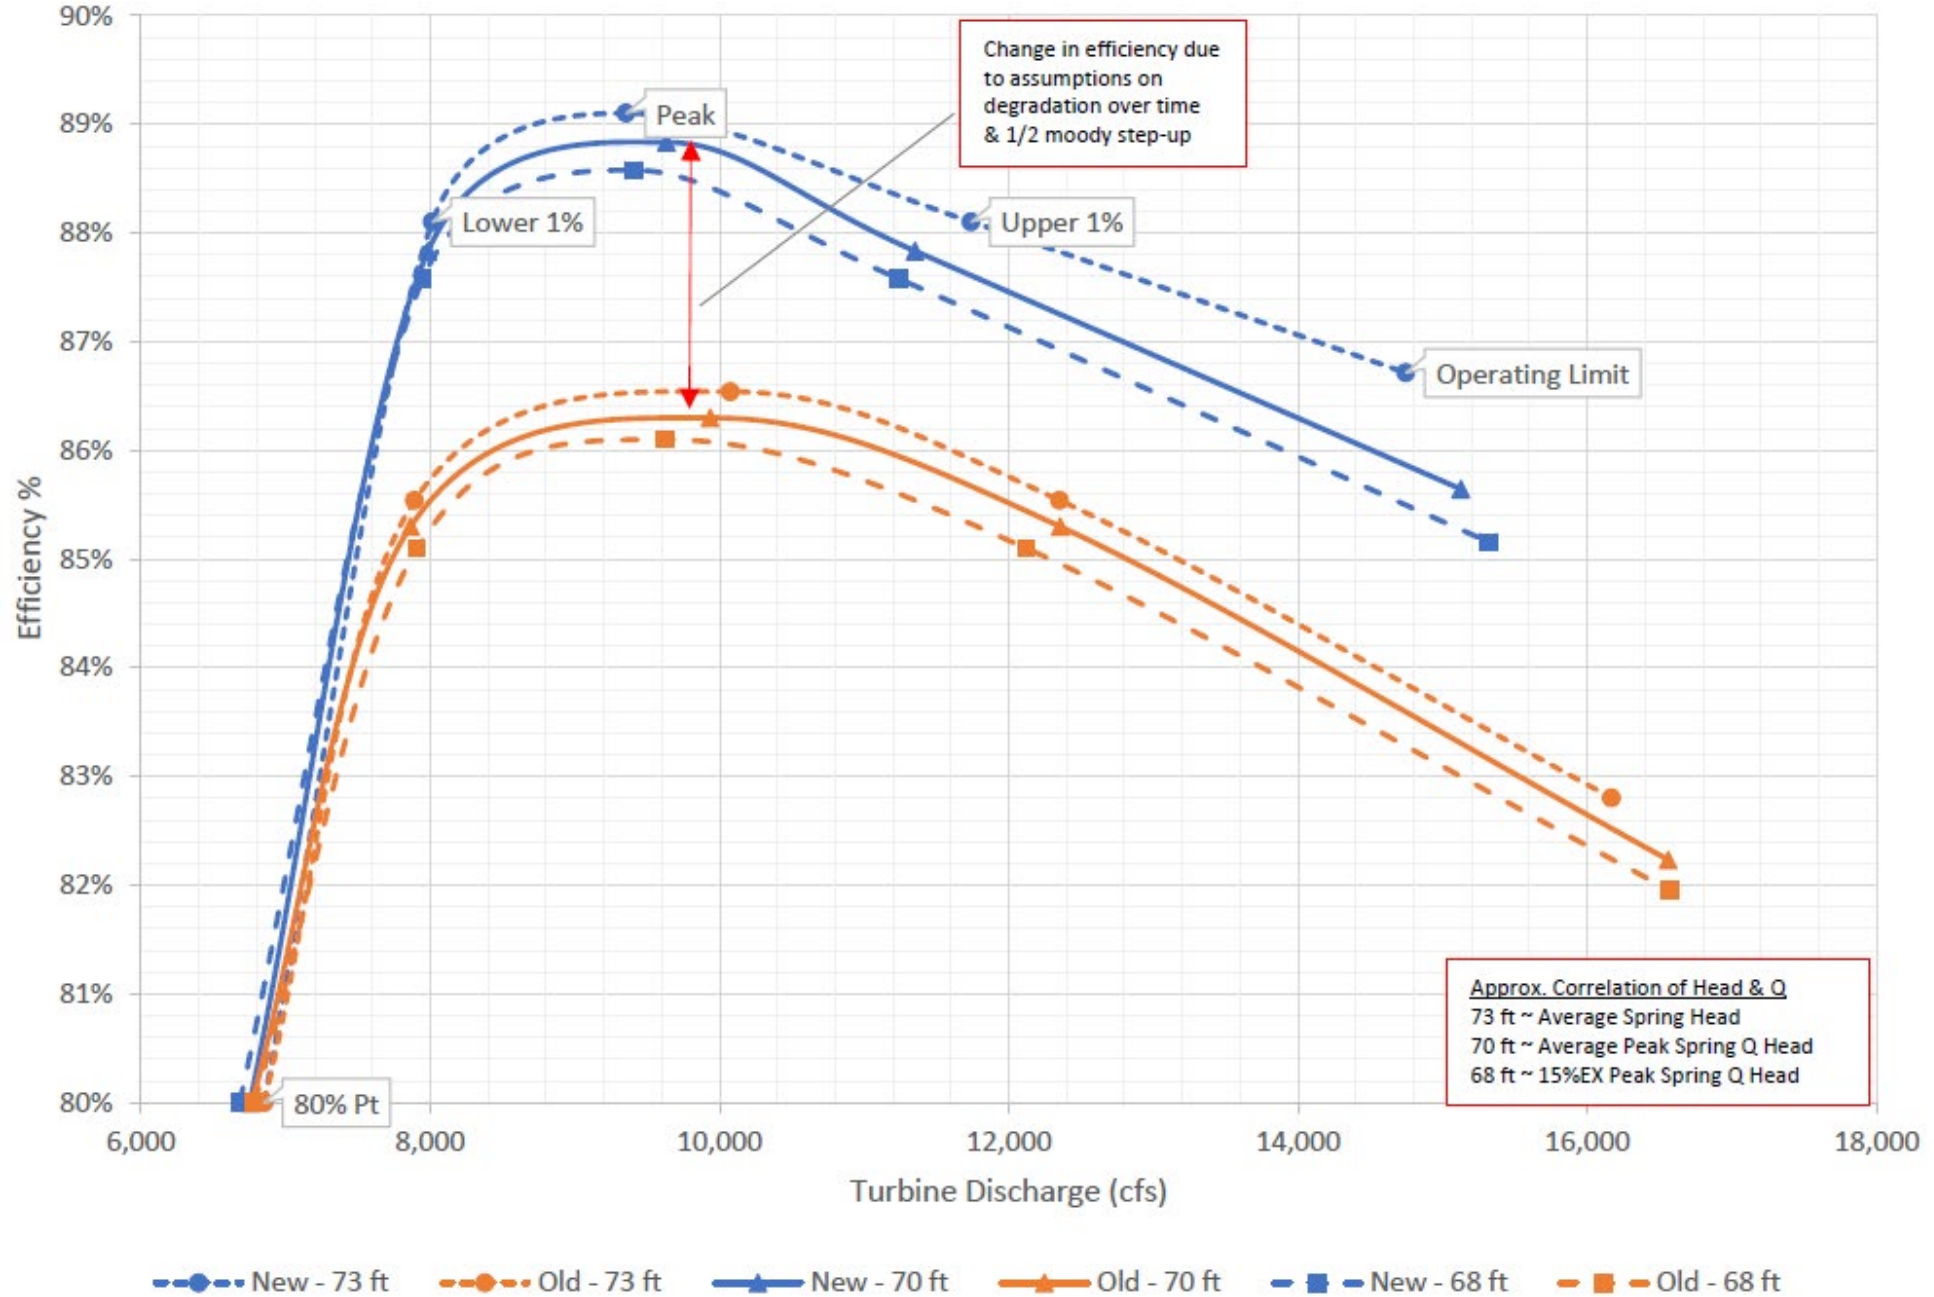
McNary Existing and Draft New Efficiency Curves
