# MCNARY SPILLWAY STATUS

FPOM  
26 September 2024

# MCNARY SPILLWAY

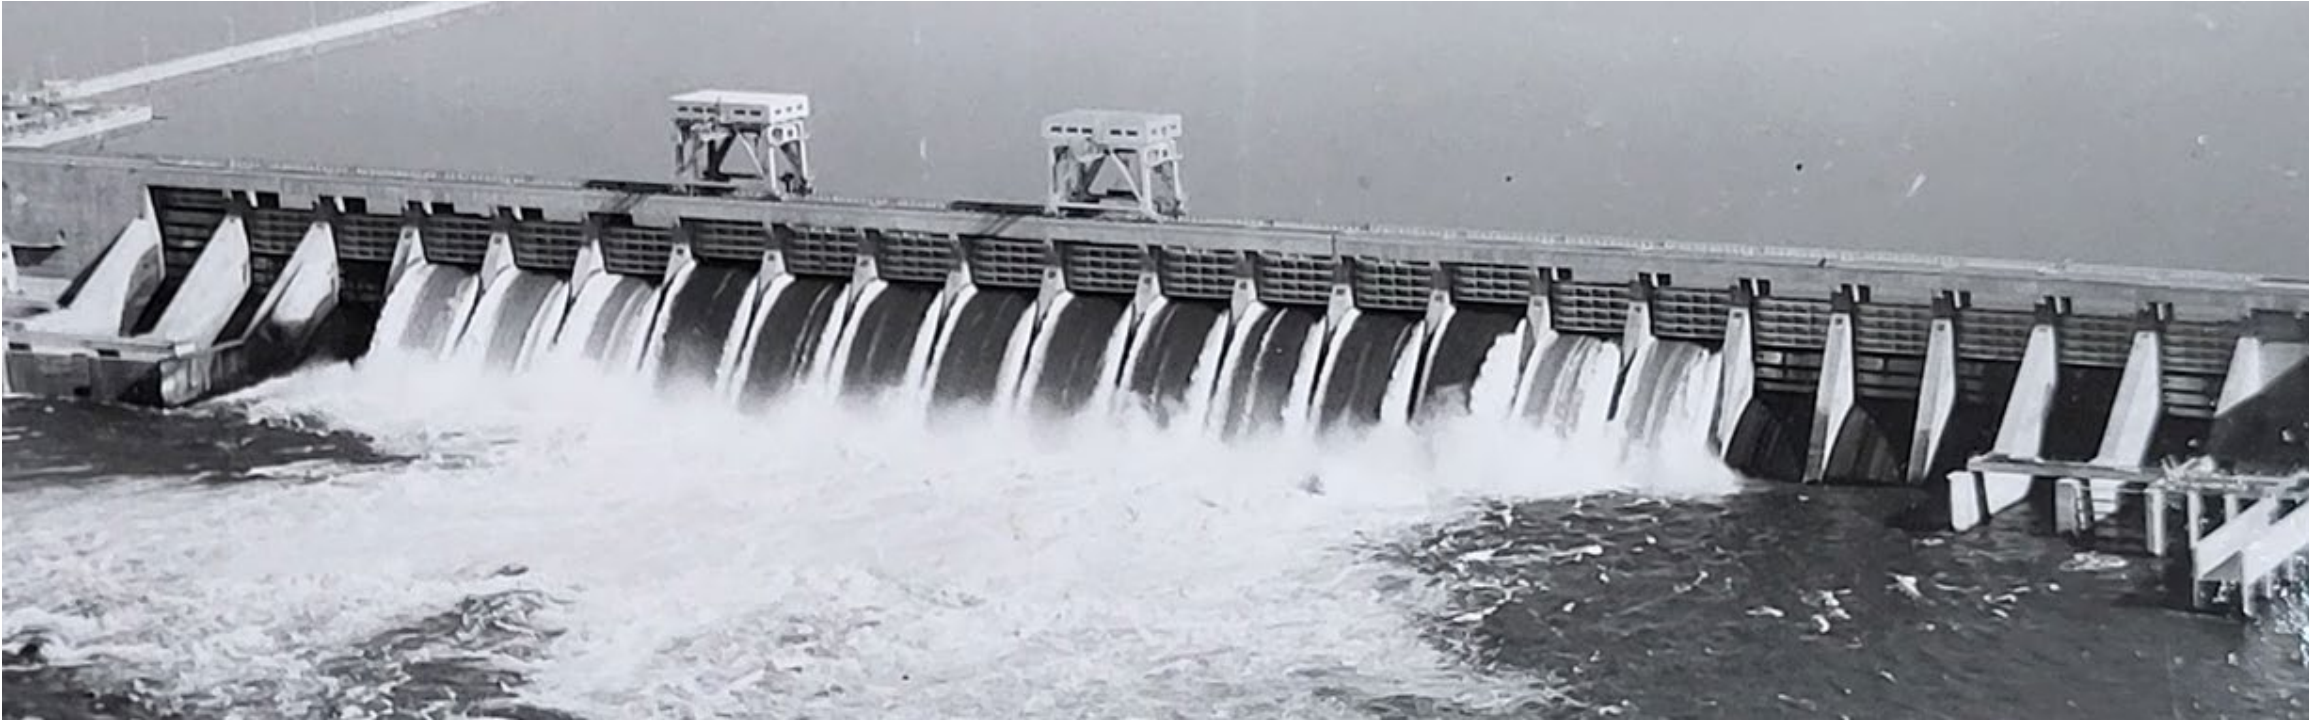
- Operational in 1954
- 22 Spillbays with double leaf vertical lift gates
- 2 Cranes (#6, #7) only initially,  
200 ton (400,000 lbs) capacity.  
Routinely operated gates in split leaf

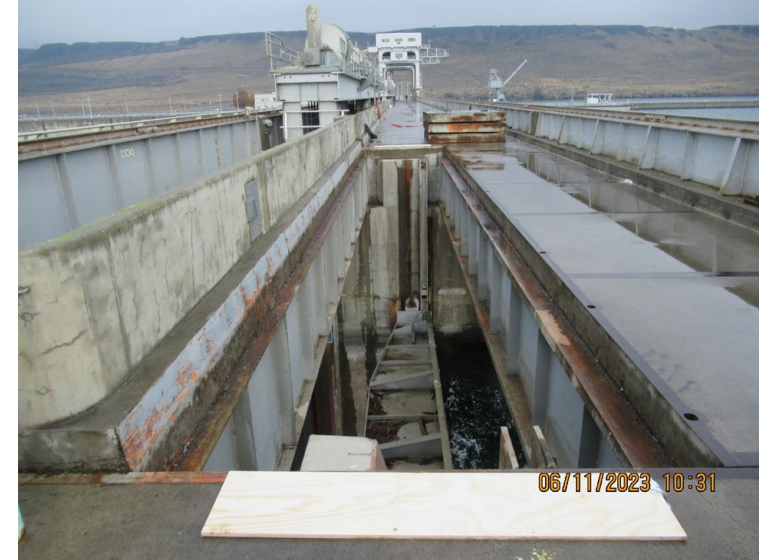
- Purchase new SLABs to allow use of spillway cranes without overloading (**PRIORITY**)
- Reduces spillway gate load from the spillway cranes and allows spillway crane operation within acceptable load limits

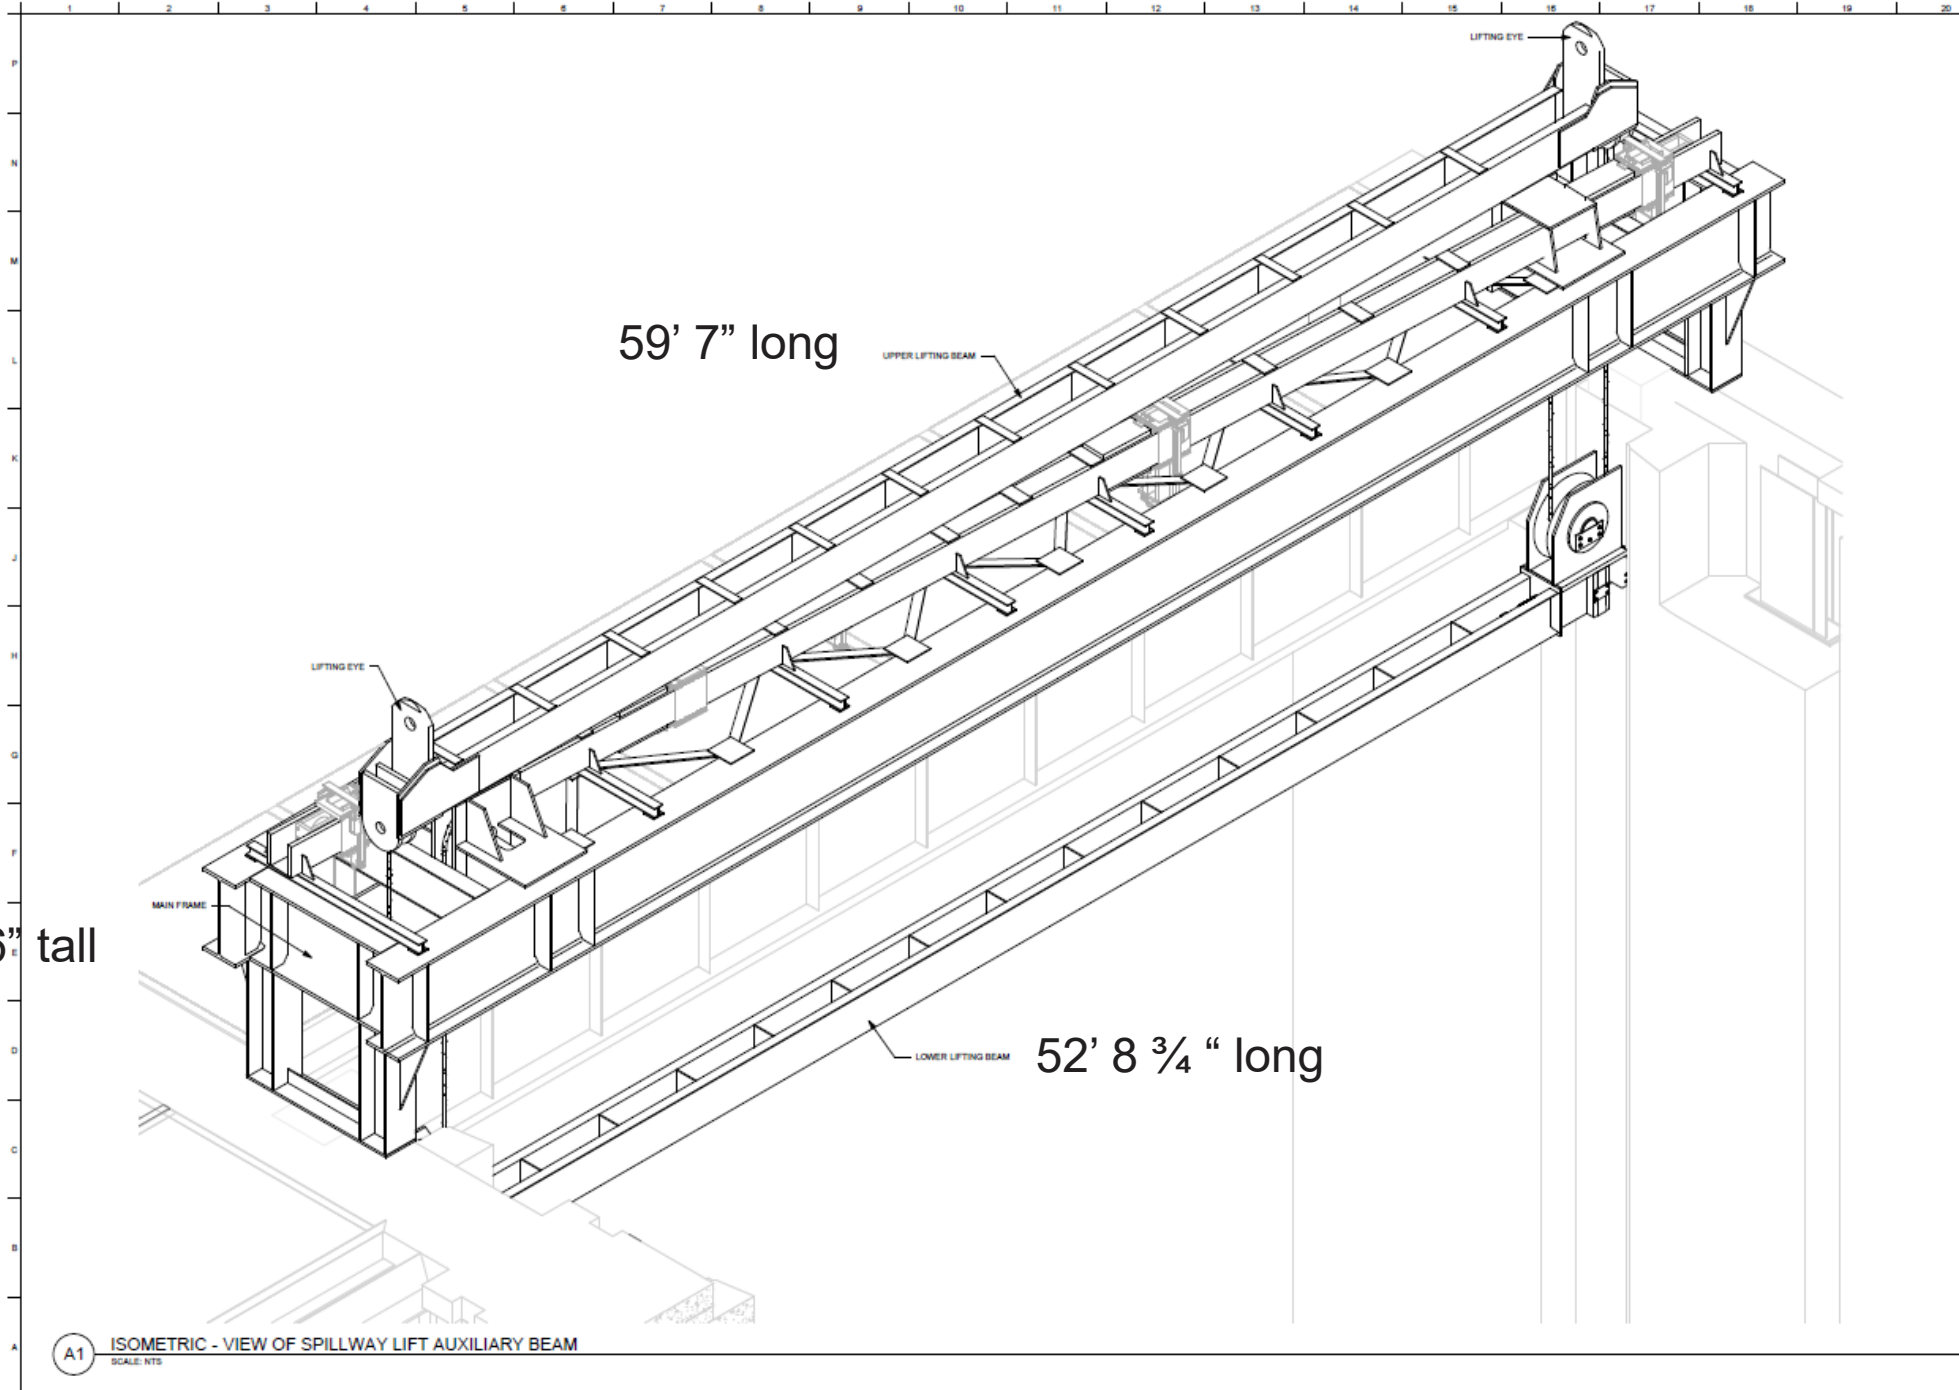
SHEET ID <b>G-004</b>
--------------------------

A1 ISOMETRIC - VIEW OF SPILLWAY LIFT AUXILIARY BEAM  
SCALE: NTS

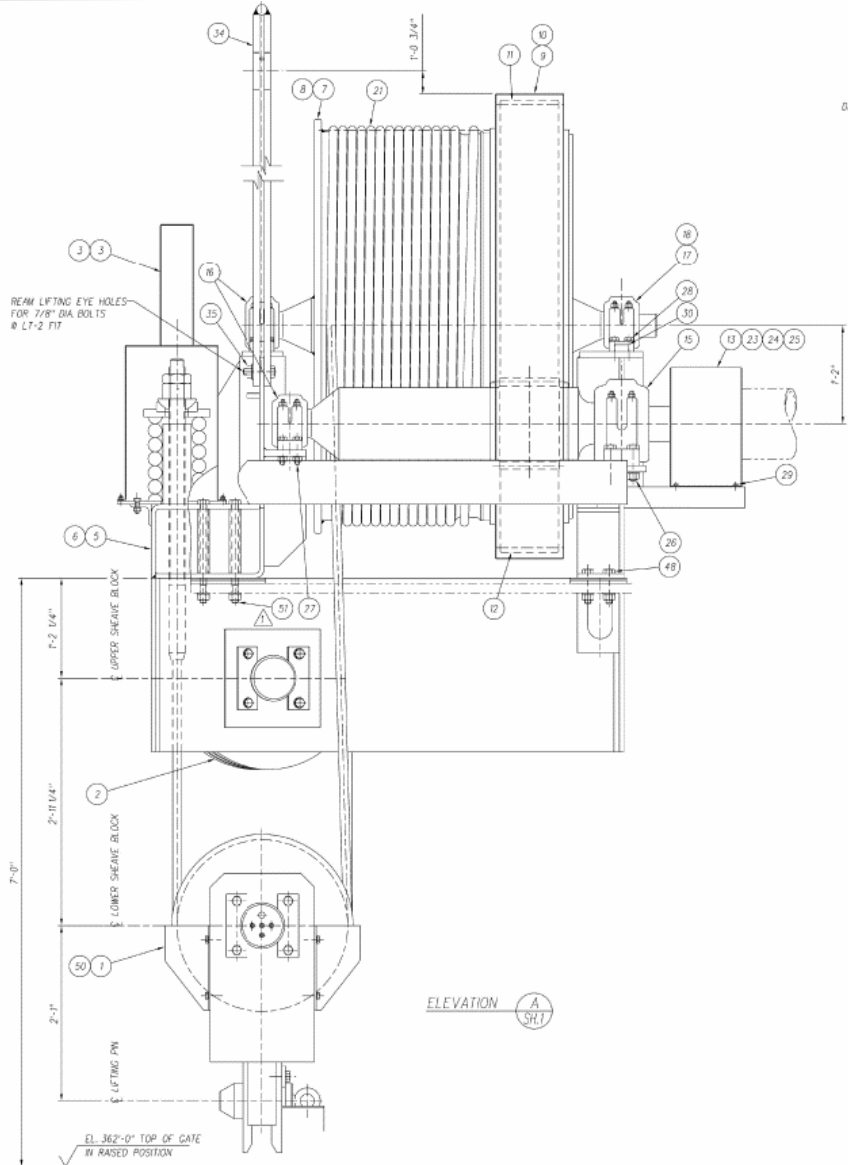
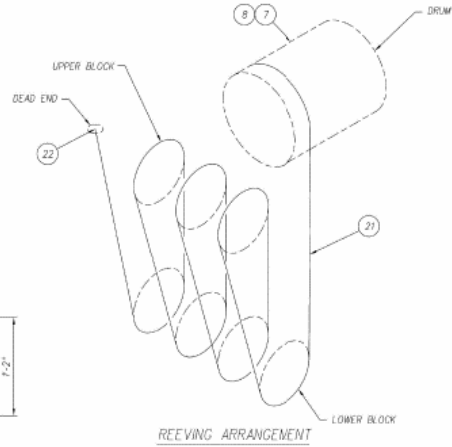
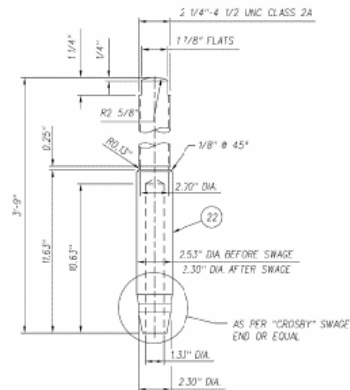
## Old Hoist Design

### DEAD END SWAGED WIRE ROPE FITTING

CUSTOM MADE BY "CROSBY" OR EQUAL FORGED FROM SPECIAL BAR QUALITY CARBON STEEL, SUITABLE FOR COLD FORMING. HARDNESS CONTROLLED BY SPHEROIDIZE ANNEALING EFFICIENCY RATING TO BE 100% BASED ON THE CATALOG STRENGTH OF THE WIRE ROPE PROOF LOAD IN ACCORDANCE WITH AISI830.9

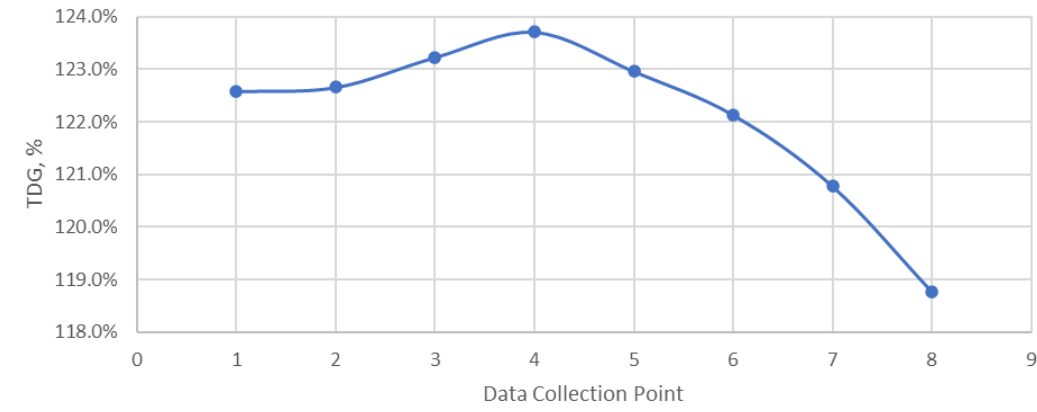
Percent TDG at 2m Depth vs. Data Collection Point

TDG Results Table						
Date	Time UTC	Air Pressure	TDG	Depth	TDG	Location Notes
MM/dd/yyyy	hh:mm:ss	mmHg	mmHg	ft	%	
6/10/2024	18:49:00	755	925	6.3	122.6%	Point 1 (same location as MCPW but at shallower depth)
6/10/2024	19:06:00	755	926	6.4	122.7%	Point 2
6/10/2024	19:25:00	754	930	6.3	123.2%	Point 3
6/10/2024	19:43:00	754	933	6.6	123.7%	Point 4
6/10/2024	20:19:00	754	927	5.9	123.0%	Point 5
6/10/2024	20:43:00	754	921	5.6	122.1%	Point 6
6/10/2024	21:04:00	754	910	6.3	120.8%	Point 7
6/10/2024	21:53:00	753	909	6.0	118.8%	Point 8
						<b>Flow 219 k</b>
						<b>Spill 159 k</b>

TDG was measured and observed for each of the red numbered pinpoints spanning the Columbia River below McNary Dam and upstream of the I-82 bridge. Points 1 through 8 represent the TDG measurements taken at approximately 6-ft (2m) depths.

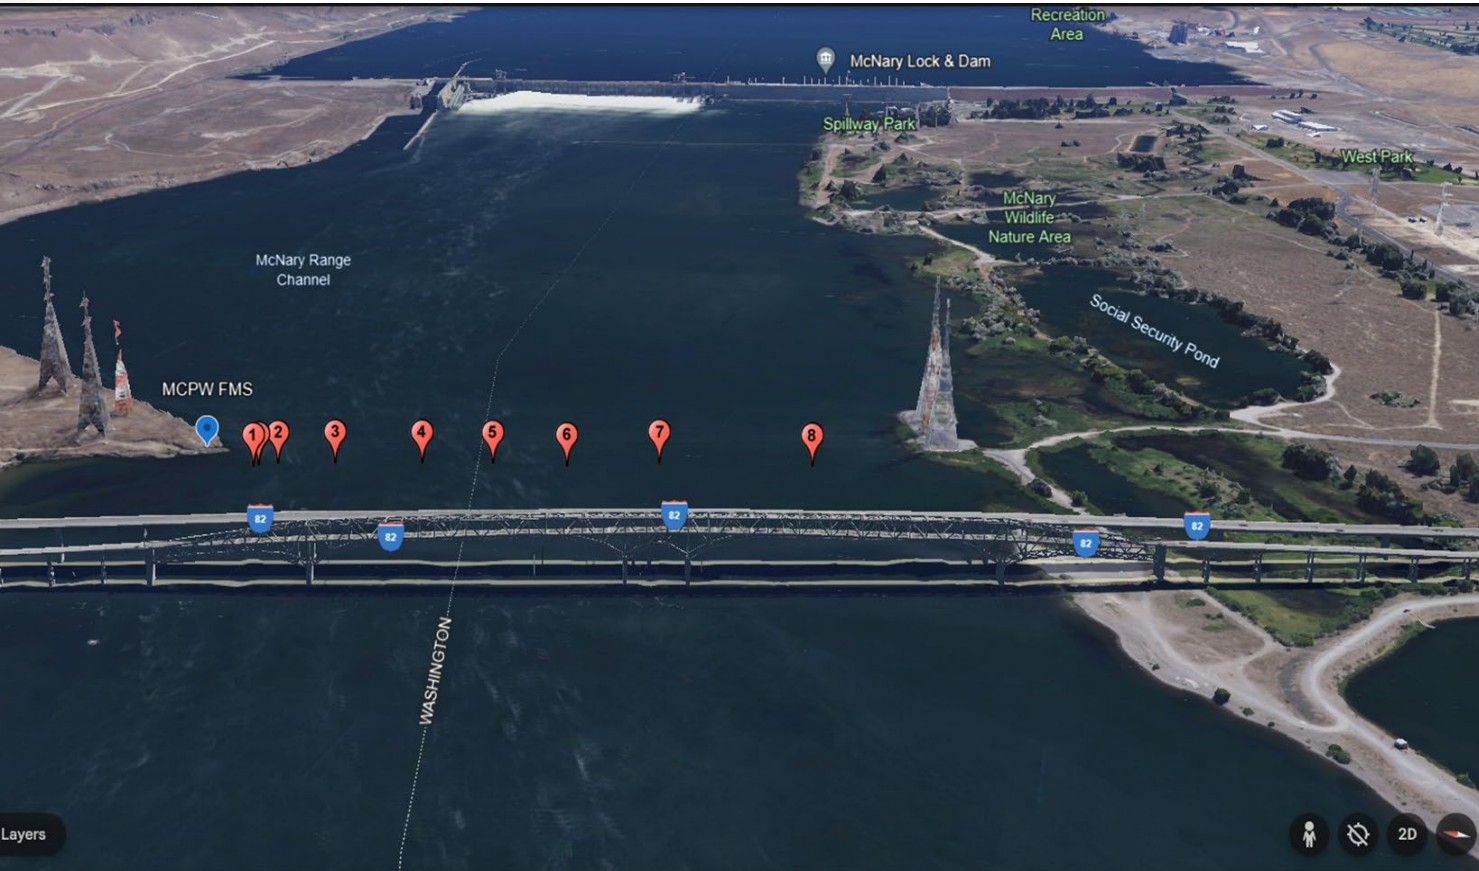
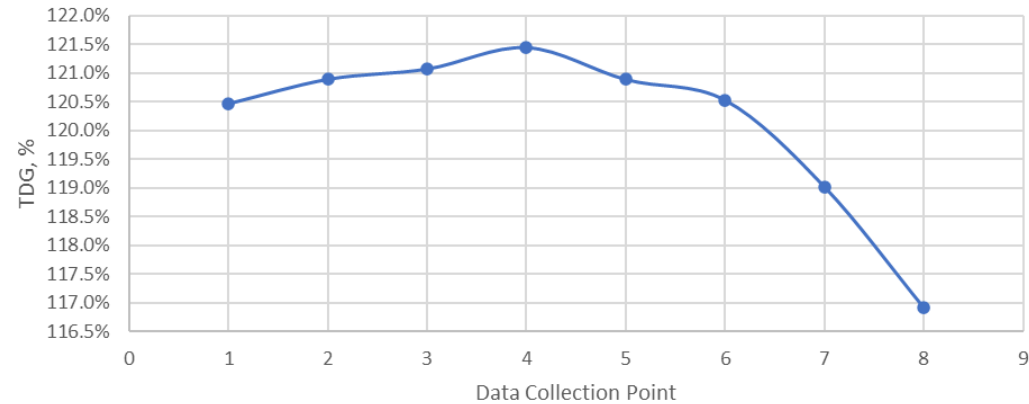
Percent TDG at 2m Depth vs. Data Collection Point

Date	Time UTC	Air Pressure	TDG	Depth	TDG	Location Notes
MM/dd/yyyy	hh:mm:ss	mmHg	mmHg	ft	%	
5/30/2024	17:08:00	762.6	919	18.2	120.5%	Correlation to MCPW. FMS readings: TDG = 120.7%, Depth = 19.0 ft
5/30/2024	17:46:00	762.4	919	6.8	120.5%	Point 1
5/30/2024	18:10:00	762.2	922	6.0	120.9%	Point 2
5/30/2024	18:36:00	761.9	923	5.7	121.1%	Point 3
5/30/2024	19:50:00	761.2	925	6.1	121.5%	Point 4
5/30/2024	20:16:00	761	920	5.8	120.9%	Point 5
5/30/2024	20:36:00	760.8	917	6.0	120.5%	Point 6
5/30/2024	21:18:00	760.4	905	5.4	119.0%	Point 7
5/30/2024	21:50:00	760	889	6.0	116.9%	Point 8

**Flow 204 kcfs**  
**Spill 144 kcfs**

TDG was measured and observed for each of the red pinpoints spanning the Columbia River below McNary Dam and upstream of the I-82 bridge. Points 1 through 8 represent the TDG measurements taken at approximately 6-ft (2m) depths. The red star pin represents the correlation measurement with the Fixed Monitoring Station (FMS) MCPW, taken at approximately 19-ft depth.

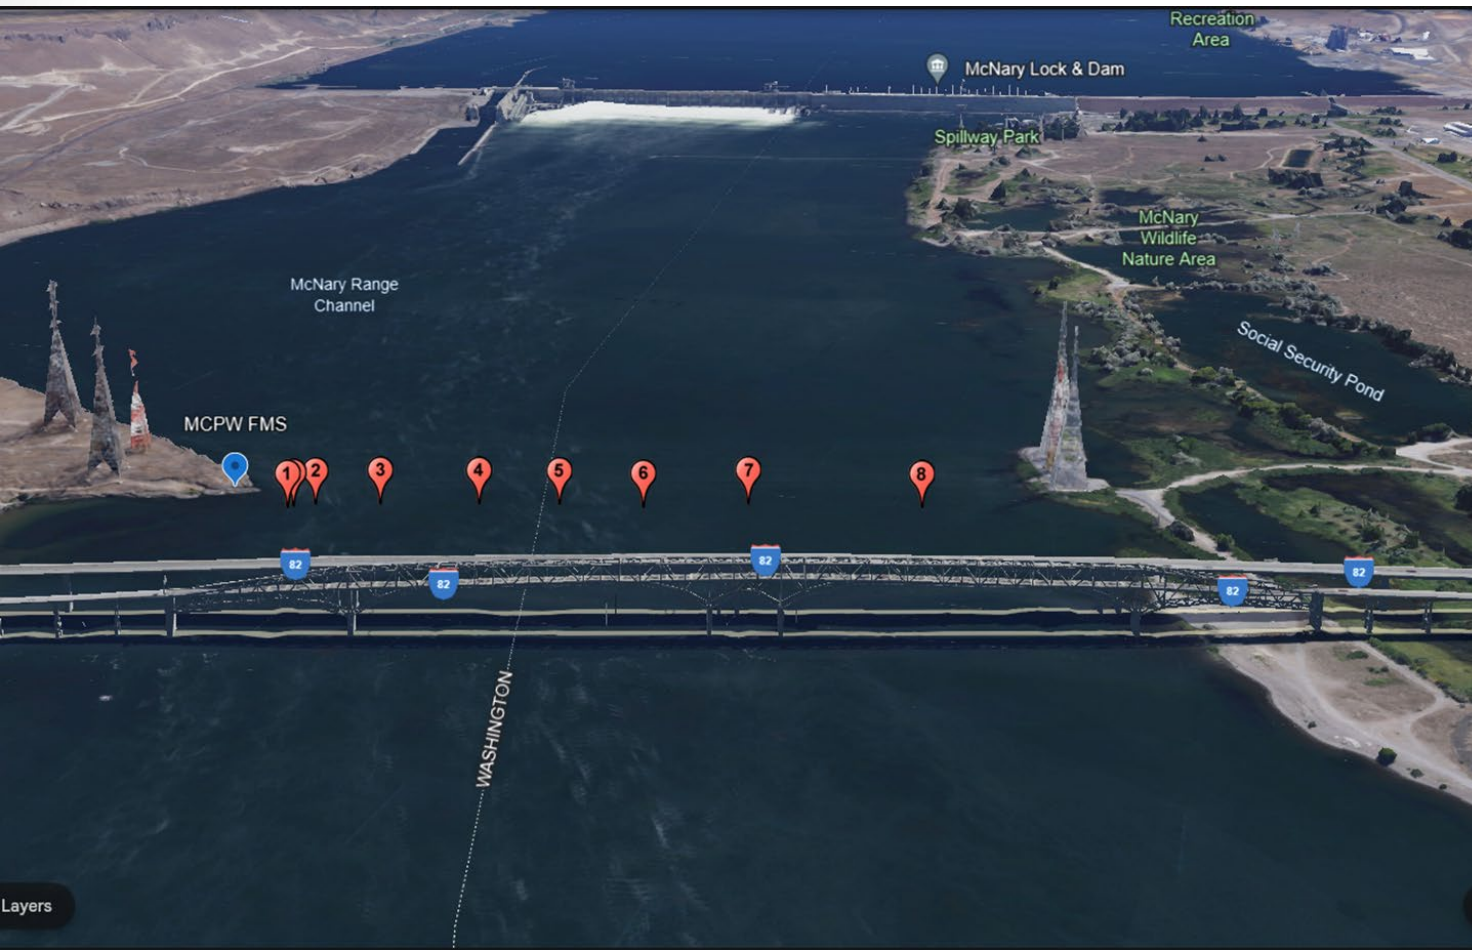
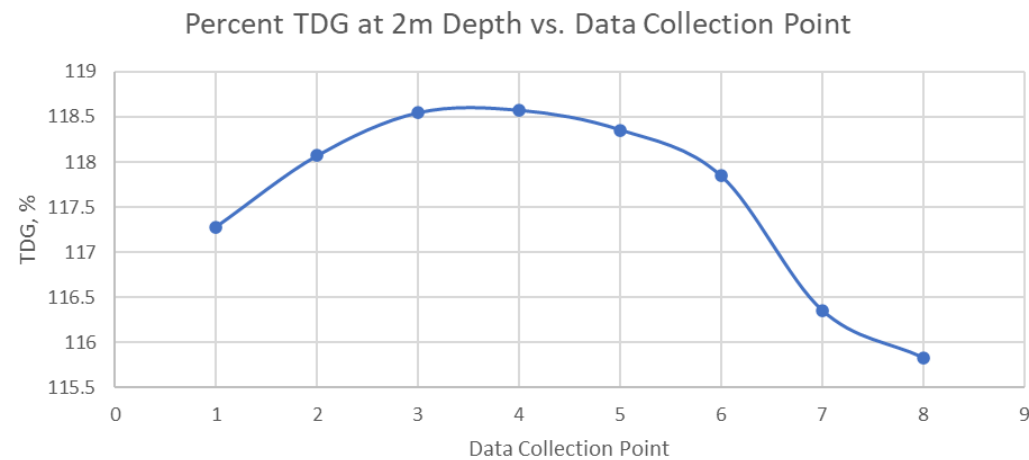
TDG Results Table						
Date	Time UTC	Air Pressure	TDG	Depth	TDG	Field Notes
MM/dd/yyyy	hh:mm:ss	mmHg	mmHg	ft	%	
4/16/2024	18:00:00	761.0	894	21.3	117.5	MCPW FMS reading: TDG = 117.4%, Depth = 19.0 ft
4/16/2024	18:08:00	761.0	893	5.6	117.3	Point 1
4/16/2024	18:22:00	761.0	899	6.1	118.1	Point 2
4/16/2024	18:38:00	760.9	902	7.6	118.5	Point 3
4/16/2024	19:50:00	760.3	902	6.1	118.6	Point 4
4/16/2024	20:20:00	760.0	900	6.1	118.4	Point 5
4/16/2024	20:48:00	759.9	896	6.6	117.8	Point 6
4/16/2024	21:25:00	760.6	885	6.8	116.4	Point 7
4/16/2024	21:52:00	759.3	880	6.5	115.8	Point 8
						<b>Flow 174 kcfs</b>
						<b>Spill 115 kcfs</b>

TDG was measured and observed for each of the red pinpoints spanning the Columbia River below McNary Dam and upstream of the I-82 bridge. Points 1 through 8 represent the TDG measurements taken at approximately 6-ft depths. The red star pin represents the correlation measurement with the Fixed Monitoring Station (FMS) MCPW, taken at approximately 20-ft depth.

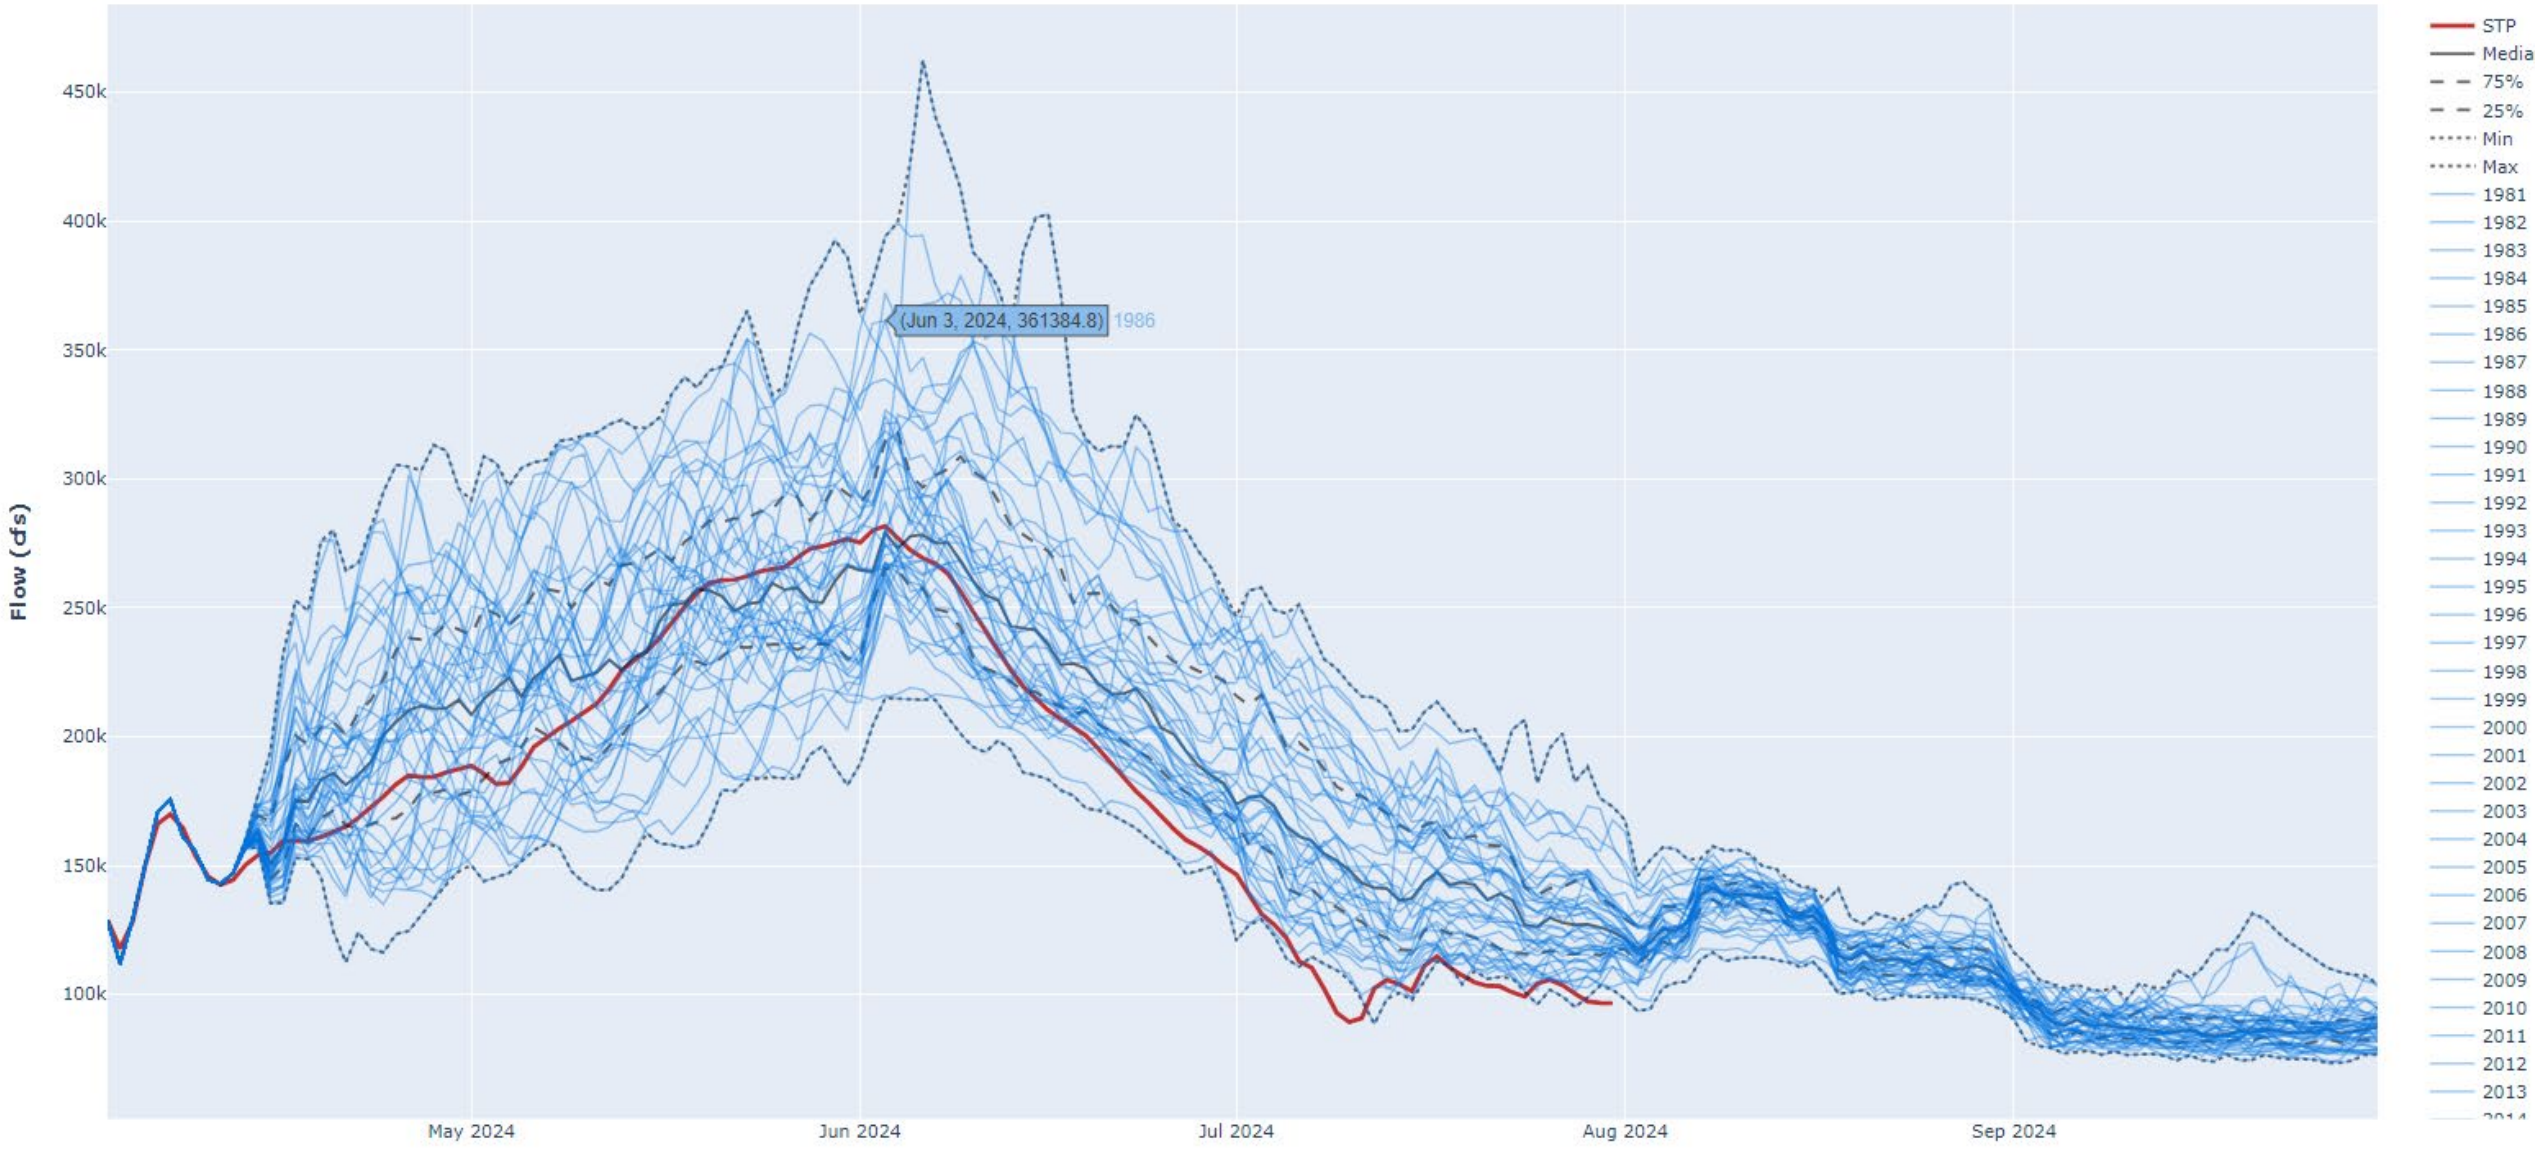
# McNary Inflow

Corps of Engineers Projections Based on 43 Ensemble Streamflow Prediction Traces  
by the Northwest River Forecast Center, National Weather Service, NOAA
