# **Behavior of White Sturgeon Near Hydroprojects and Fishways**

M.J. Parsley, C.D. Wright, B.K. van der Leeuw, E.E. Kofoot  
U.S. Geological Survey  
Western Fisheries Research Center  
Columbia River Research Laboratory  
5501A Cook-Underwood Road  
Cook, WA 98605

U.S. Army Corps of Engineers  
Portland District

Submitted:  
July 14, 2006

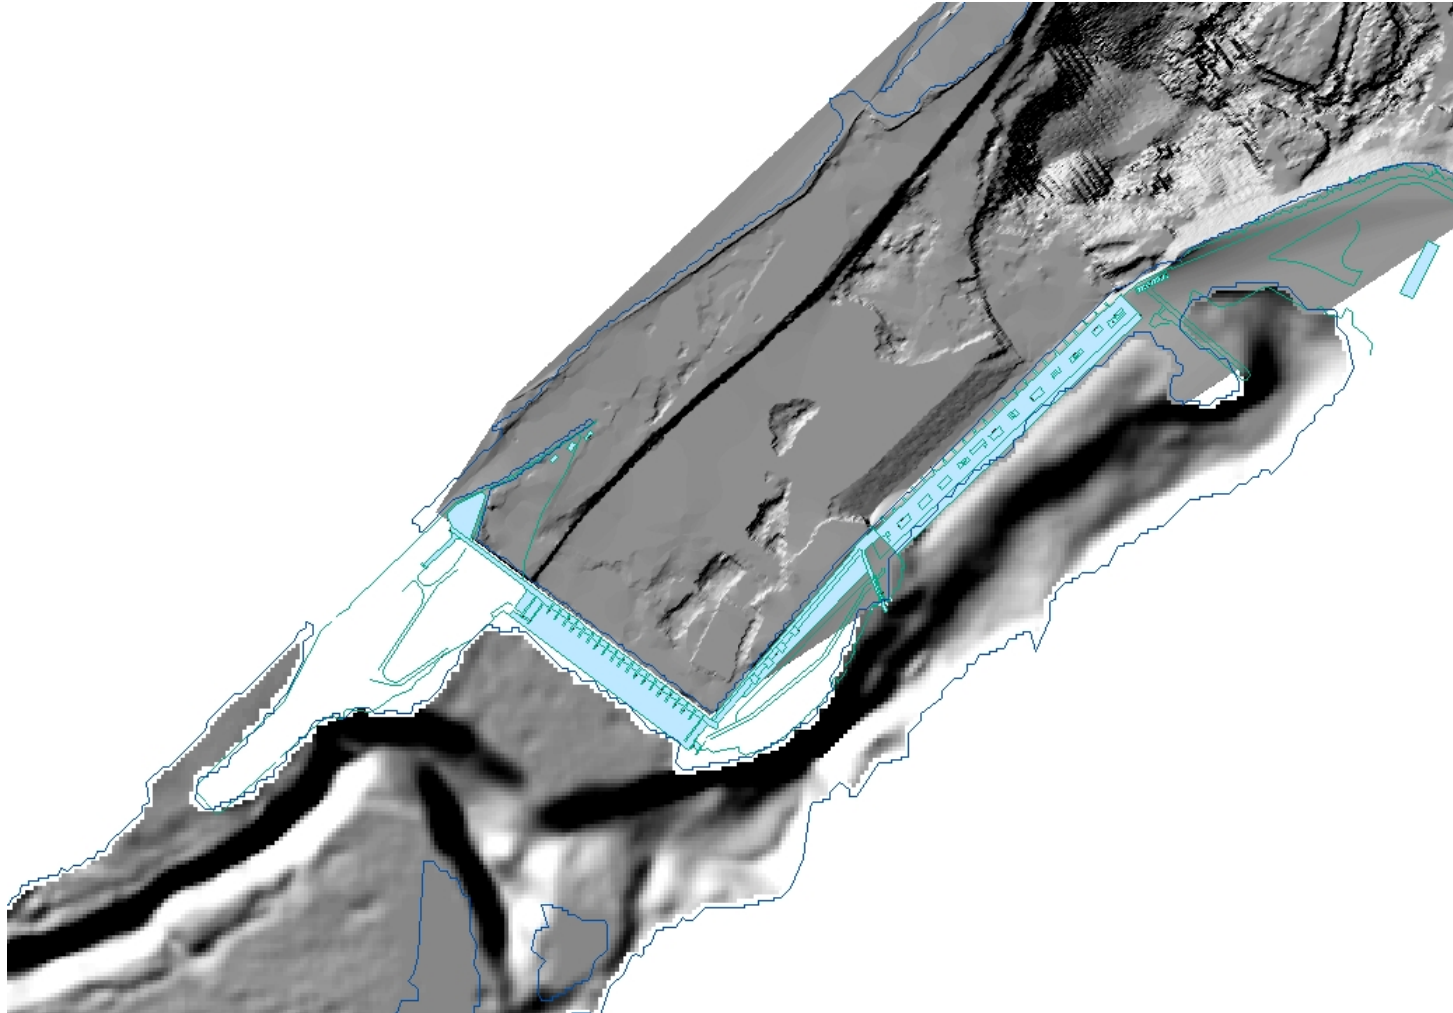
Figure 1. Shaded relief of river bathymetry near The Dalles Dam. River flow is from right to left. Note the excavated forebay and depression immediately in front of the turbines created during construction. The original river thalweg followed the channel to the lower right of the image, which was plugged with rock during construction and created the area called the cul-de-sac.

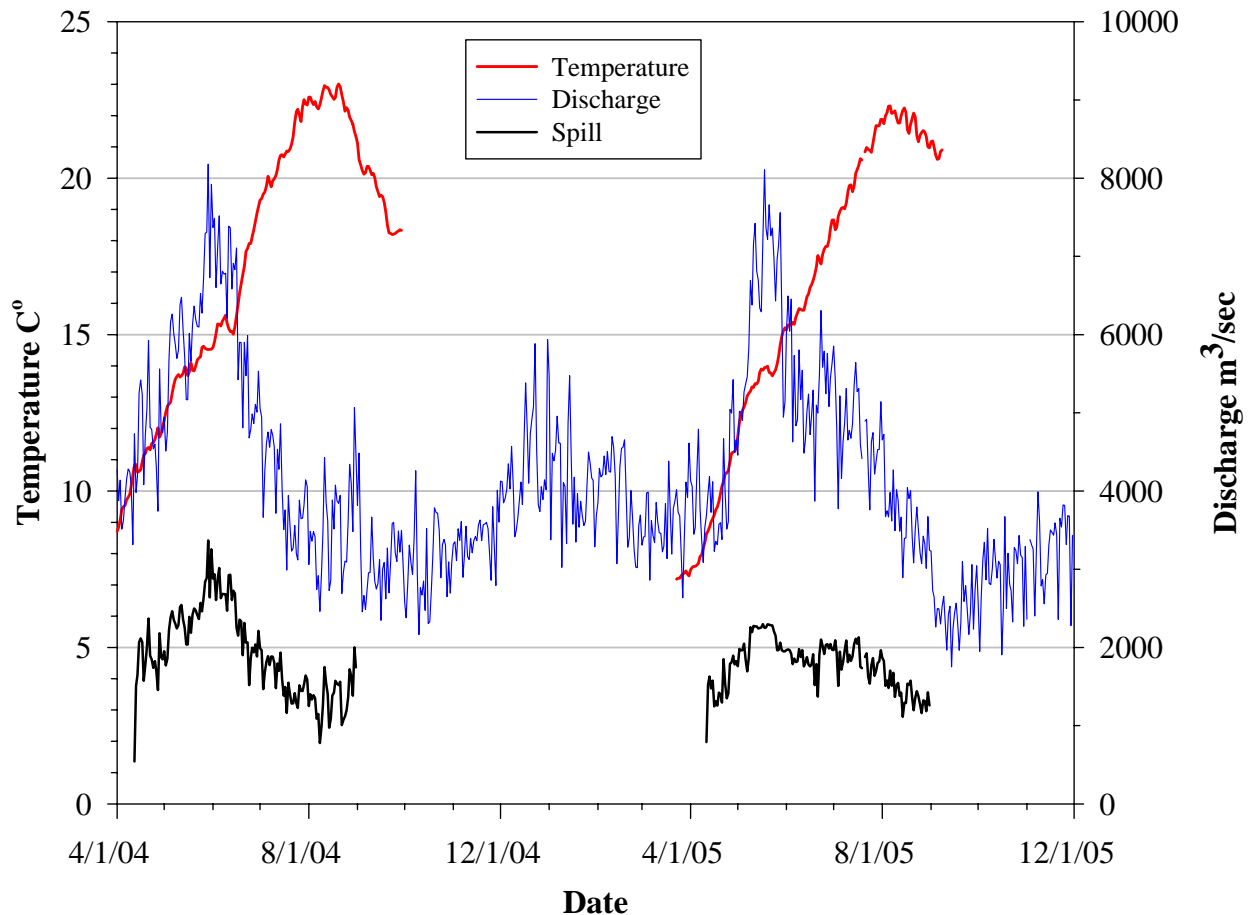
Figure 2. Mean daily water temperatures (red; upper line), total river discharge (blue; middle line), and spill discharge (black; lower line) that occurred during the study period. Data were obtained from the Columbia River DART website (<http://www.cqs.washington.edu/dart/>). Temperature data were not available for the late fall, winter, and early spring.

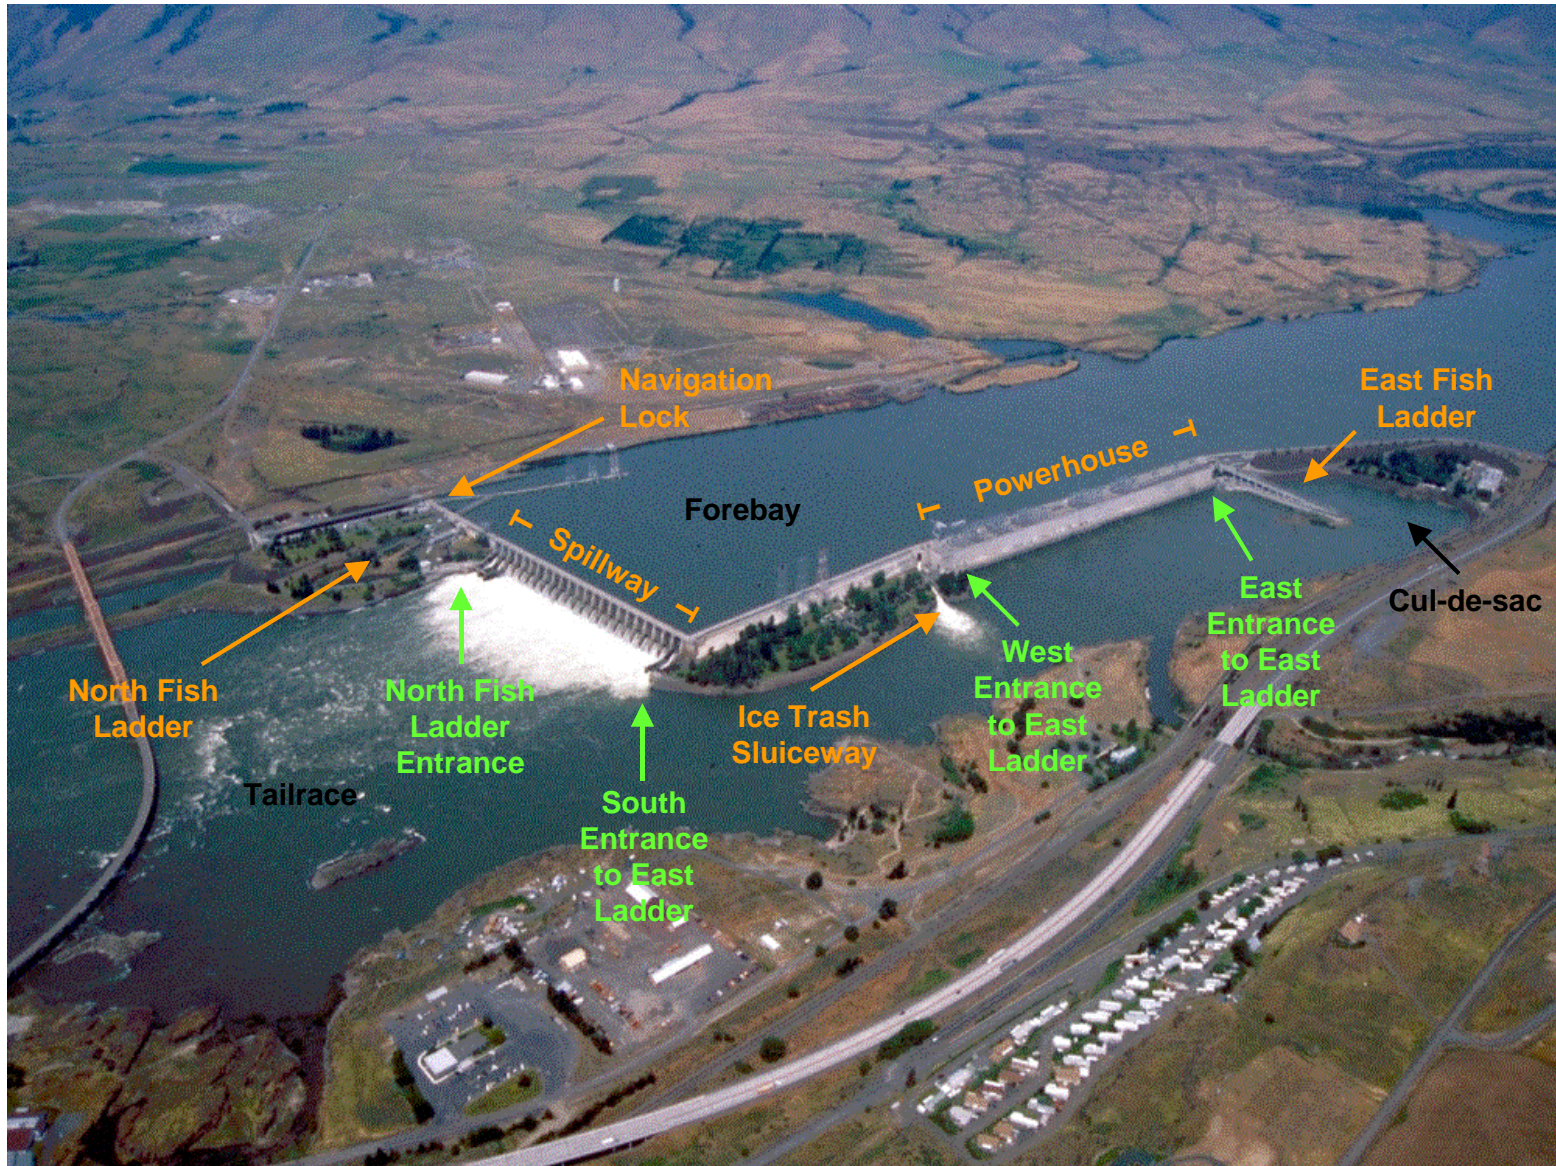
Figure 3. Aerial photograph of The Dalles Dam with key fish passage features noted.

The river bottom near the dam is comprised of relatively flat excavated regions upstream of the dam, as well as deep holes and gorges upstream and downstream formed by the basalt flows that constrained the original river channel (Figure 1). The total river discharge, spill, and water temperatures that occurred during the study period are show in Figure 2. The Dalles Dam has two fish ladders; both are overflow weir ladders with orifices. The North ladder has one entrance while the East ladder has three separate entrances (Table 1, Figure 3).

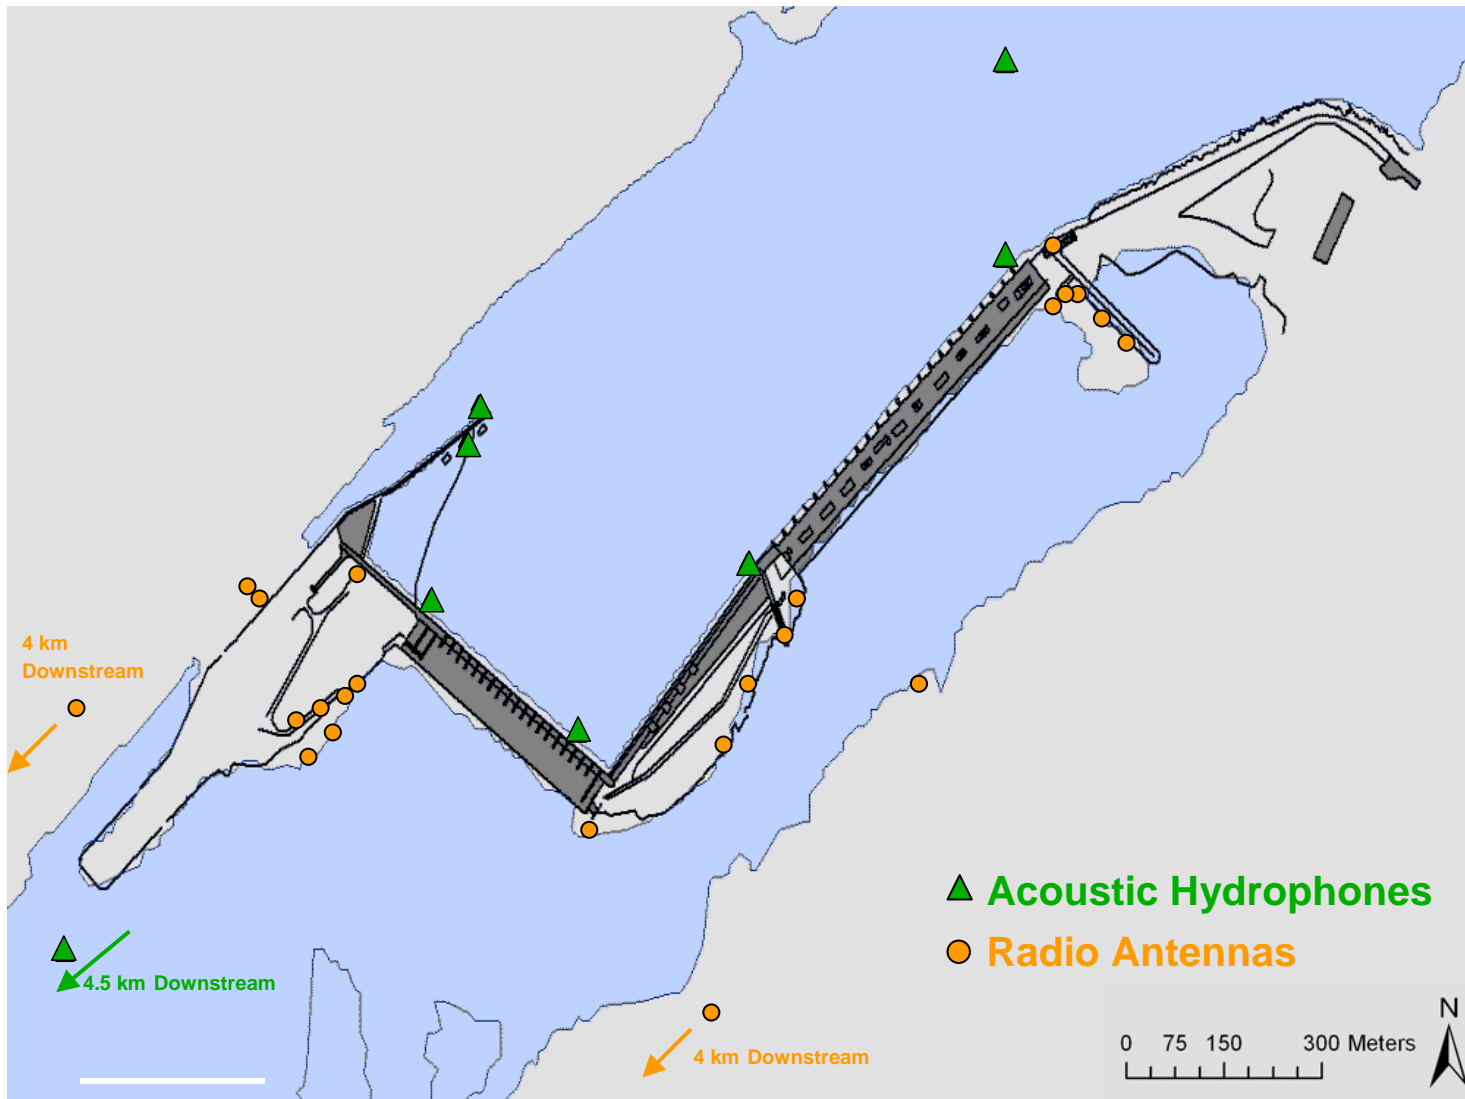
Figure 4. Locations of acoustic hydrophones and radio antennas around The Dalles Dam during 2004. Two radio antennas and one hydrophone were located 4 and 4.5 km downstream of the dam and are not illustrated in their proper location in this graphic.

Radio antennas and hydrophones were dispersed to provide coverage of key areas (Figures 4 and 5). Radio antennas provided coverage primarily of the fish ladders while hydrophones were used to provide coverage of areas where water depths would attenuate radio signals. During 2004, four acoustic receivers with seven hydrophones were installed in the forebay of the dam and one acoustic receiver with a single hydrophone was installed approximately 4 km downstream of the dam at the existing USGS gauging station (Station 14105700). Thus in 2004 the hydrophones and receivers provided forbay use information and dispersion to the downstream gate, while radio antennas and receivers provided information primarily on fish ladder use with limited coverage of the immediate tailrace. Radio receiver sites remained fixed throughout the study period but additional acoustic receivers and hydrophones were added in 2005. In addition to the radio sites at The Dalles Dam, radio receivers throughout the Bonneville and Dalles reservoirs operated by the University of Idaho were also set to monitor for these sturgeon. Periodic mobile surveys with portable radio and acoustic receivers operated from a vessel were also conducted to document sturgeon presence as far downstream as the estuary.

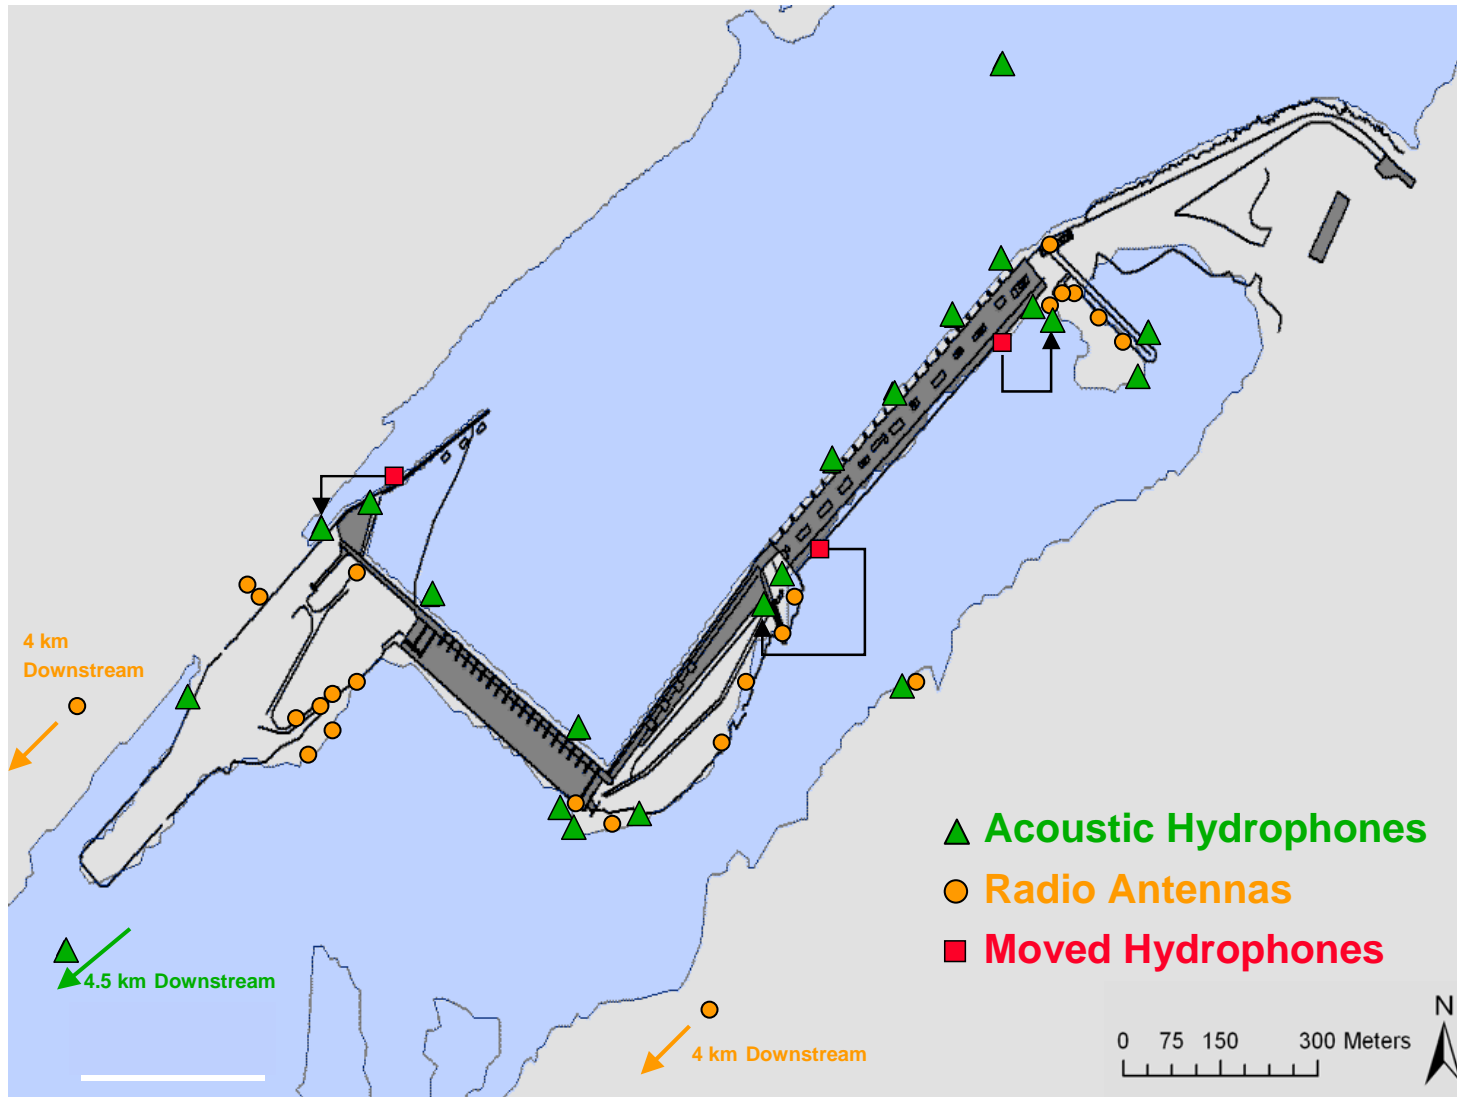
Figure 5. Locations of acoustic hydrophones and radio antennas around The Dalles Dam during 2005. Thirteen additional hydrophones were added and three existing hydrophones moved in 2005 to provide better coverage.

During 2005 an increased emphasis was placed on determining routes of downstream passage and eight additional acoustic receivers with 13 hydrophones were added to the existing array (Figure 5). These were positioned to increase the acoustic coverage of the tailrace, the forebay side of the powerhouse, and navigation lock. Figure 6 shows the approximate detection ranges of all acoustic hydrophones used during the study. Recognizing that maintaining hydrophones within the zone of spill downstream of the dam would be problematic, an approach was taken to maximize the probability of detecting fish that passed downstream through the turbines, ice/trash sluiceway, and navigation lock, leaving the tailrace side of the spillway as the only unmonitored passage route. With this approach, we assumed that any fish that passed downstream and was not noted as passing via these monitored routes must have passed through the open spill gates. Additional hydrophones were deployed to determine the direction of fish movement between the powerhouse and spillway areas, giving further information on their routes of downstream passage.

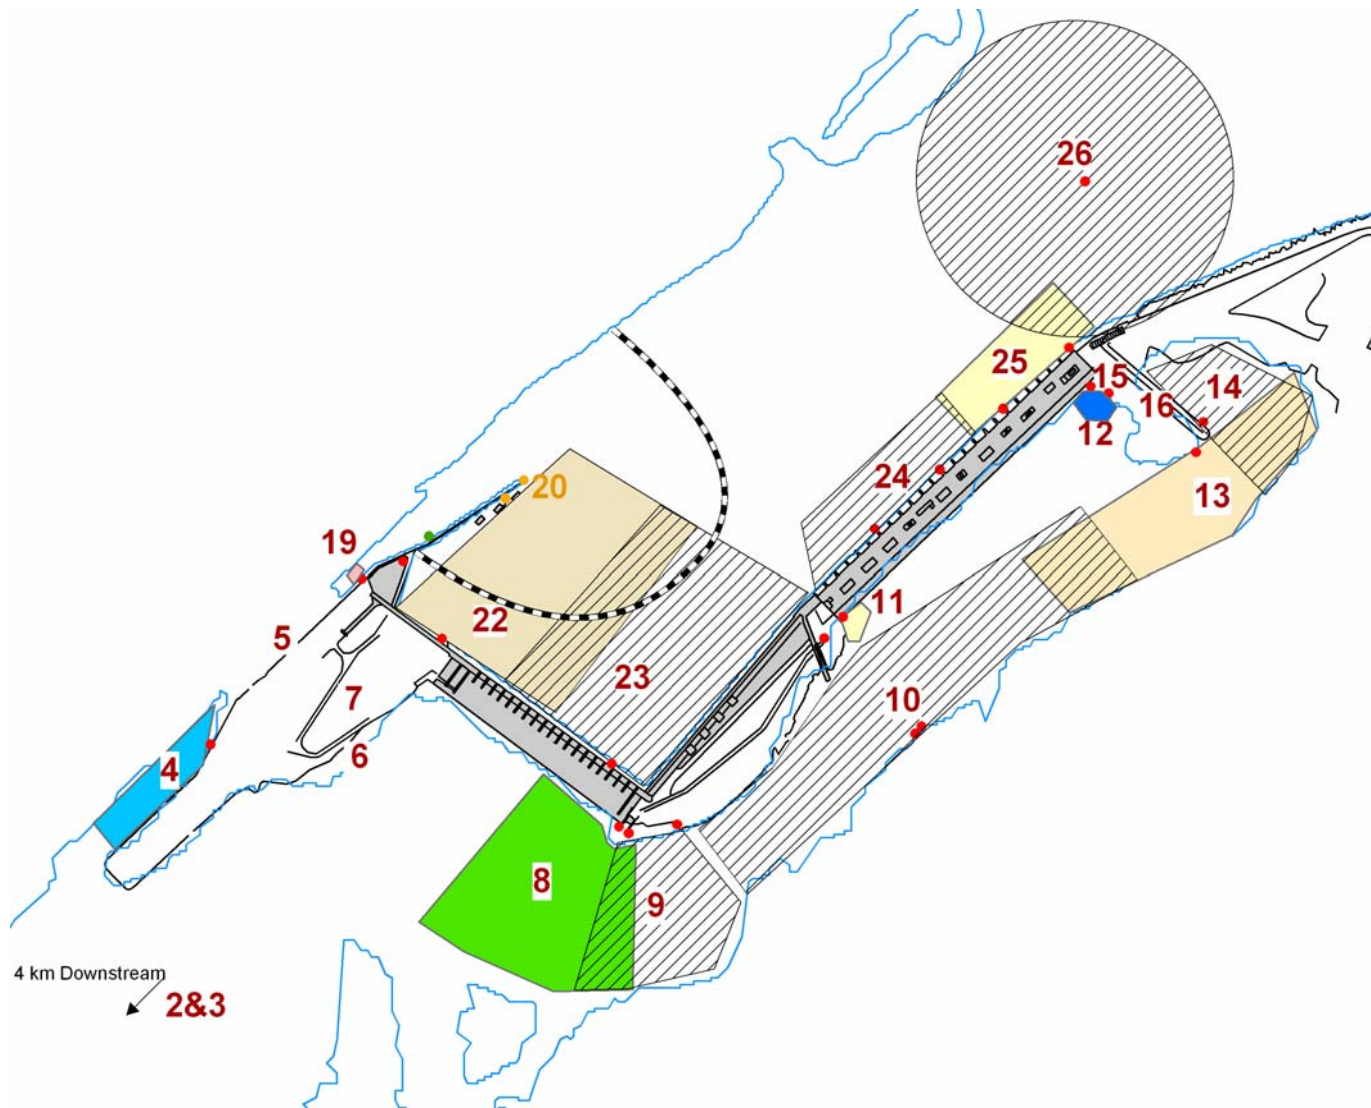
Figure 6. A generalization of the zones of detection of hydrophones deployed during this study. Daily ambient acoustic conditions, riverbed morphometry, and seasonal changes in river discharge and dam operations influence detection ranges. Location 20 was removed after 2004; the dashed line around it indicates its estimated zone for the time it was operational.

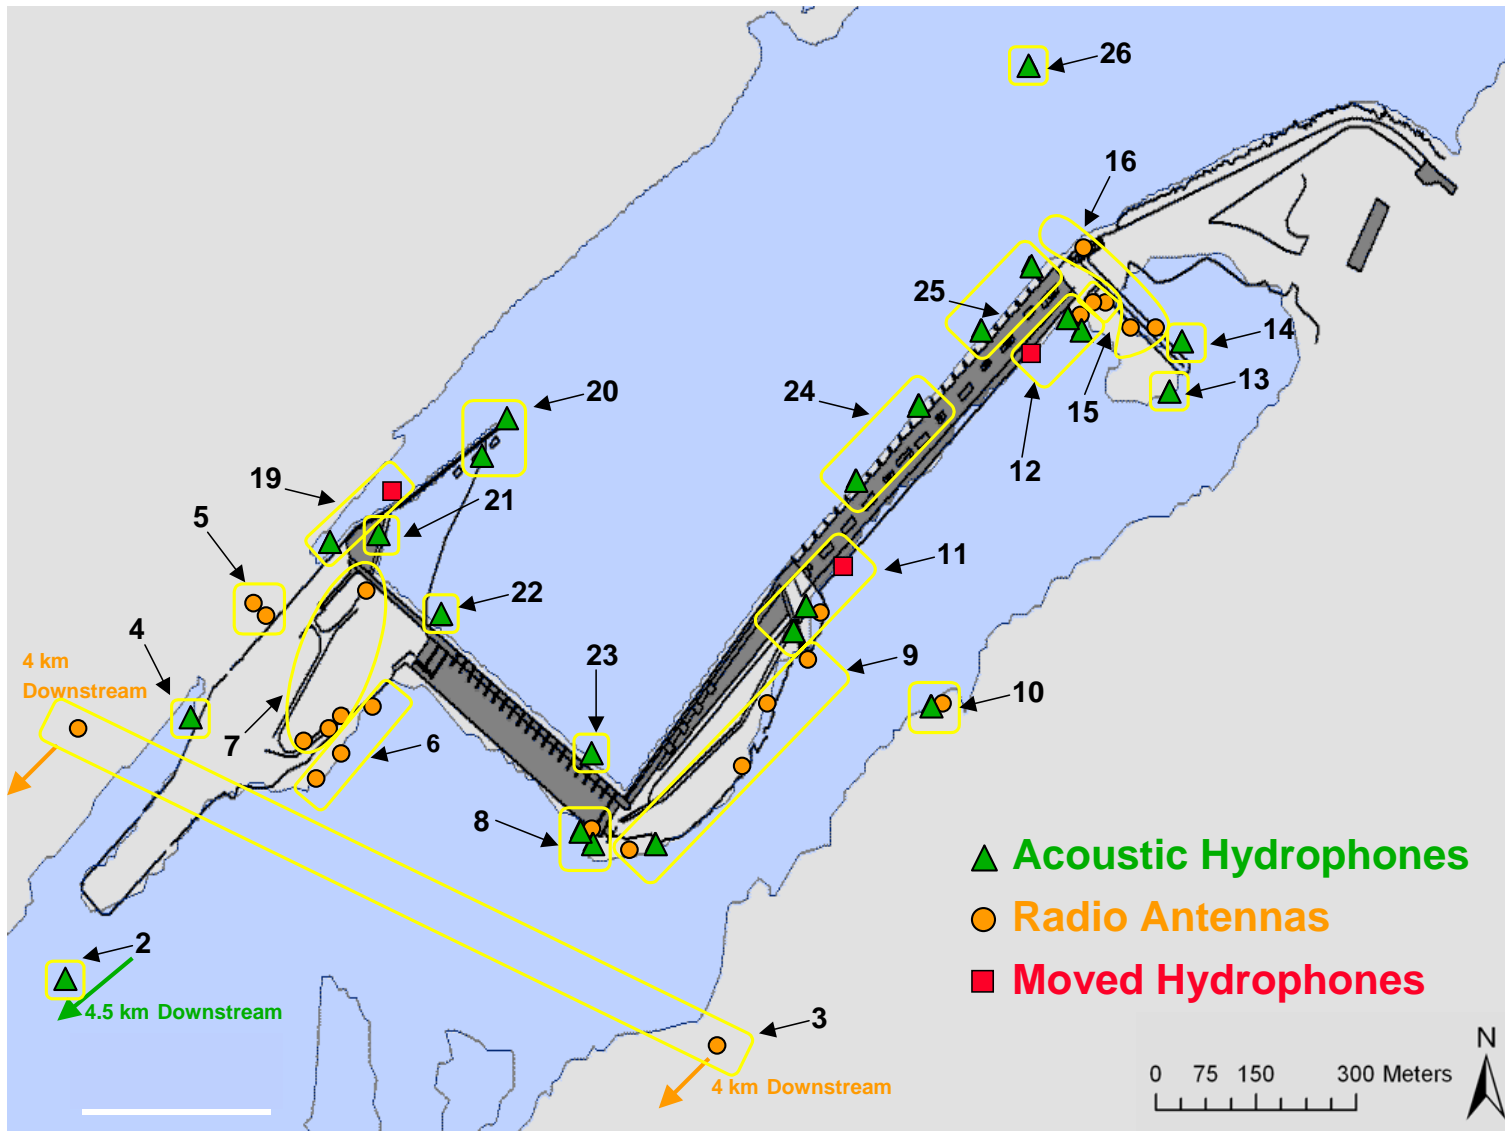
Figure 7. Aggregations of hydrophones and radio antennas and associated site locations used in analyses. Hydrophones and antennas bounded by lines were aggregated into a single site, indicated by a numeral, for analysis.

The acoustic and radio datasets were then combined into a summary dataset. Data were condensed by noting first and last detections of a fish at a specific site, then eliminating the redundant data between the two events. Daily individual fish histories over time were created by aggregating radio and acoustic data among antenna and hydrophone sites. Fish that were detected at more than one site during a given day were assigned to the location with the most detections. This enabled the display and examination of individual long-term movement patterns and passage events. Broader scale population movements were assessed by aggregating data from specific hydrophones and radio antennas located in close proximity to each other into single sites (Figure 7).

(Figure 11). The fish was consistently detected at hydrophone group 8 (Figure 7) located at the south end of the spillway from May 9 through June 21. The last detection at hydrophone group 8 was at 1330 hours on June 21 and the first detection on a radio antenna within the north fish ladder at antenna group 7 (Figure 7) was at 1508 hours, suggesting the fish moved across the stilling basin towards the north fish ladder entrance during the period when spill was shut off. This fish had resided in the north fish ladder for an extended period of time during 2004 and was in the north ladder at the conclusion of this study (Figure 10).

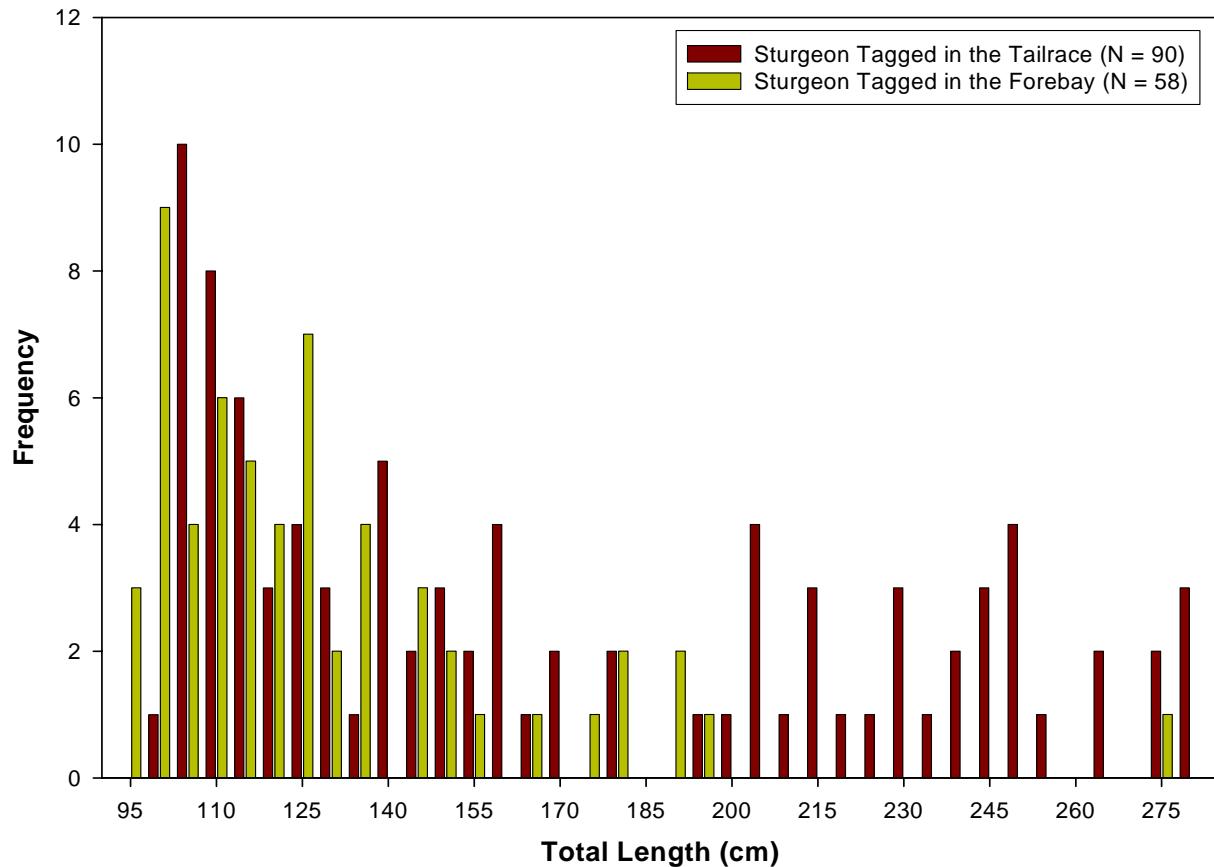
Figure 8. Length frequency of fish tagged in the forebay and tailrace.

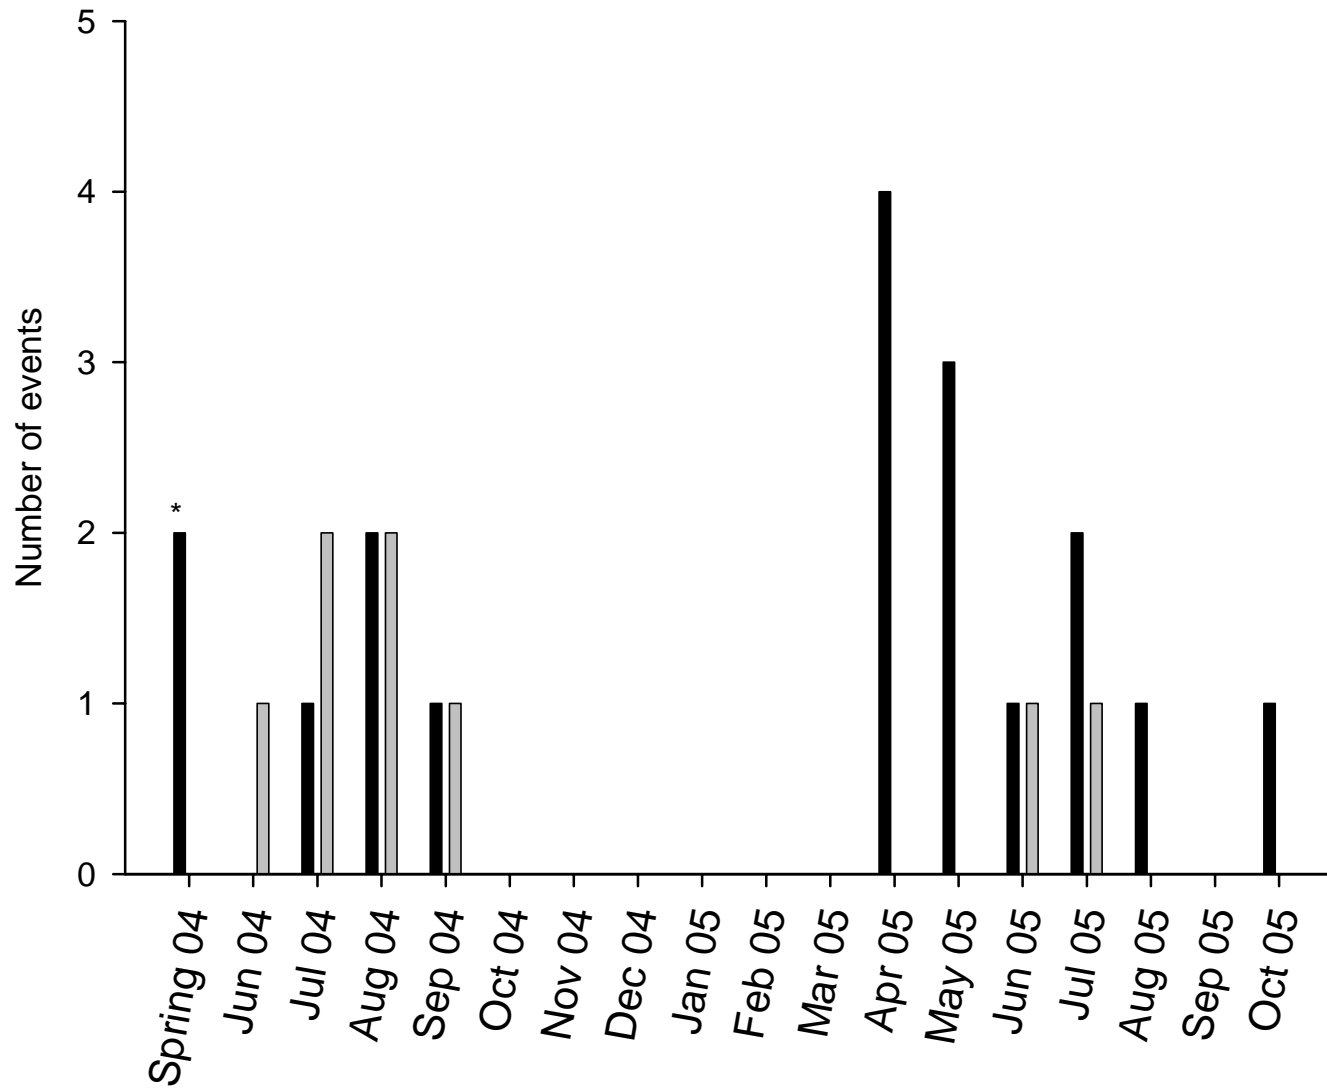
Figure 9. Passage events by month. Black bars indicate downstream passage, and gray bars indicate upstream passage.

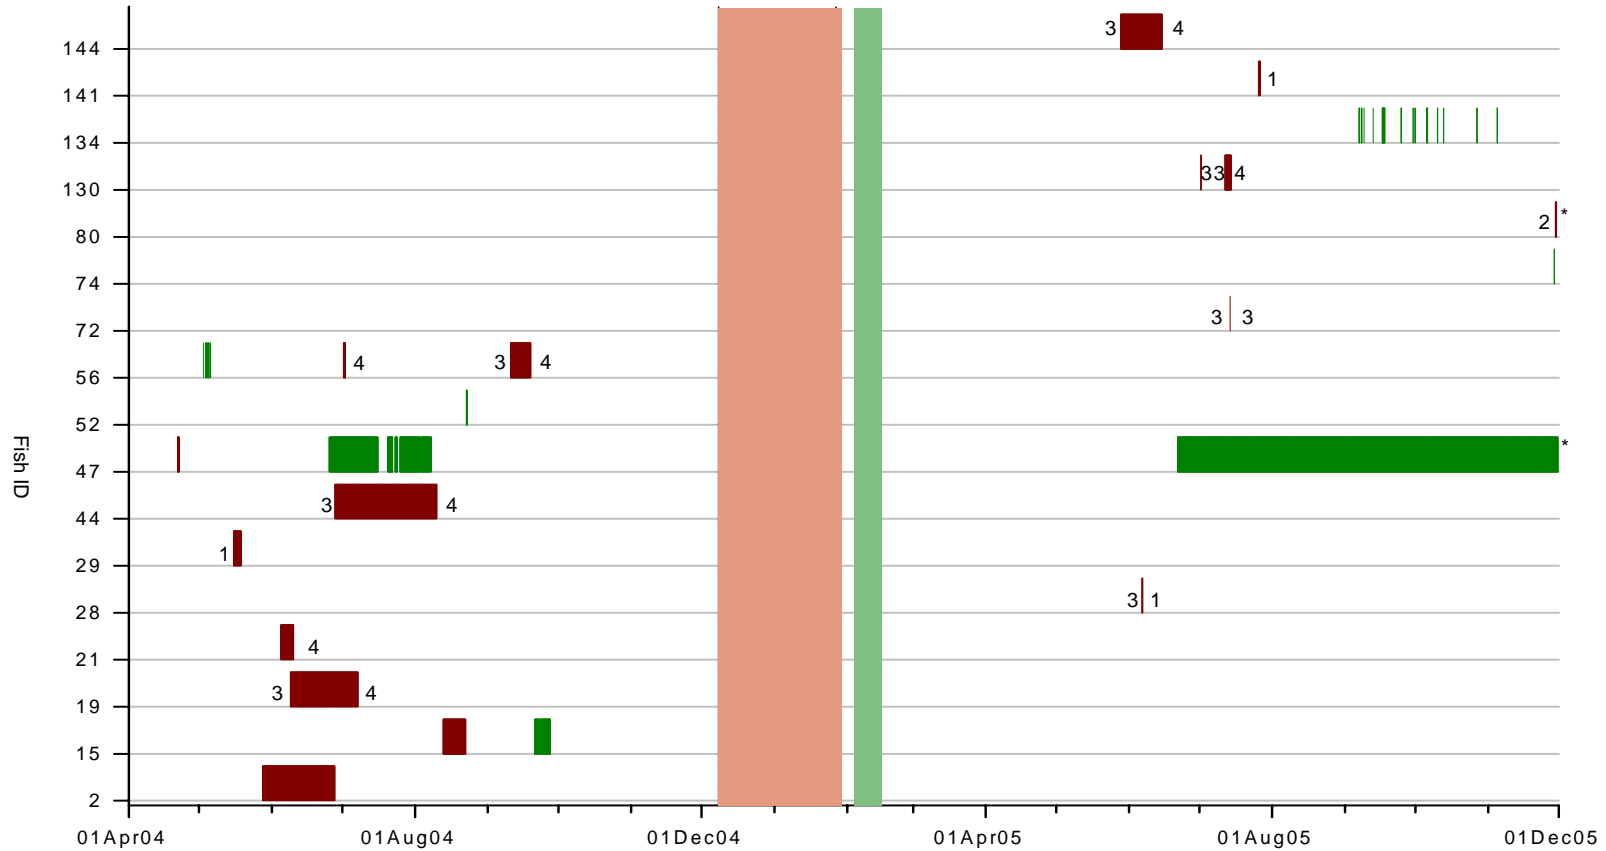
Figure 10. Ladder occupancy by individual fish during the study period and dates when the ladders were dewatered for maintenance. Horizontal green bars indicate residence times in the north ladder and horizontal red bars indicate residence times in the east ladder. Numbers indicate known entrance and exit locations at the east ladder, where 1 = south entrance, 2 = west entrance, 3 = east entrance, and 4 = top of east ladder. The north ladder has only one entrance that is located adjacent to the northernmost spillway. Two fish (ID 47 and 80) were in the ladders at the end of the study. Vertical bars indicate periods when the ladders (green = north, red = east) were dewatered for annual maintenance.

White sturgeon may respond quickly to changes in local hydraulic conditions as dam operations change. One fish (ID 47) entered the north fish ladder on June 21, 2005 at approximately 1500 hours (Figure 10). Interestingly, spillway and north ladder attraction flow operations were suspended on this day for about three hours to inspect the spillway<sup>1</sup>. Spill was stopped at approximately 1200 hours and was restarted sometime between 1500 and 1600 hours

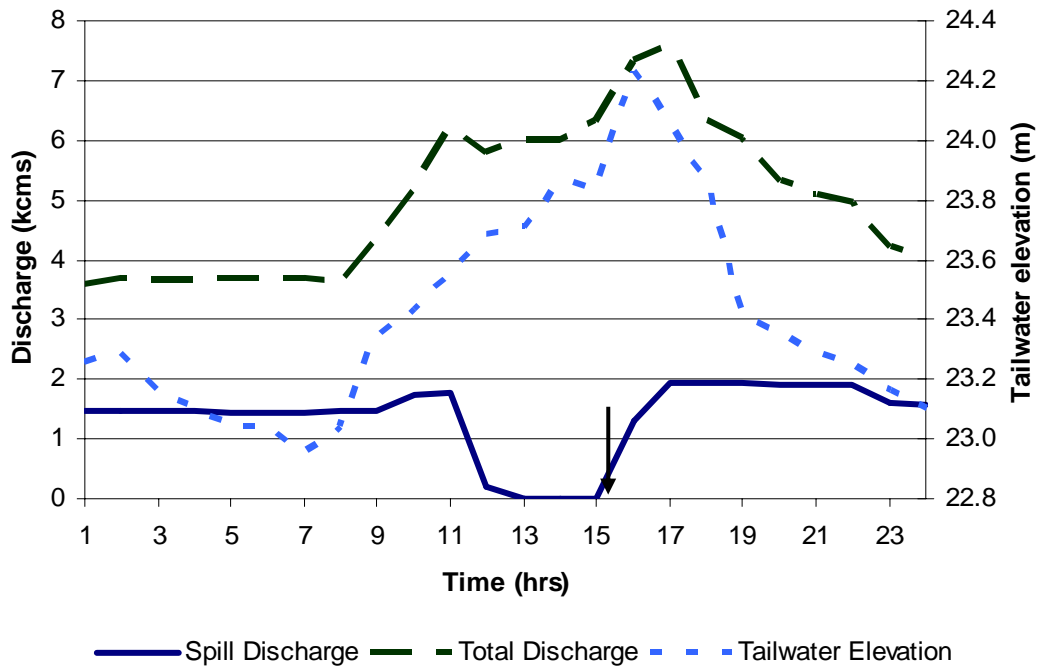
Figure 11. Hourly river discharge and tailwater elevation at The Dalles Dam on June 21, 2005. On this day spill discharge and north fish ladder attraction flows were temporally suspended for while inspections of the spillway were made. One tagged white sturgeon (ID 47) entered the north fish ladder at 1508 hours (vertical arrow). This fish was last detected at hydrophones located on the southern end of the spillway at 1330 hrs.

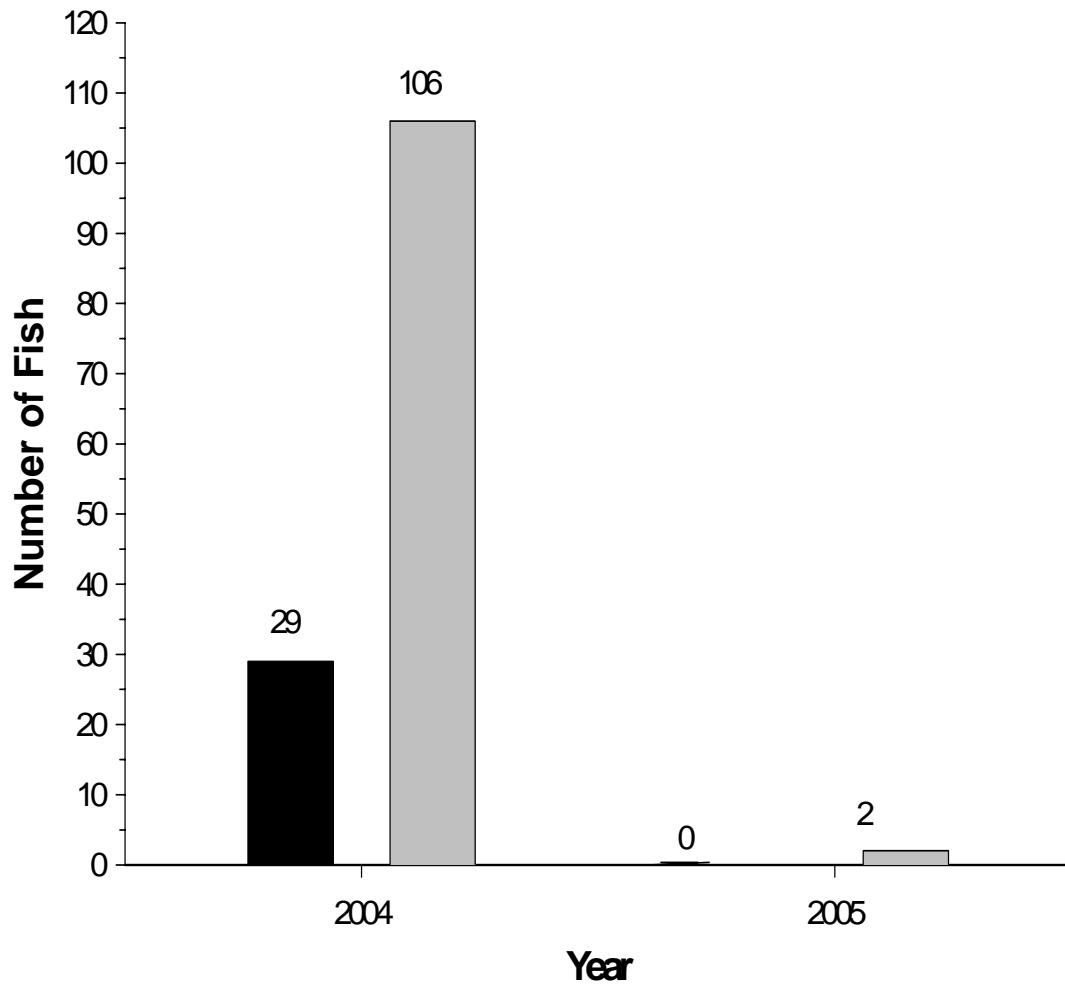
Figure 12. Ladder counts of white sturgeon during 2004 and 2005 (U.S. Army Corps of Engineers unpublished data). Black bars indicate north ladder counts, and gray bars indicate east ladder counts. Counting stations are located in the upper reaches of each ladder, and therefore do not include fish that entered ladders but did not ascend to the counting stations.

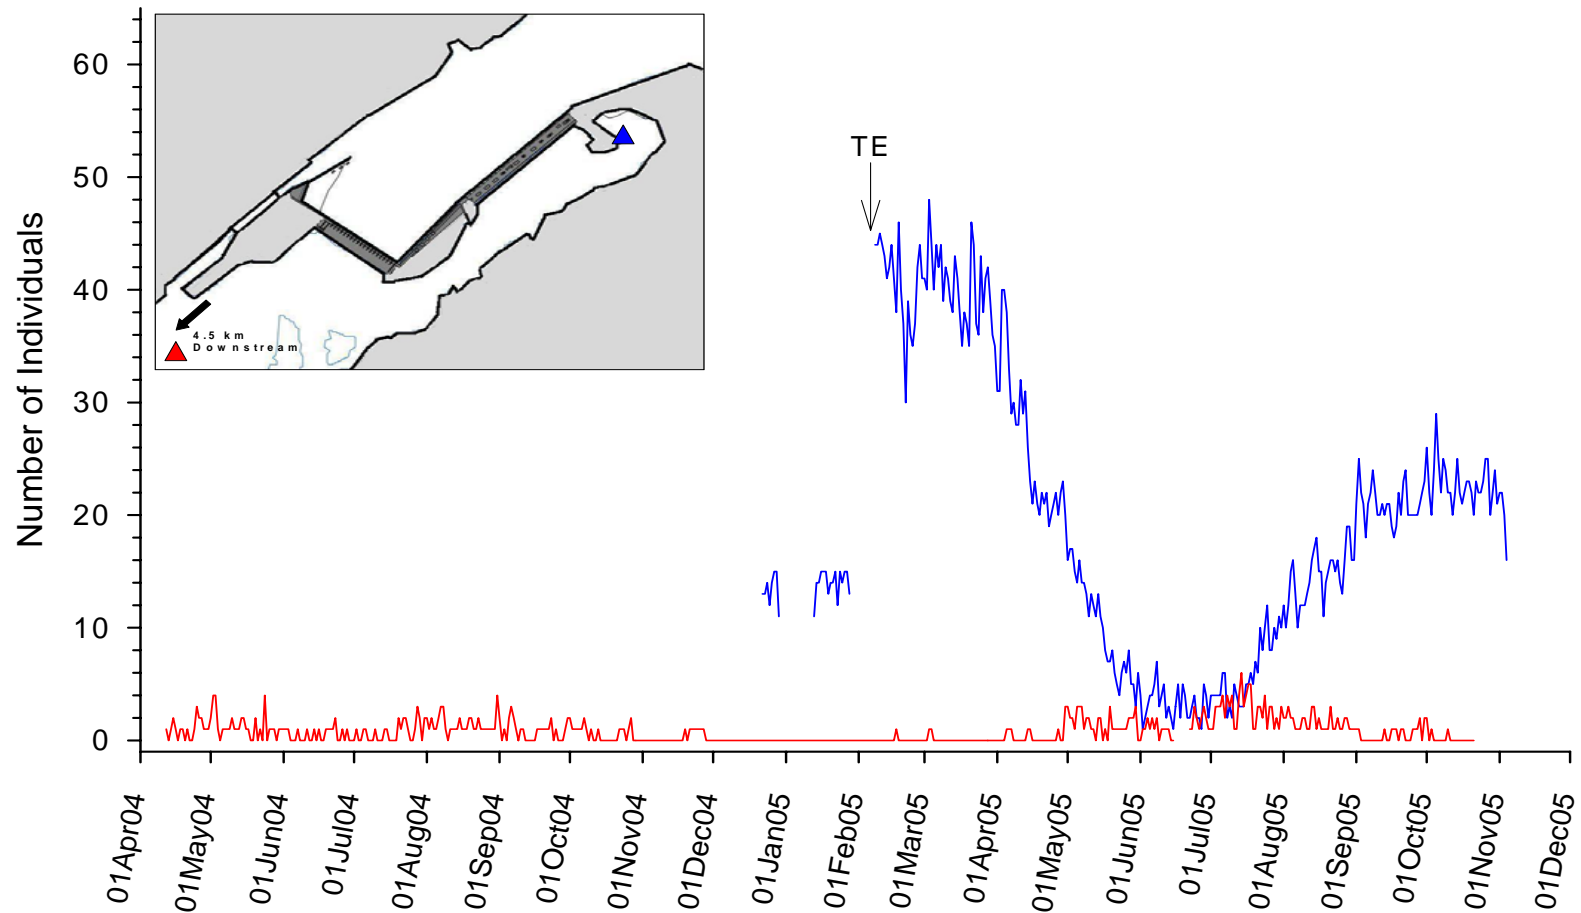
Figure 13. Evidence of a winter aggregation of white sturgeon in the cul-de-sac and a summer dispersal downstream as indicated by the number of individual fish detected at two key hydrophones (see inset); one located in the cul-de-sac (blue line) and one downstream at the gauging station (red line). The solar powered hydrophone in the cul-de-sac was installed in December 2004 and experienced brief power outages due to low daylight conditions. Thirty-nine fish were released into the cul-de-sac during a tagging event (TE) from 31 January – 2 February 2005.

Seasonal patterns of aggregation and dispersal in the forebay and tailrace are evident when plots of the number of individual sturgeon detected each day at distinct hydrophones are examined (Figures 13 and 14). Since there were no hydrophones located in the tailrace near the dam in 2004, only data collected during 2005 can be used to show population movements downstream of the dam. However, the plots show an apparent abundance of fish in the cul-de-sac during winter months, dispersal downstream during spring and summer months, and a reformation of an aggregation in the cul-de-sac during the fall (Figure 13). Detections at other locations around the dam, including the hydrophone located furthest downstream at the gauging station (Location 2), indicate that fish aggregate in the cul-de-sac during winter. Lower numbers of individuals occurred at this downstream area during winter months and numbers increased during spring and summer (Figure 13), supporting a pattern of dispersal from an upstream wintering area in the cul-de-sac.

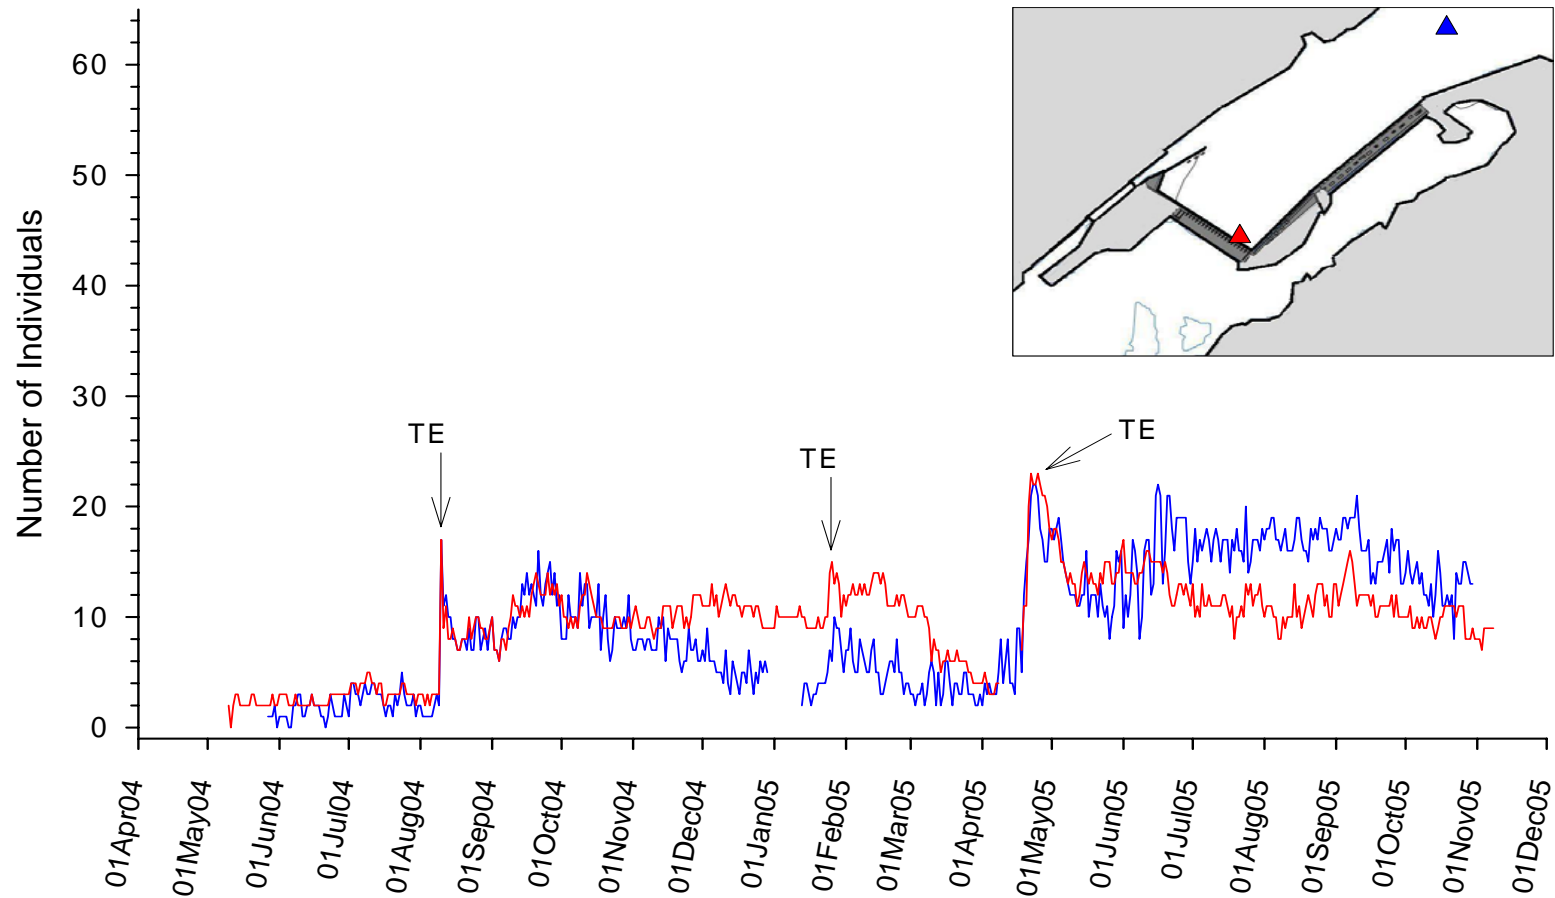
Figure 14. Evidence of a seasonal aggregation of white sturgeon in the forebay as indicated by the number of individual fish detected at two key hydrophones (see inset); one located on a barge moored in the forebay (blue line) and one deployed along the spillway proximal to the non-overflow wall (red line). The solar powered hydrophone on the barge experienced a brief power outage during late December 2004 and early January 2005 due to low daylight conditions. Additional fish were released into the forebay during three tagging events (TE); 20 fish were released during 9-12 August 2004, 9 fish during 24-28 January 2005, and 21 fish were released during 18-22 April 2005.

The tagged white sturgeon in the forebay showed a less distinct pattern of seasonal aggregation. During winter of early 2005 more white sturgeon were detected at hydrophones near the spillway when compared to detections at the forebay barge (Location 26; Figure 14). Conversely, during the late summer and fall of 2005 a slightly greater number of white sturgeon were detected at the forebay barge (Location 26) than at hydrophones near the spillway.
